REPORT ON
**FLOOD
MITIGATION
KOCHI**

IRRIGATION DEPARTMENT
ERNAKULAM
2021

EXECUTIVE SUMMARY

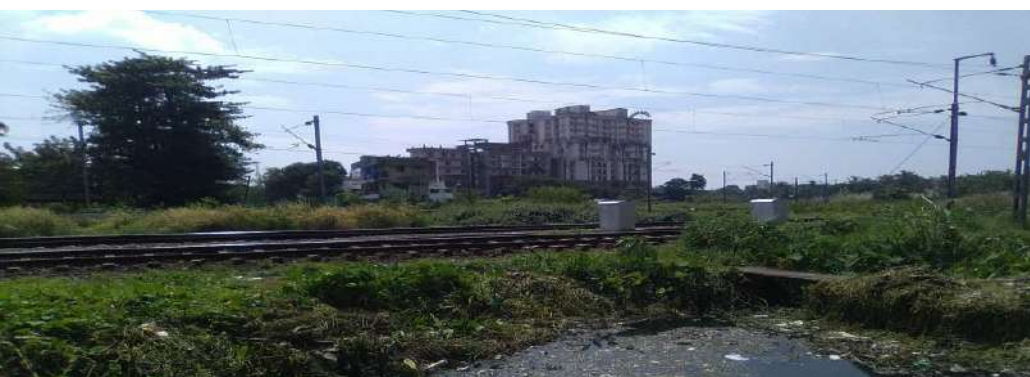
The main obstruction for free flow of water through this canal is at the Railway crossing portion. The canal at Ch.4.512km is crossing the Ernakulam - Kottayam railway line (Triangular Junction) with a mere width of 1.2m. The length of railway track crossing is 81m with a width of 1.2m. The width of canal on U/S and D/S side of railway track is about 6m. The 360 degree turn of water to cross railway track is the major cause of flooding in Ernakulam City during heavy rain. The railway line virtually divides the canal into two parts. The flow in this part is completely blocked. The railway culvert is not sufficiently wide enough to have continuous flow of the canal. Only an underpass is joining the 2 parts of the canal. The Canal is split into two by Ernakulam - Kottayam railway track. The Canal has to be constructed straight instead of existing route which is taking a 360 degree turn for a length of 81m. the straight length of canal is only 41m and can be constructed with advanced construction technologies like Push Through method, this is the major cause of flooding in Kochi Corporation. The South Railway Station, KSRTC and surrounding areas face flood like situation every year during monsoon season. This can be prevented by making canal to its full width as in U/S and D/S and by avoiding sharp bends. The construction has to be done in co-ordination with Railway Authorities and Railway Traffic has to be regulated during construction season. These are illustrated in Fig 15 & Fig.16 and the works to be carried out are described below.

Schematic diagram of the obstruction at Railway track crossing

- Clearing light, thick and thorny jungle.
- De-silting and removal of debris
- Shifting of cables, pipes and ducts
- TP Canal is crossing 4 Lane Main Railway track with sharp bends. The canal is taking 360 degree turn to cross railway track and joins with original canal. The width of canal is only 1.2m. TP Canal is taking a U Turn to cover a length of 41m. The existing box culvert has to be replaced and canal has to be made straight across railway track to discharge flood water.
- Construction of New Canal by Push Through Technique for a length of 41m.
- 4 Major Drains discharging storm/effluent water into TP Canal - To be relocated and re-constructed scientifically.
- Install Sewage Treatment Plants

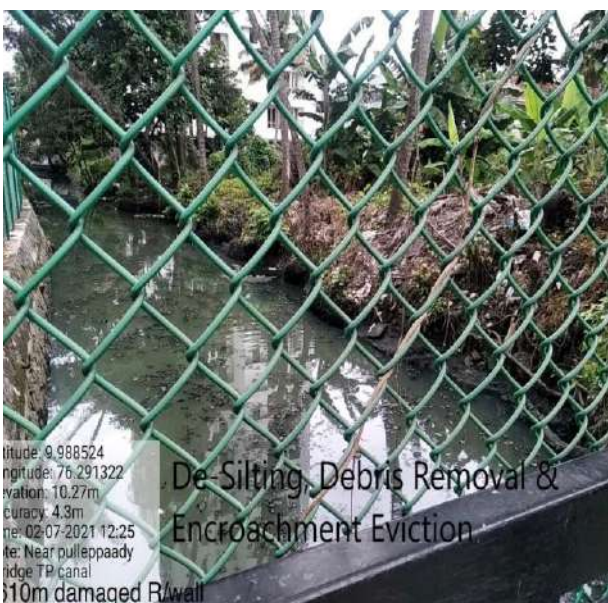
Encroachment – To be evicted

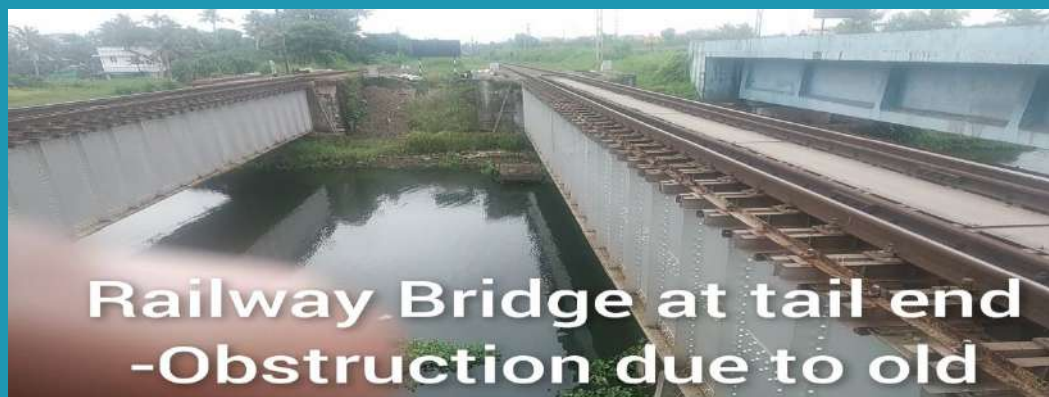
The depth on mouth of TP Canal where the Canal meets Chitturpuzha is very less. Considerable silt and debris are deposited on mouth of canal and it prevents discharge of City Storm Water into Kayal/Puzha, There are 3 Railway Bridge situated on mouth of TP Canal. The girder of one bridge (1st Bridge on U/S) is low lying and flood water touched the bottom of girder during 2018 flood. The deposition of silt and debris on mouth of canal creates Afflux and City area will get flooded even for a small intensity rain. There are some damaged remains of concrete structures which also obstructs the normal flow of water. The Water Flushing Mechanism of TP Canal is possible only after the removal of Delta on mouth of TP Canal. This reach is shown in Fig.24. The following works have to be carried out in this reach to clear dark grey water in TP Canal.

Railway Bridge to be Raised and Removal of Deposited Silt

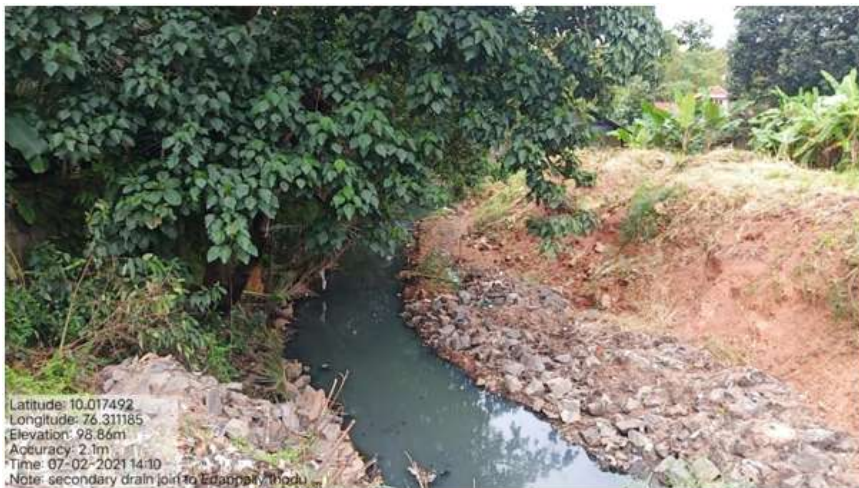
(i) Chainage 3230 : Drain joining to Edapally thodu

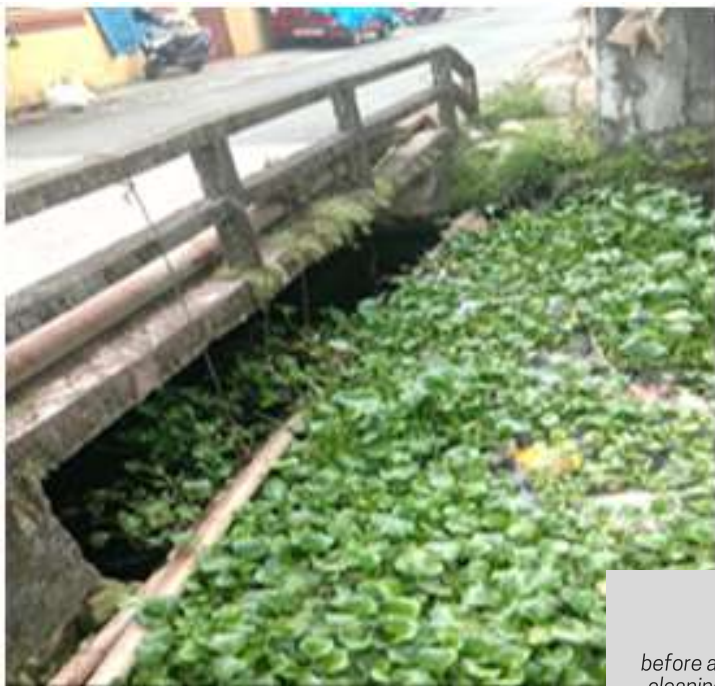
Near joining point of Adimurithodu before and after cleaning.(OBT)

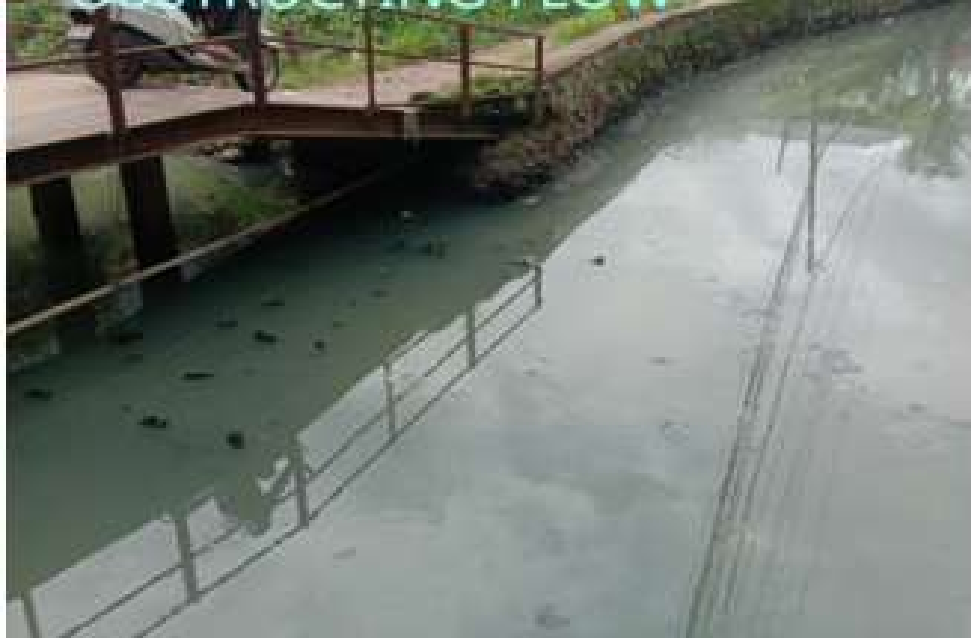
At Ch :995m Culvert At Adimuri Thodu Junction

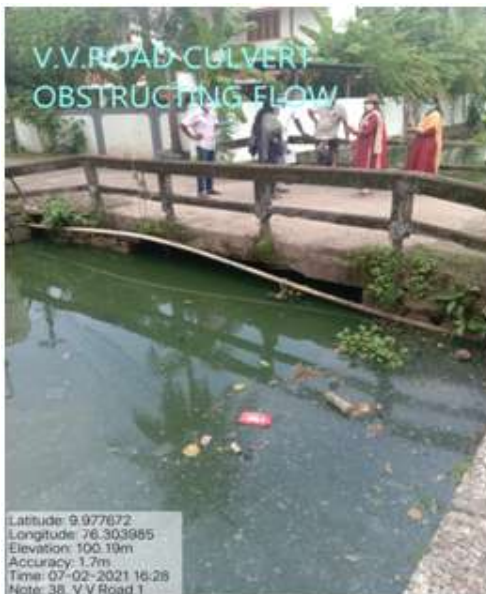
At Ch: 4068m-V.V.Road Culvert

The culverts in the V.V.Road (ch. 4068m) and St. Sebastian Road(ch. 4155m) have very low vertical clearance and a narrower water way and need to be reconstructed .The area has been subjected to flooding during heavy rains. There is an iron bridge at Ch 4408m at the downstream of Railnagararea .Waste accumulation and presence of water weeds,improperly aligned cable have been noticed here which causes hindrances to the uninterrupted flow of water.

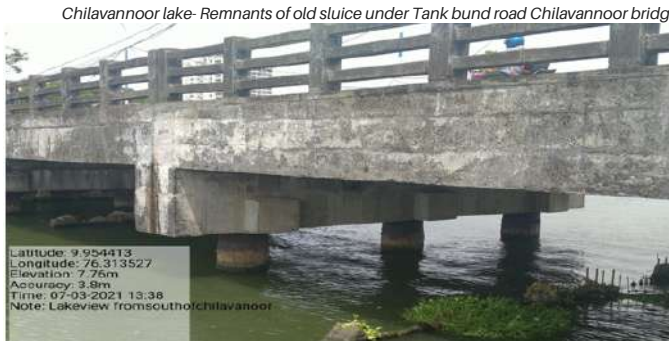
- Remnants of old concrete sluice is observed under Chilavannoor bridge on Tank Bund road causing obstruction to flow.

Chilavannoor lake- Remnants of old sluice under Tank bund road Chilavannoor bridge

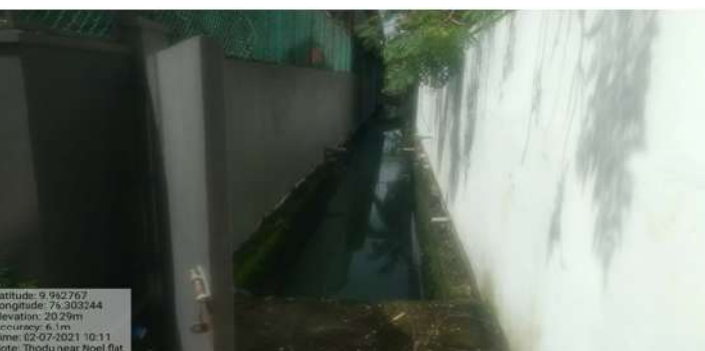
Starting Point of the Thodu near NOEL Apartment, Kadavanthra

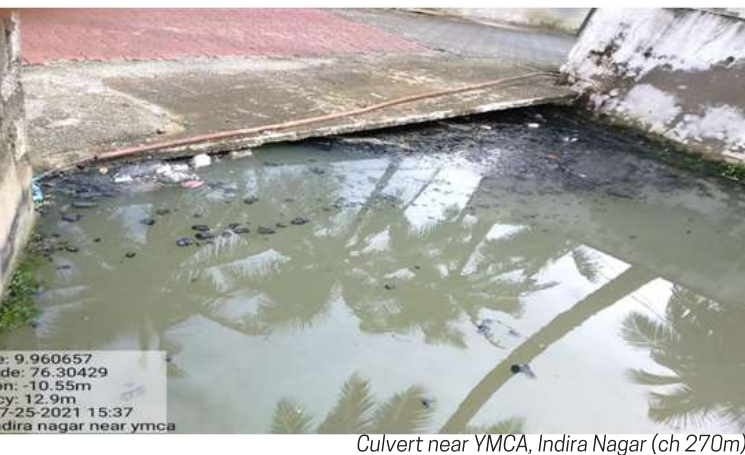
Culvert near YMCA, Indira Nagar (ch 270m)

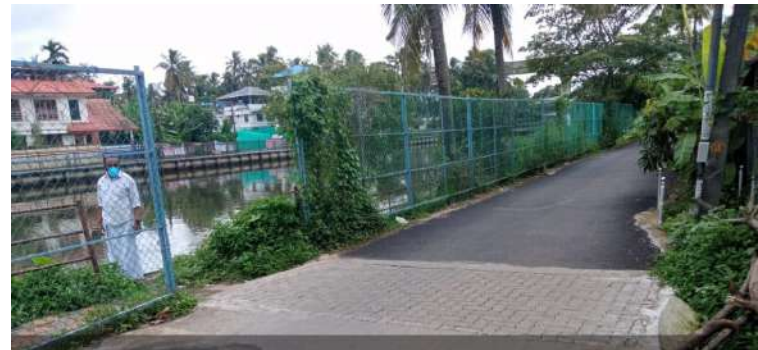
- ❖ At ch: 2080m, Thuruthy Temple road is crossing, and there no sufficient clearance at this culvert.
- ❖ From ch: 2080m to the end point, ch: 2600m, the entire length of thodu is covered with slabs and encroachment is there.

At Champakkara Kannadilladu road Athirthi thodu is completely covered.

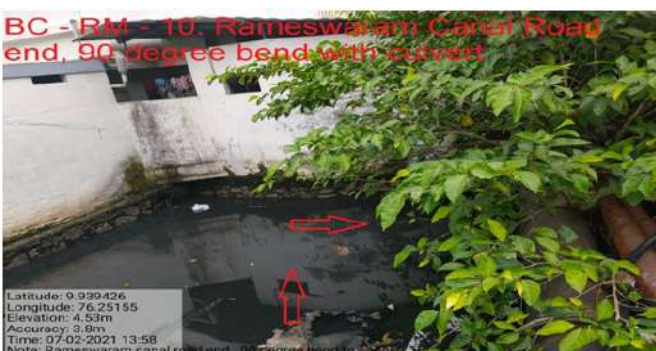
In Ward No. 25, at Ch.1217m- Sharp bend with culvert

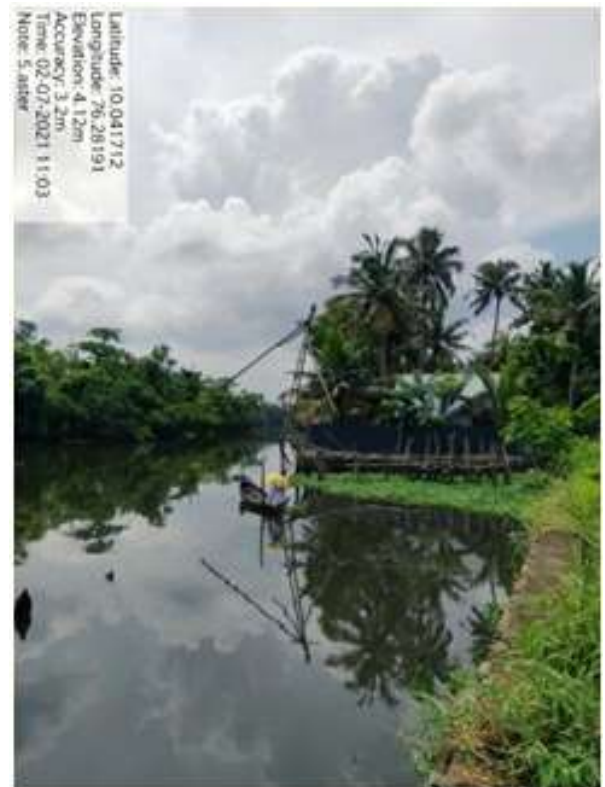
On preliminary inspection, heavy siltation has been observed at a few metres away from the Changadampokku thodu outlet behind Amrutha Hospital, approximately over a length of 200m

Sudden decrease in width

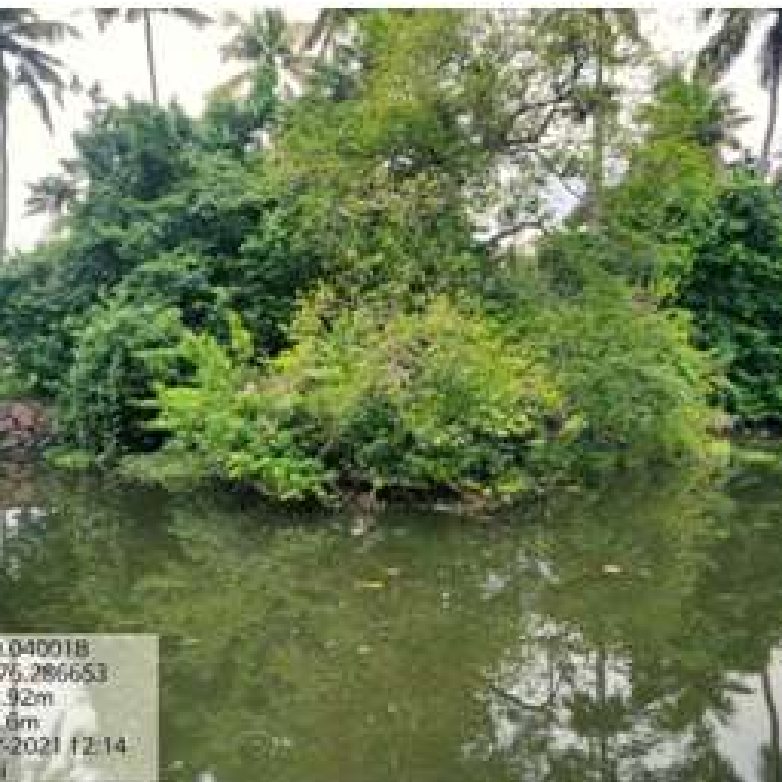
Tree fallen into the water body

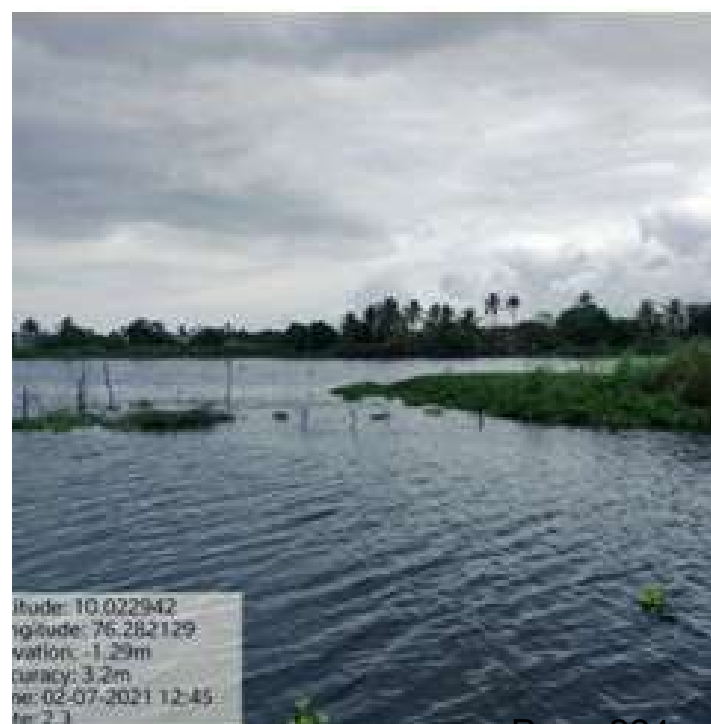
Heavy siltation has been observed near the outlet of TP canal, over a length of approximately 500m. Here, the river width is nearly 500m, therefore approximately 0.25sq.km. of area needs to be desilted here. There are also deltas / thuruthus formed in this area.

Thuruthu formed near outlet of TP Canal

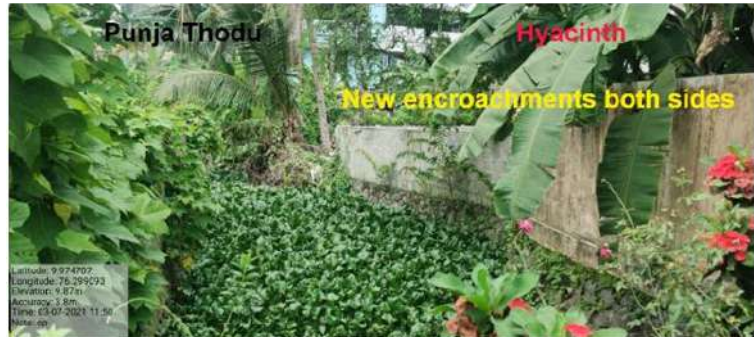
Both sides encroached by erecting walls, also thodu full of hyacinth

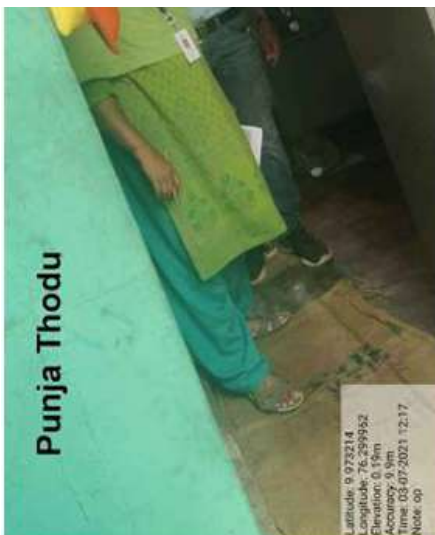
Thodu inside house covered by slabs

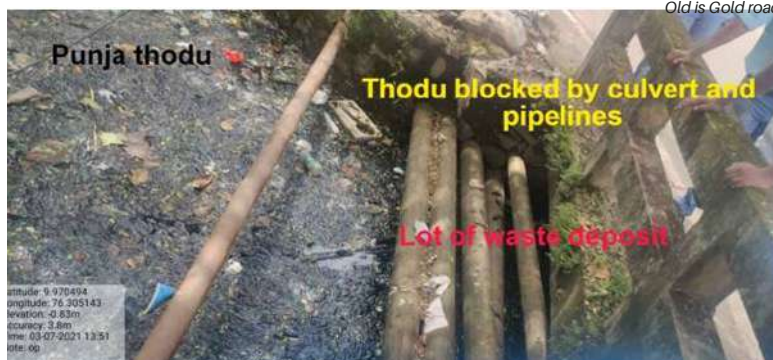
Thodu blocked by culvert and pipelines

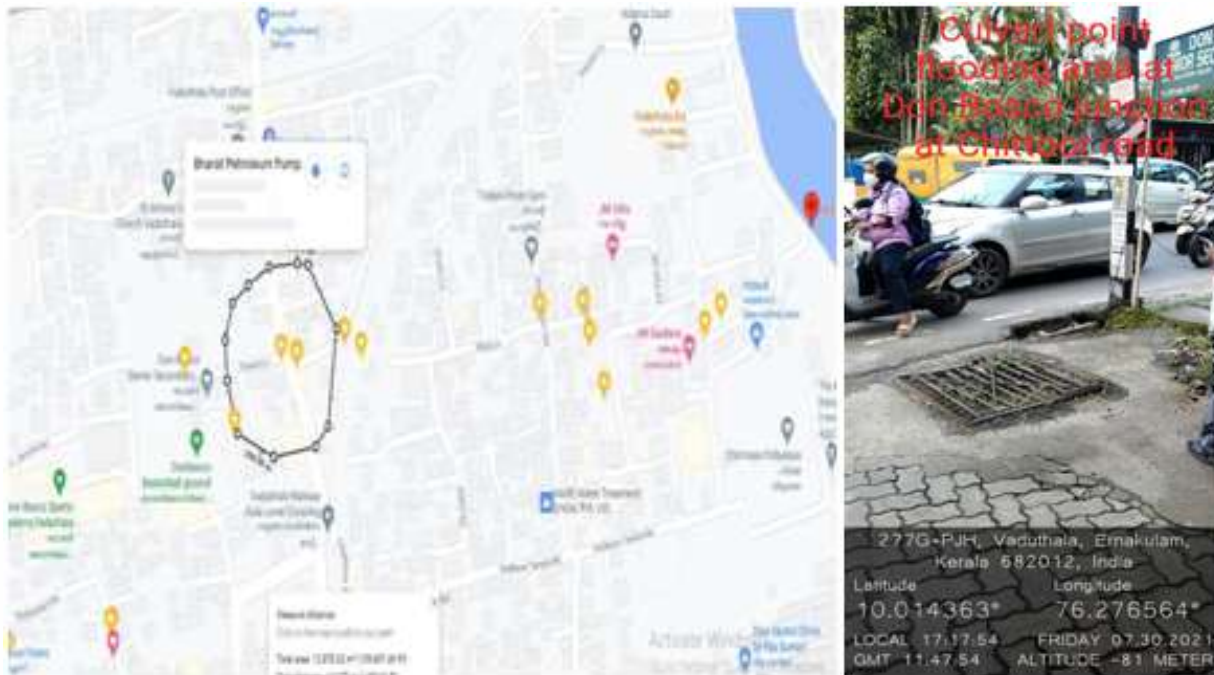
Don Bosco junction a flooding Area
