MANAGEMENT OF COASTAL EROSION ALONG PONDICHERRY COAST

National Institute of Ocean Technology (NIOT)

06-10-2014

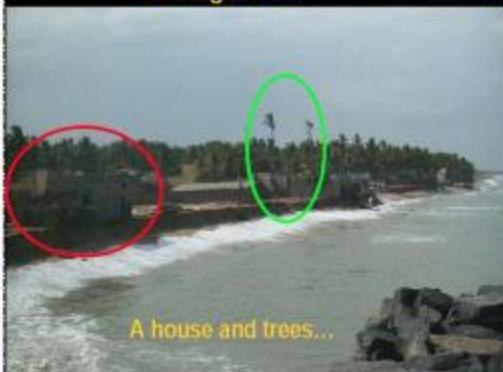
1st August '02

A house and trees...

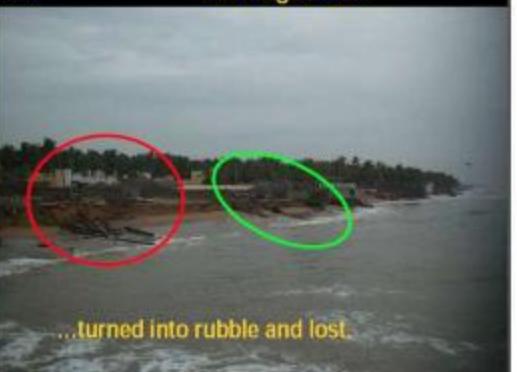
8th August '02

... a week later

...turned into rubble and lost.

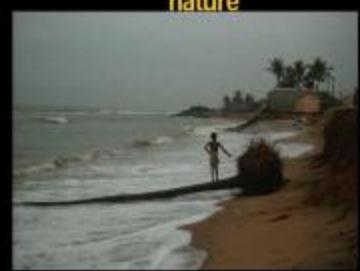
After construction of Pondicherry Port severe erosion on Northern coast
Accretion on the southern coast

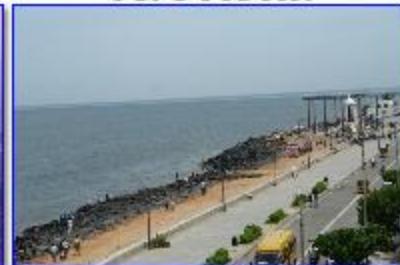
At Present

Natural Beach

Sea wall protection

Strengthened sea wall

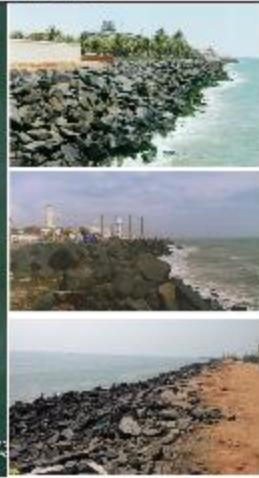
➤ Seawall of length 6 km was constructed, which steepened beach

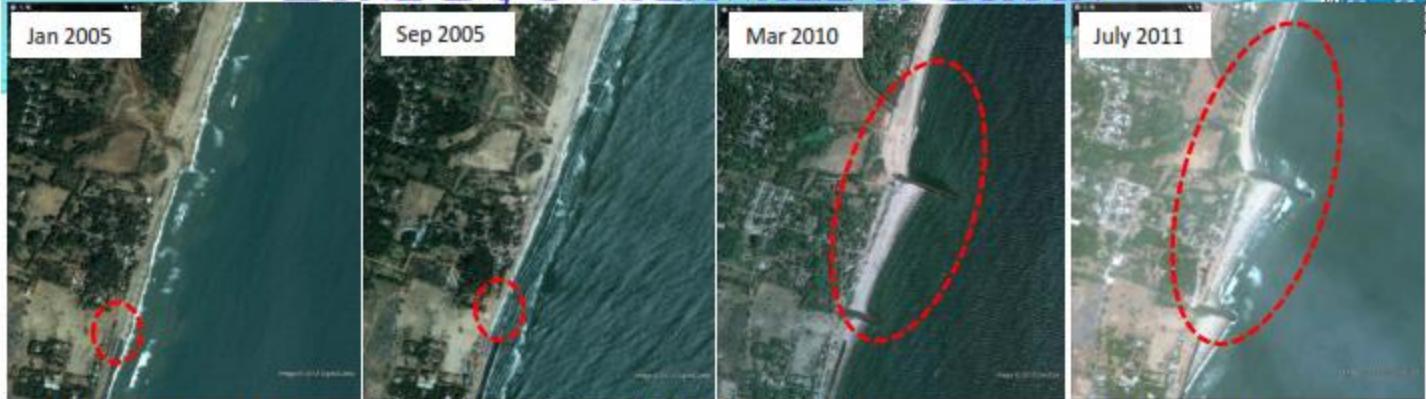
ZONE B , C : SEAWALL & GROIN

6 km length of seawall was constructed by Pondicherry

2 km length of coast line protected by both seawall and groins by Tamil Nadu

The erosion problem shifted further north

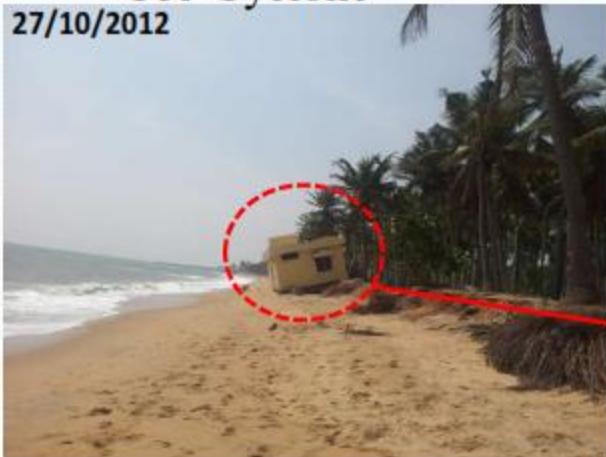
27/10/2012

Pre-Cyclone

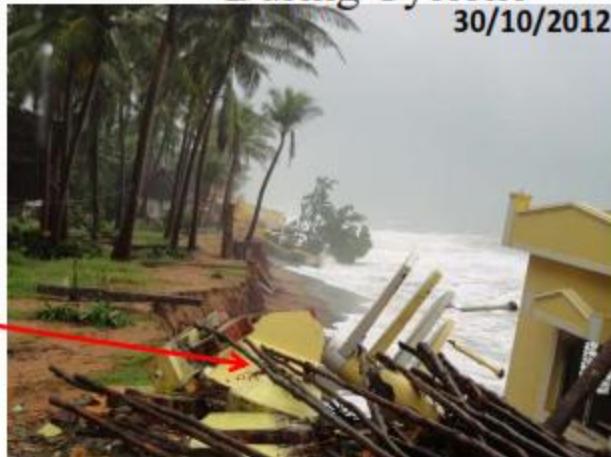
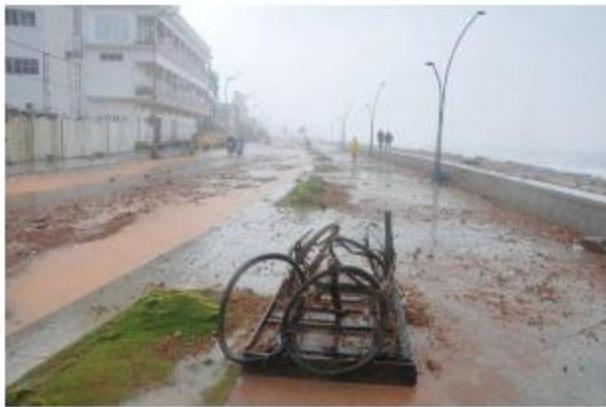
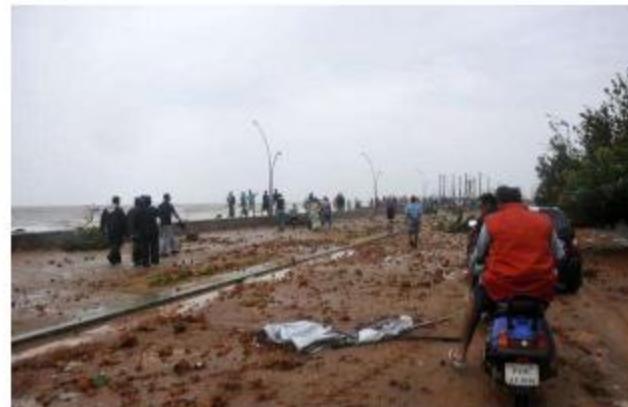
30/10/2012

During Cyclone

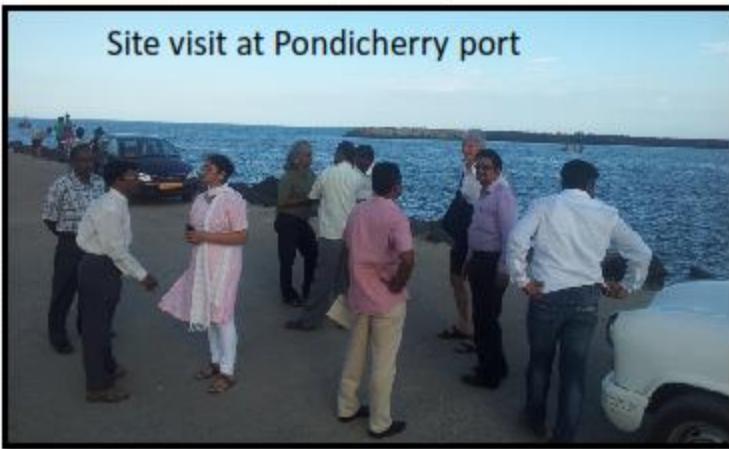
Site visit at Pondicherry port

As an initial step beach nourishment with a quantity of 50,000 m³ Can be carried out to north of port break water during July – August 2013.

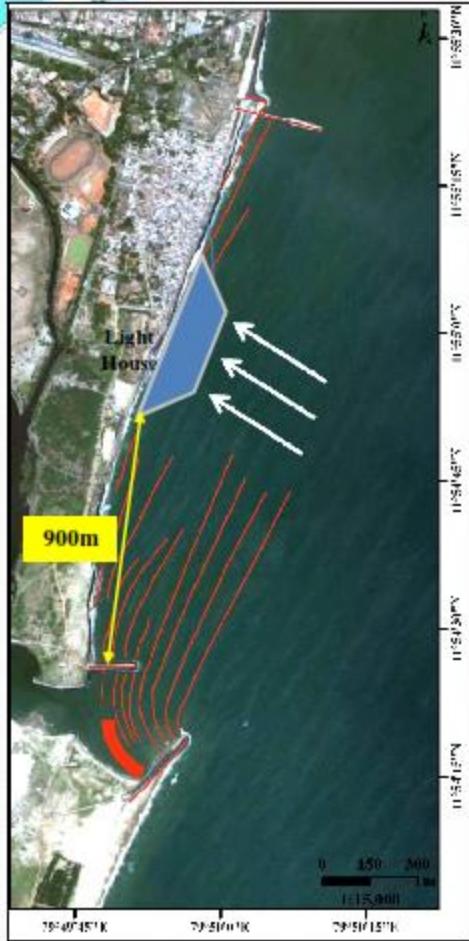
DIRECTION OF SEASONAL COASTAL CURRENTS

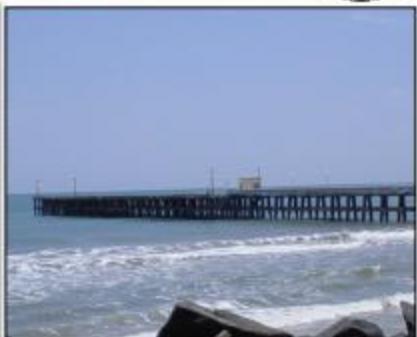
Coastal Structures
(South to North)

Sno	Coastal Morphology	Length (m)
1	North Breakwater	0
2	Seawall	575
3	Sandy Beach	130
4	Seawall	105
5	Sandy Beach	70
6	Seawall	70
7	Sandy Beach	65
8	Seawall	800
9	Jetty	5
10	Sandy Beach	30
11	Groyne	25

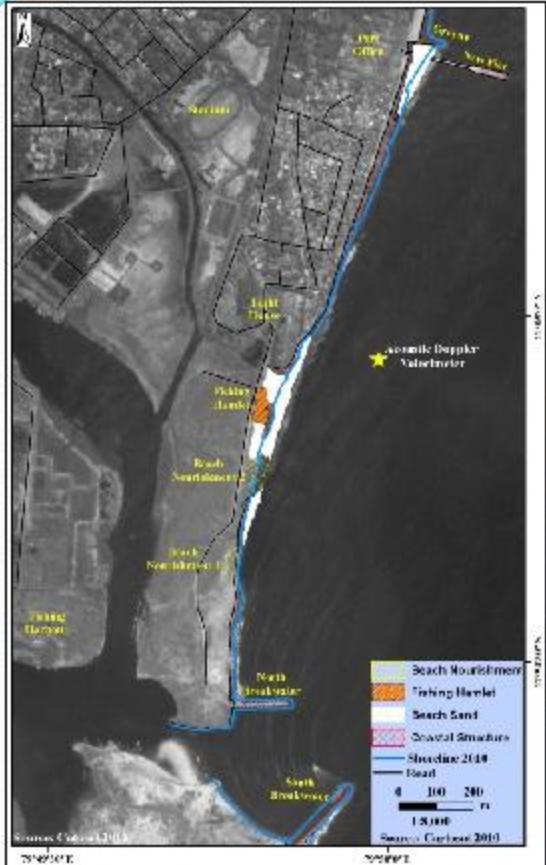
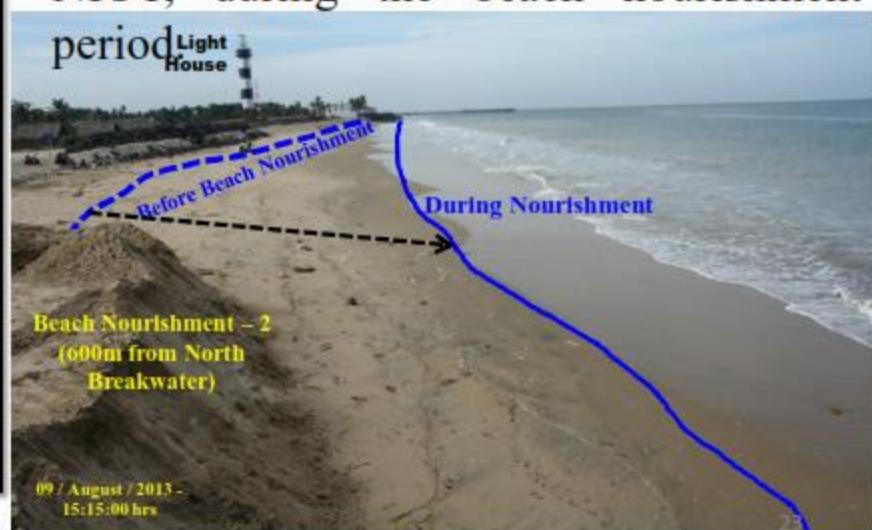
INITIAL BEACH NOURISHMENT

- NIOT proposed nourishment locations are 600m and 900m from the northern breakwater
- Government of Pondicherry proposed to measure the nearshore currents by NIOT, during the beach nourishment period

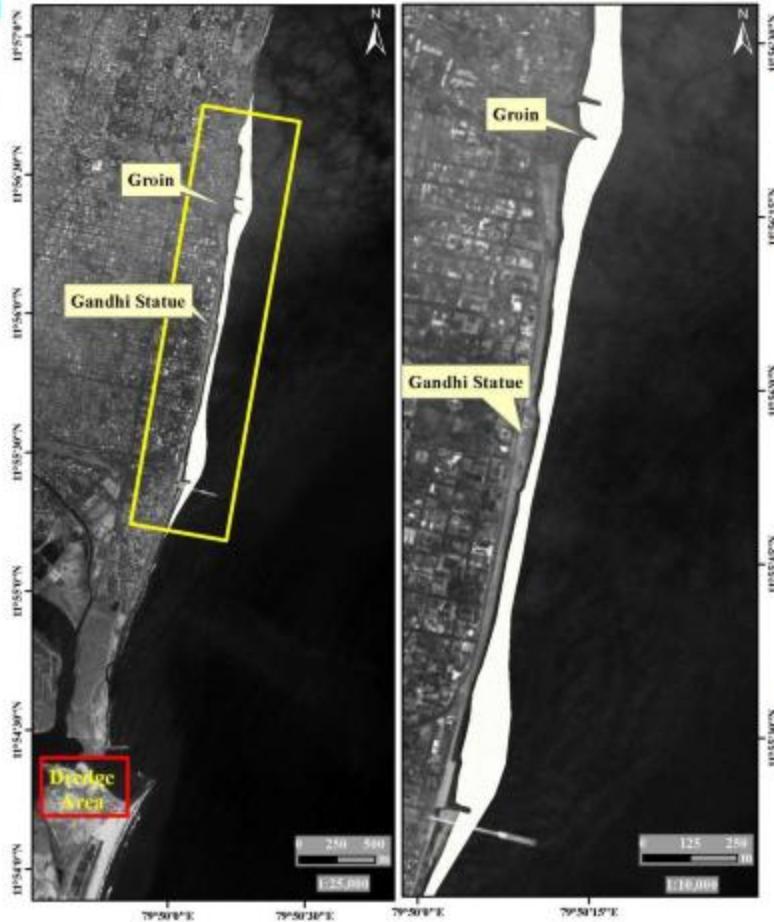
OPTION 1 - BEACH NOURISHMENT

- Nourishment between Groynes using dredged sand from harbour mouth.
- Advantages:
 - Soft solution
 - If erosion continues, it will leave hazards on the beach or in the surf zone.
 - Structures behind beach are protected
- Disadvantages:
 - Repetitive process.
 - Increase siltation at harbour mouth during NE Monsoon
