REPORT ON
**FLOOD
MITIGATION
KOCHI**

IRRIGATION DEPARTMENT
ERNAKULAM
2021

EXECUTIVE SUMMARY

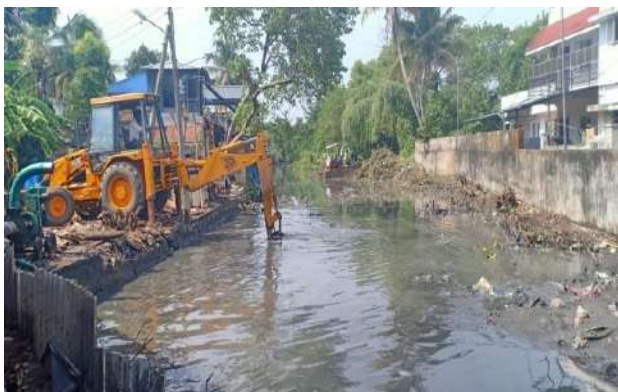
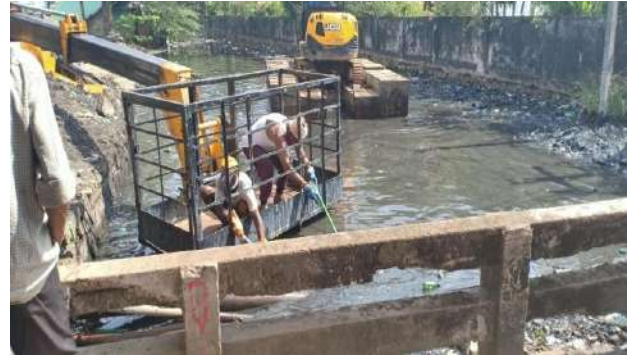
2. Renovation of Koithara Canal

Koithara canal is a major canal which starts from Thevara- Perandoor canal near Panampilly Nagar and passes through Koithara area and finally merges to Thevara canal. Due to construction of a Railway Overbridge in Koithara, free water flow through this canal was blocked for over 30 years.

For the construction of Ernakulam –Alappuzha Rail overbridge, an existing culvert was brought beneath the waterway and about 72cm thick concrete slab was casted over this to form roadway. As a result, this canal was fully blocked. Also a pile cap forming part of Rail Overbridge

was constructed across this canal, thus worsening the condition of this canal. During rains, the adjacent areas of canal get completely submerged. The Project was envisaged to open up the blocked canal.

Provisions were included in the Project to clear the vegetation blocking water flow in canal, desilt and clean the canal and to clear the deposited concrete debris in the canal and to demolish and reconstruct the blocked culvert. As the blockage is removed, water flow is restored in the canal. The water through this canal reaches Kayal mouth through Thevara Canal.

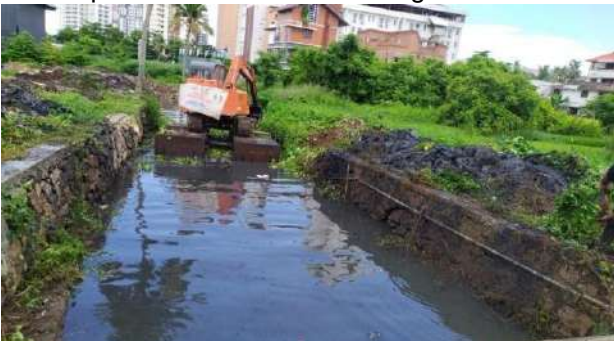
4. Changadampokkuthodu

At the portion of Rail line crossing at Elamakkara,

the flow was almost fully blocked by old concrete pipes and remnants of earthen bund and

damaged concrete piles used in the construction of rail bridge. As part of Operation Breakthrough the obstructions in this canal were cleared including the mouth portion. The work is completed and there is evident increase in water flow through the thodu.

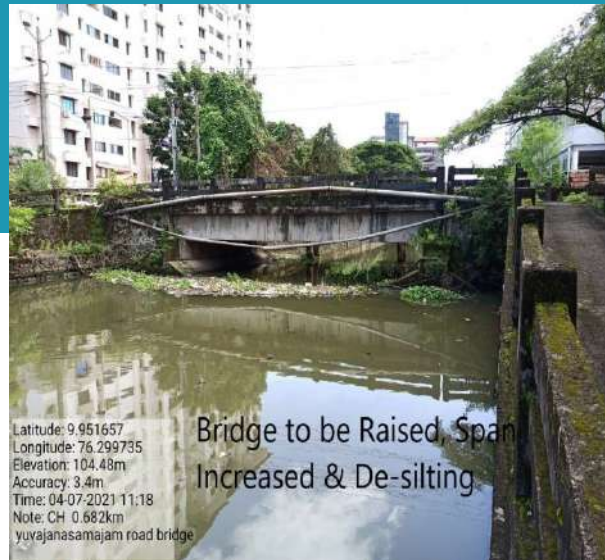
Yuvajanasamajam Road Bridge – To be Re-constructed

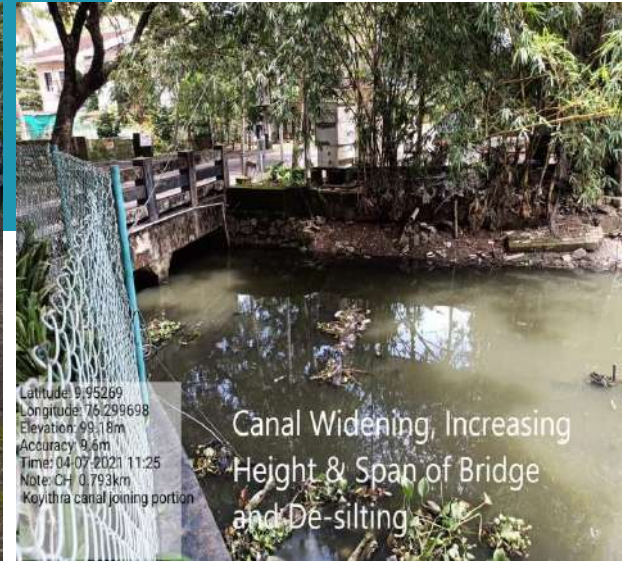
Koyithara Canal Junction Bridge – To be Re-constructed

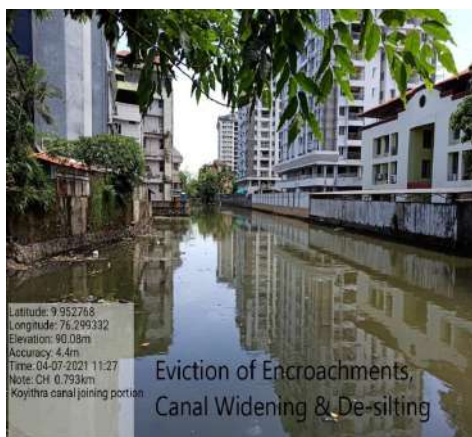
Koyithara Canal Junction View – Encroachments to be evicted

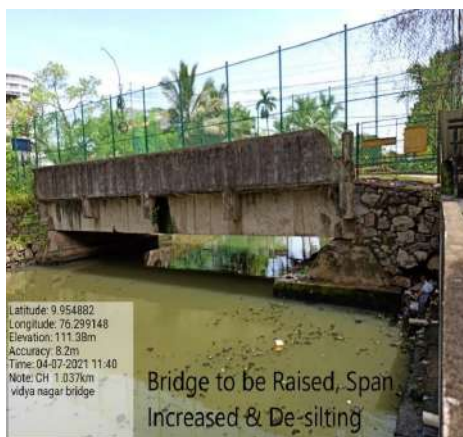
The abutments of Vidya Nagar Road Bridge are situated in TP Canal reducing canal width marginally. The vertical clearance of the bridge with respect to water level is about 1m which is less compared to the flood point of view. So the bridge has to be reconstructed with sufficient Horizontal and Vertical clearance. The view from Koyithara Canal Junction shows that there is large scale encroachment on both sides of canal. The encroachment has to be evicted and TP Canal has to be brought back to its original shape. The features are shown in Fig.4.

Vidya Nagar Road Bridge – To be Re-constructed

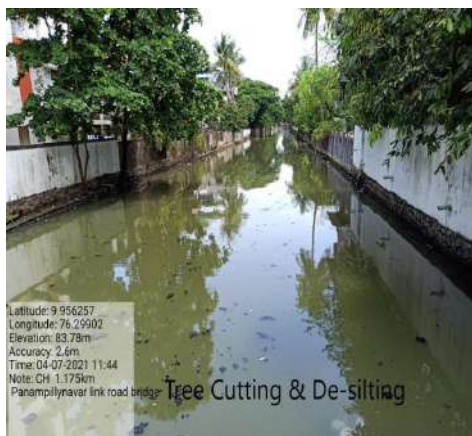
Panampilly Nagar Link Road Bridge View – Encroachments to be evicted

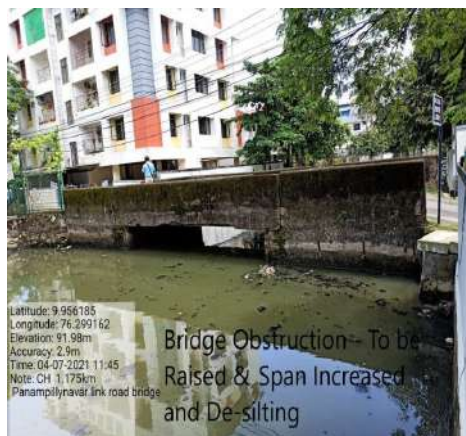
The abutments of Panampilly Nagar Link Road Bridge are situated in TP Canal reducing canal width marginally. The vertical clearance of the bridge with respect to water level is about 0.7m which is less compared to the flood point of view. So the bridge has to be reconstructed with sufficient Horizontal and Vertical clearance. The view from Koyithara Canal Junction shows that there is large scale encroachment on both sides of canal. The encroachment has to be evicted and TP Canal has to be brought back to its original shape. The features are shown in Fig.5.

Panampilly Nagar Link Road Bridge – To be Re-constructed

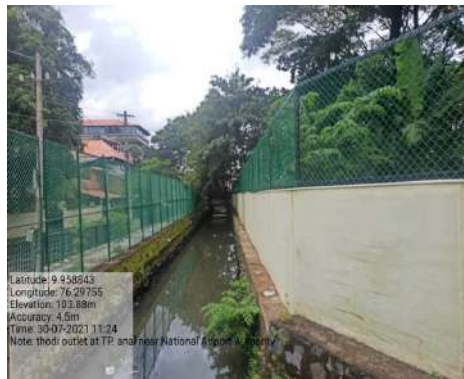
The abutments of 15th Cross Road Bridge are situated in TP Canal reducing canal width marginally. The vertical clearance of the bridge with respect to water level is about 1m which is less compared to the flood point of view. The storm water from M G Road is getting discharged into TP Canal by means of a leading channel from that area. The leading channel is completely covered with slabs and filled with debris. It creates flood like situation in Panampilly Nagar and Ravipuram area. A Petty Para arrangement is being made by Kochi Corporation to drain out excess water from Panampilly Nagar area to TP Canal. The storm water from MG Road has to be diverted directly into Kayal near Shipyard area so that the water load of TP Canal can be minimized. The Bridge has to be reconstructed with sufficient Horizontal and Vertical clearance. The view from 15th Cross Bridge shows that there is large scale encroachment on both sides of canal. The encroachment has to be evicted and TP Canal has to be brought back to its original shape. The features are shown in Fig.6.

Branch Canal to TP Canal from MG Road – To be Re-align

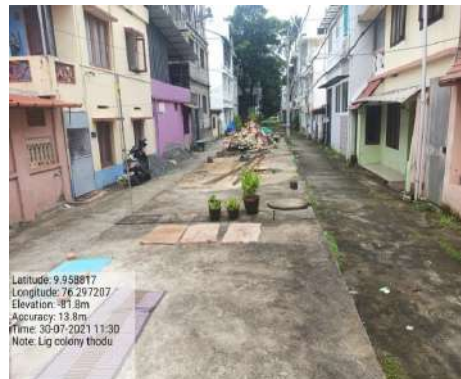
LIG Colony Thodu – Covered with Concrete Slabs – To be opened

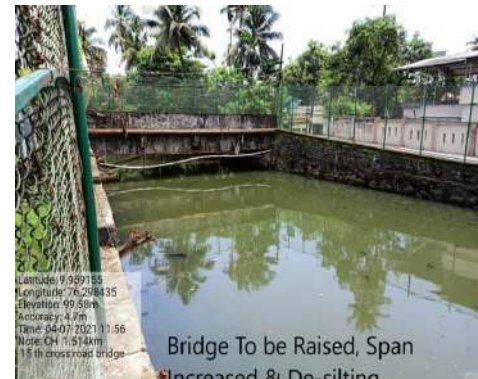
Bridge To be Raised, Span increased & De-silting

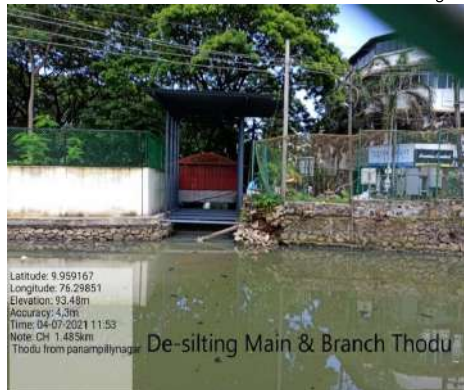
De-silting Main & Branch Thodu
Branch Thodu Jn. from MG Road – Petty Para arrangement – To be diverted

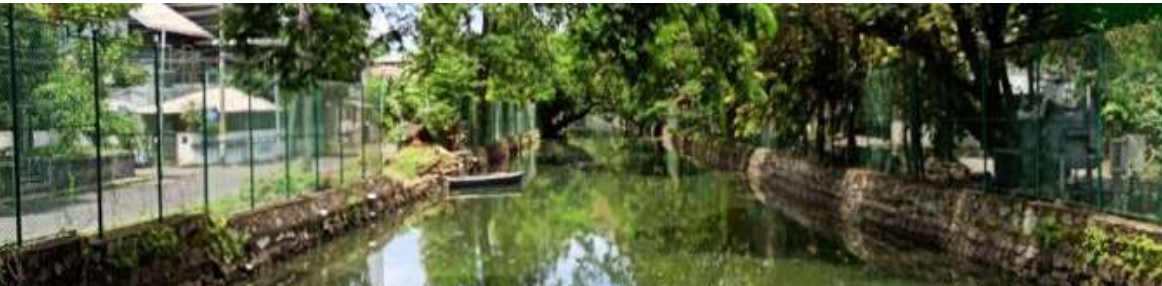
Trees / Branches to be Pruned

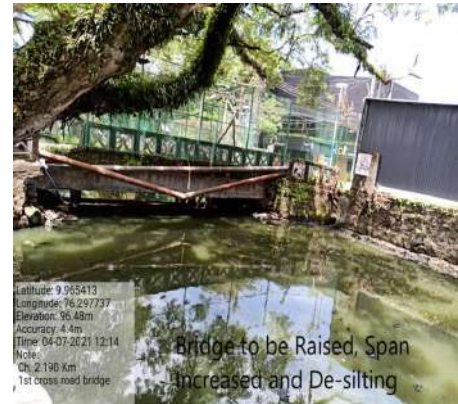
The abutments of 1st Cross Road Bridge are situated in TP Canal reducing canal width marginally. The vertical clearance of the bridge with respect to water level is about 1m which is less compared to the flood point of view. So the bridge has to be reconstructed with sufficient Horizontal and Vertical clearance. The view from 1st Cross Road Bridge shows that there are a large number of trees/branches grown into TP Canal. The leaves and branches falling from trees obstruct the natural flow of water and it has to be cleared by trimming/cutting branches/trees. The features are shown in Fig.7. The following works are proposed in this reach.

Bridge to be Raised, Span Increased and De-silting
1st Cross Road Bridge View - To be Re-constructed

- Clearing light, thick and thorny jungle
- Trimming / Cutting branches of trees
- De-silting and removal of debris
- Shifting of cables, ducts and pipes
- Eviction of Encroachment
- Span and Height (Vertical & Horizontal clearance) of 1st Cross Road Bridge to be increased
- 6 major drains (storm water) and small pipe drains discharging effluent into TP canal which have to be relocated

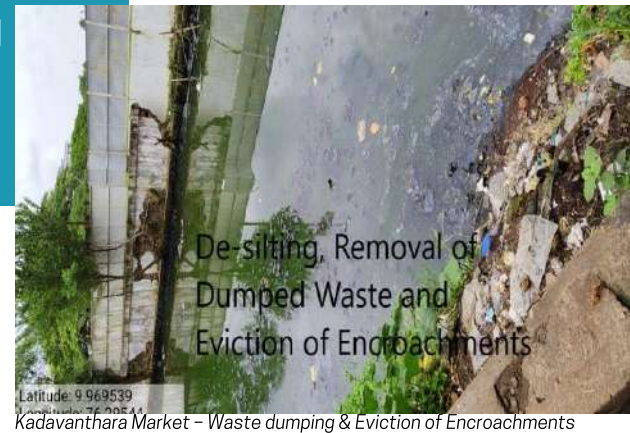
Kadavanthara Market – Waste dumping & Eviction of Encroachments

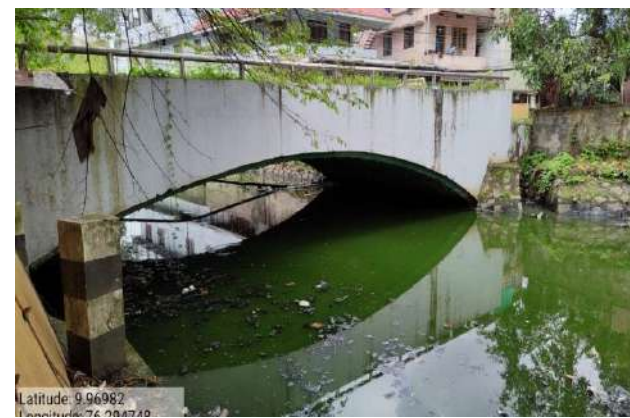
Purushu Menon Road Bridge – To Be Re-constructed

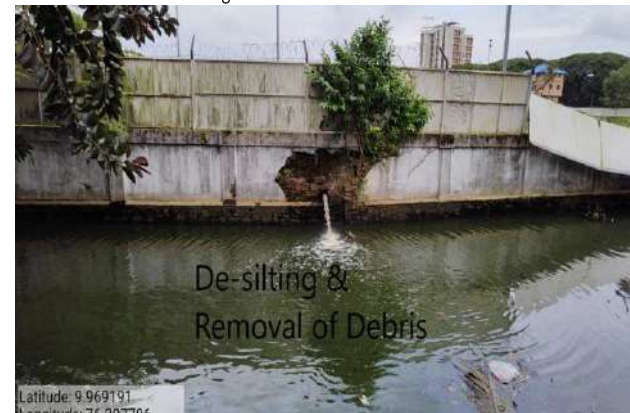
BPCL Effluent Outlet – To be Closed

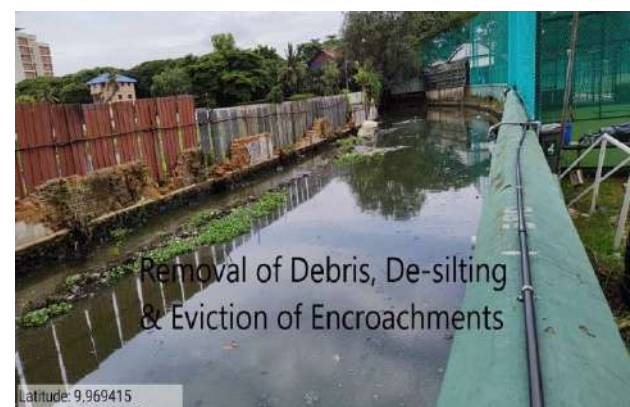
Encroachments to be Evicted

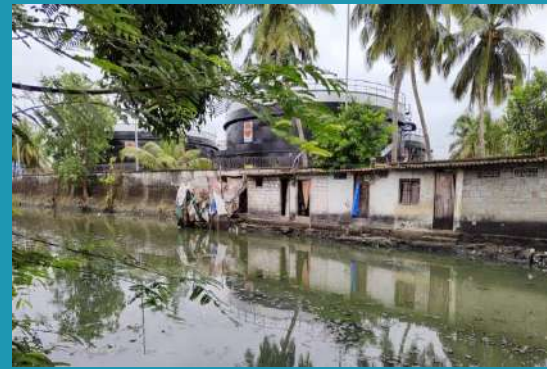
Encroachment – To be Evicted / Rehabilitated

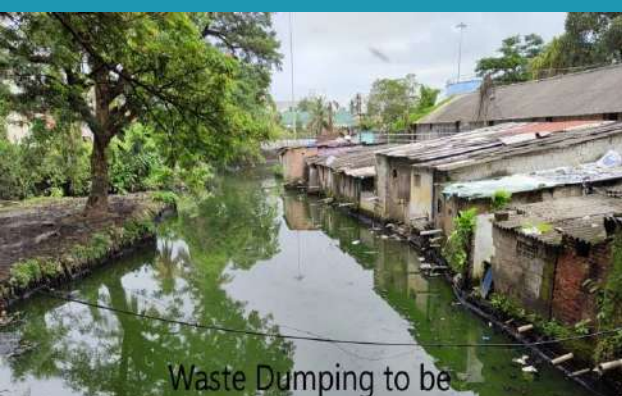
Encroachment & Discharge of Toilet / Household Waste – To be Evicted / Rehabilitated

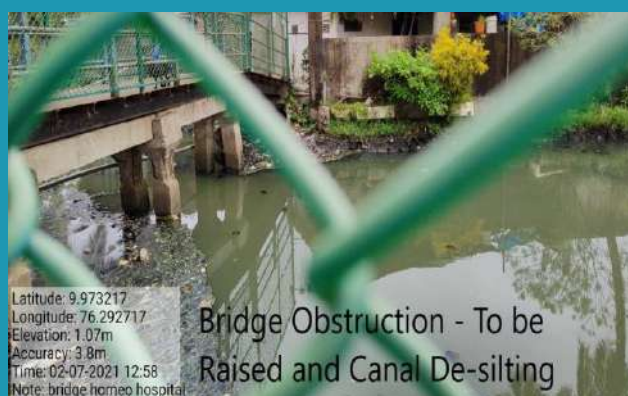
Homoeo Hospital Bridge – To be Re-constructed

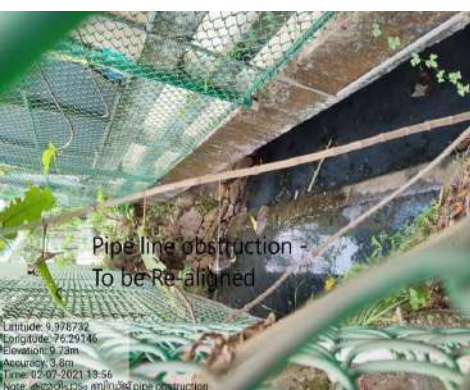
KWA Pipe Line to be Shifted and CD Works to be Re-constructed

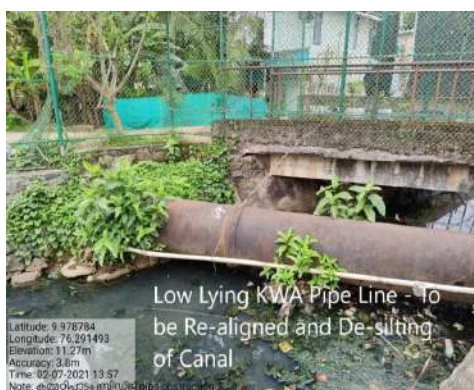
KWA Pipe Line to be Shifted

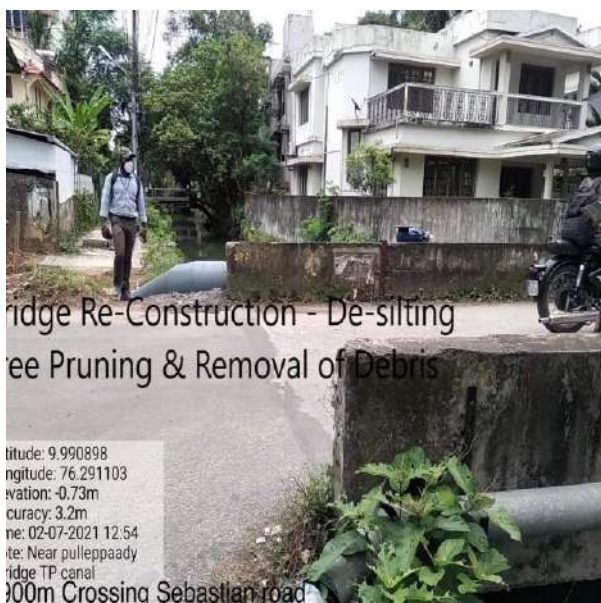
De-silting of Canal and Tree to be cut

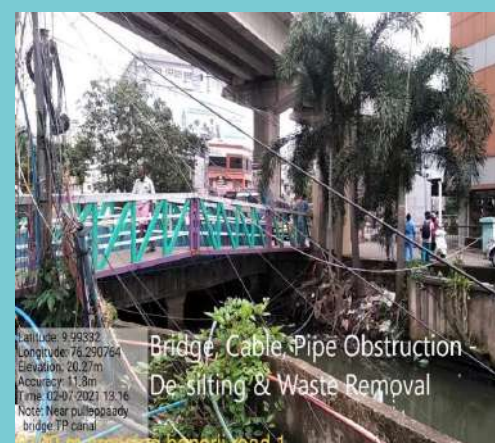
De-silting of Canal and Tree to be cut

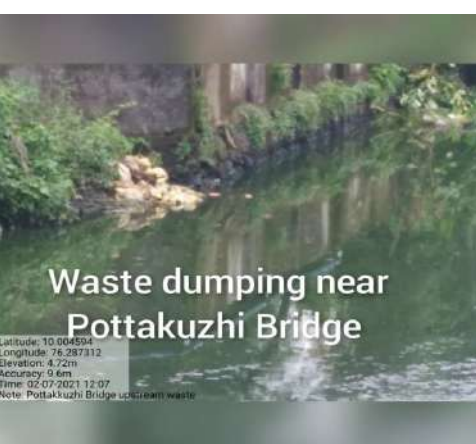
Pottakuzhi Bridge – Waste Dumping to be Banned

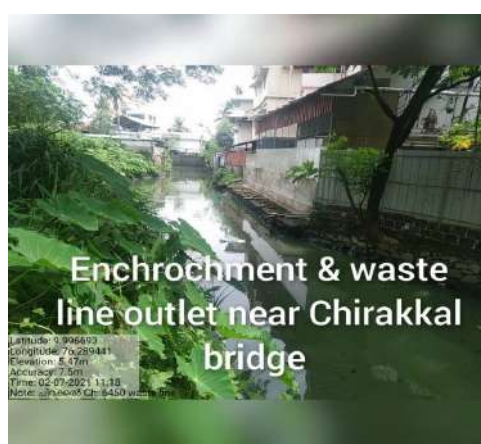
Encroachment to be Evicted and Waste Water Discharge to be Banned

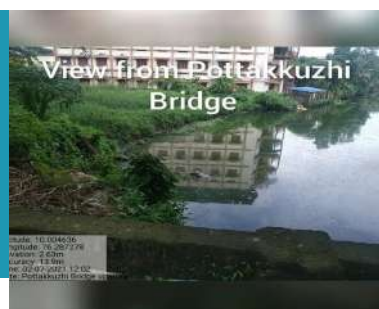
Pottakuzhi Bridge – Waste Dumping to be Banned

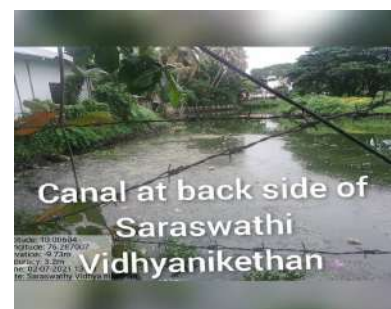
Encroachment and Waste Water Discharge – To be Banned

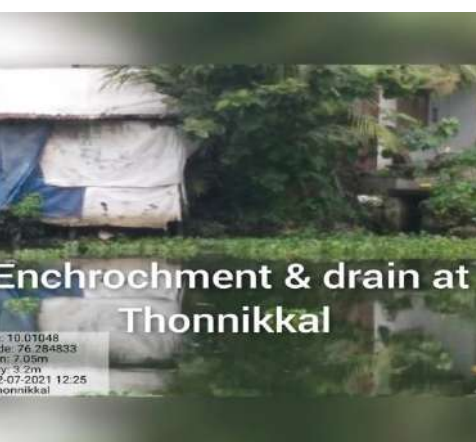
Encroachment and Waste Water Discharge – To be Rehabilitated

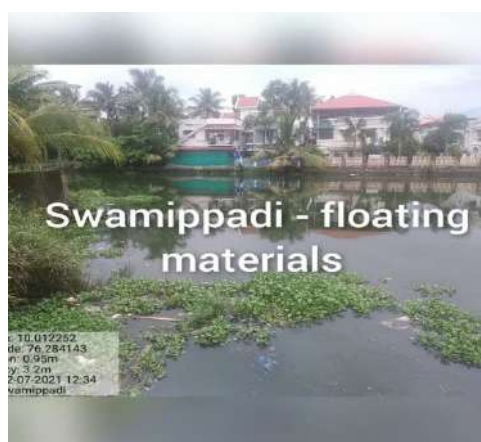
Water Hyacinth – To be removed

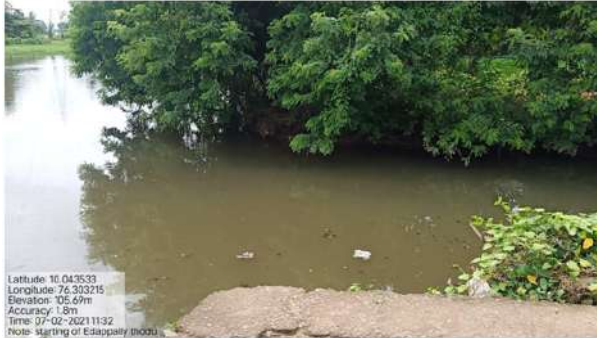
(a) Chainage 0.00: Starting point of Edapally thodu

Starting point of Edapally thodu From Periyar- CH 0.00

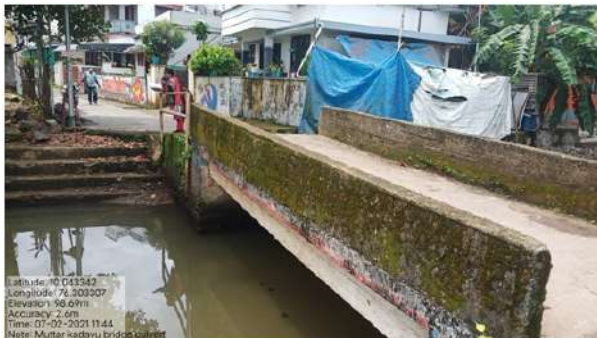
(b) Chainage 36: Muttar kadavu Bridge culvert

Chainage 36: Culvert have less vertical clearance, reconstruction of existing bridge is essential

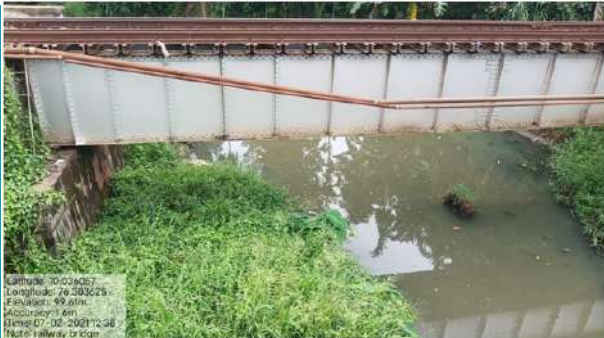
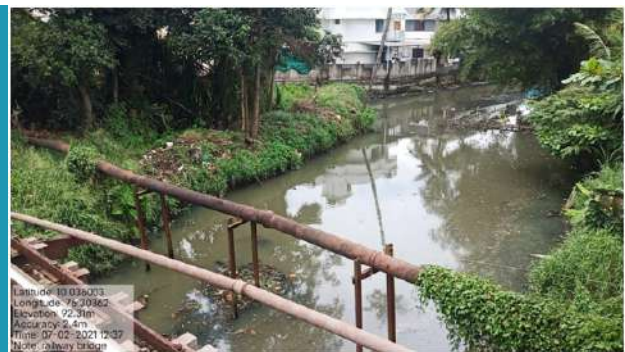
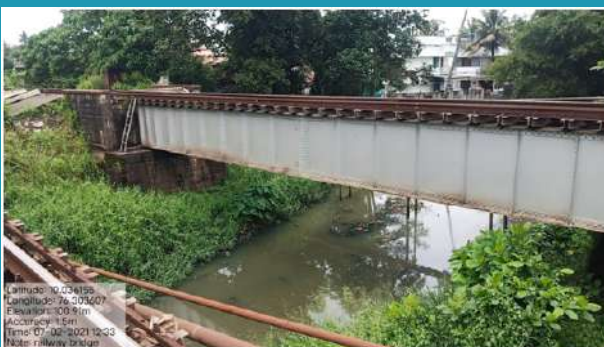
(c) Chainage 1000: Railway Bridge

Chainage 1000: Covered with vegetation on both banks, Disposal of waste and silt deposition

- Obstruction to free flow of water due to KWA pipe laid across the thodu near Edappally bridge which should be realigned to avoid accumulation of solid waste and to ensure free flow of water.
- Waste deposition in the thodu from outside near railway bridge, Chambakadavu bridge, NH Edappally bridge, Marottychodupalam, Timber bridge, Pipe line, Chembumukku bridge to be controlled by implementing proper waste management methods and enforcing stringent measures.
- In some stretches the trees are seen over fallen into the water body may cause obstruction to the flow of water. It has to be uprooted.

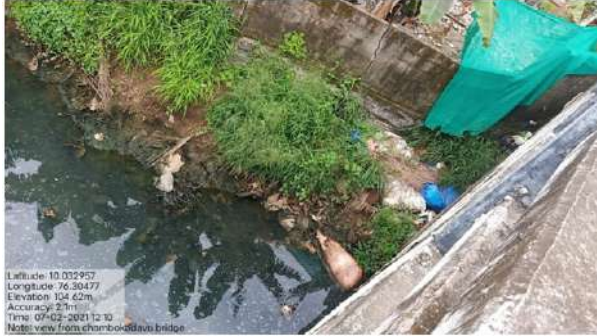
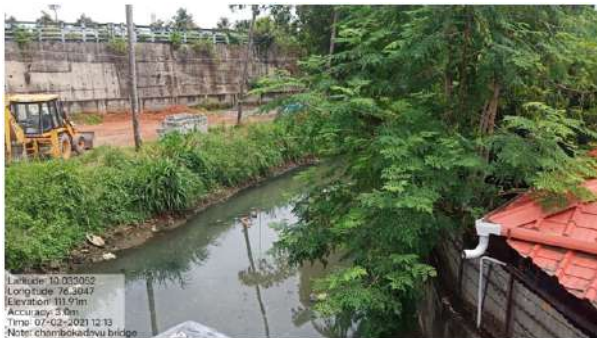
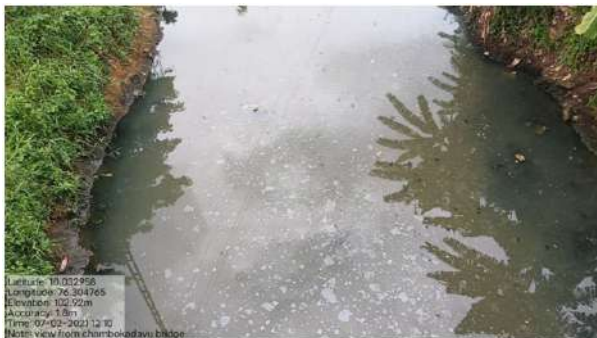
(d) Chainage 1500:
Chambokadav Bridge

Chainage 1500: Disposal of waste, Covered with vegetation on both banks, Water is polluted and appears to be oily in appearance.

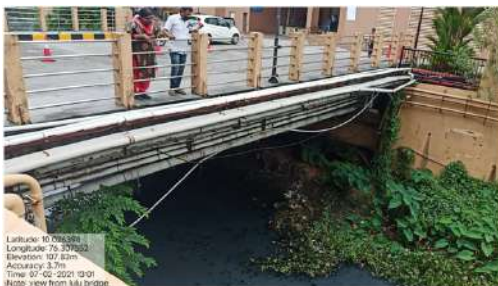
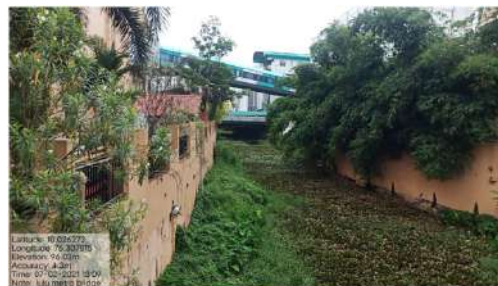
(e) Chainage
2360: Lulu
Private
Bridge

Chainage 2360: Fully covered with hyacinth & Silt deposited

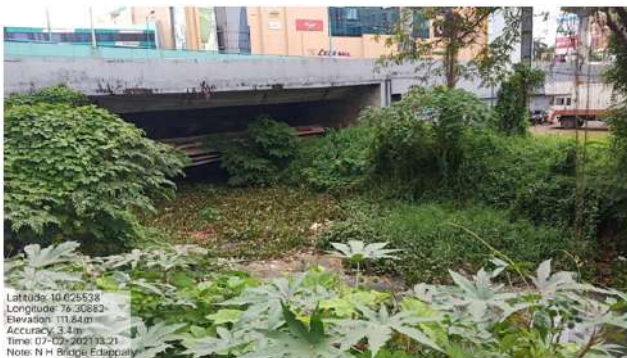
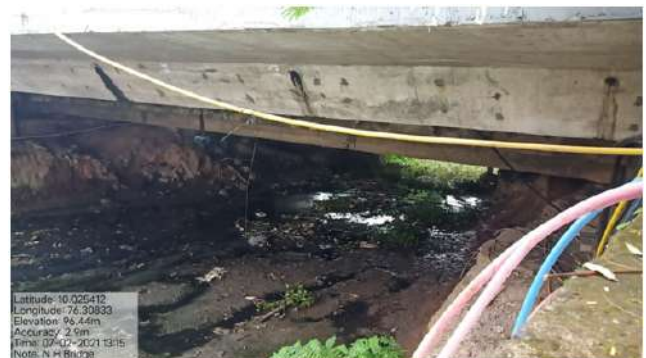
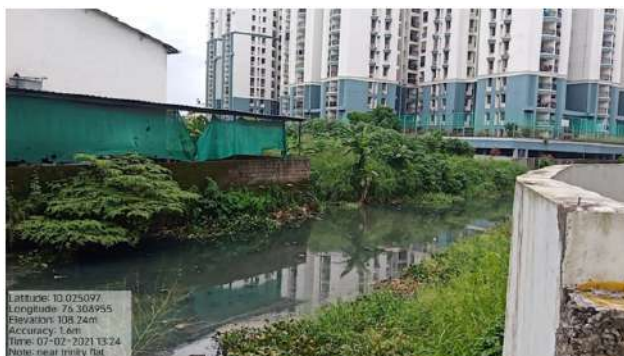
(f) Chainage 2500: NH bridge Edapally

Chainage 2500: KWA pipe located over the beam of old bridge which is a major obstruction, fully covered with hyacinth, silt deposition and waste disposal

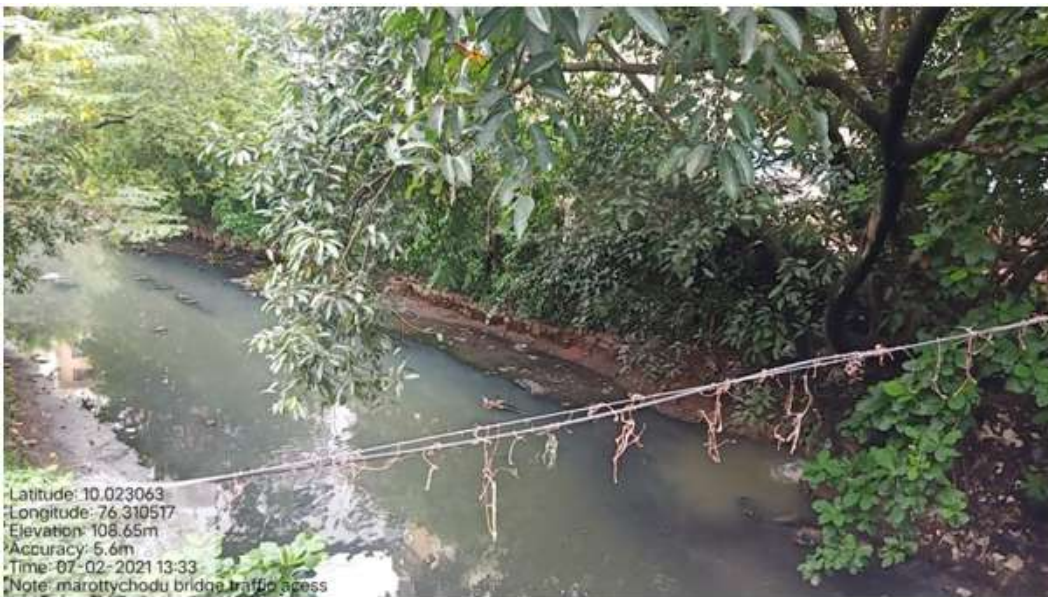
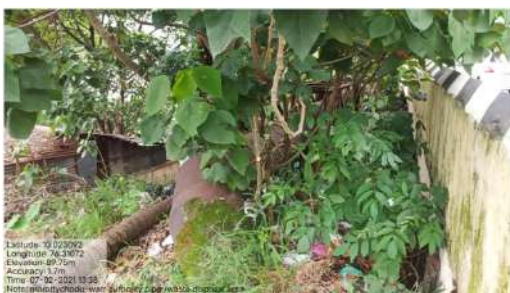
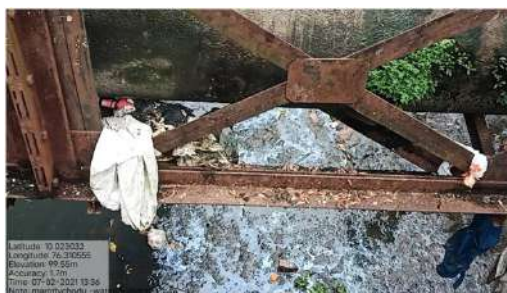
(g) Chainage 2850:
Marotty chodu palam

Chainage 2850: Trees grown to the bank of thodu, the disposal of waste is noticed

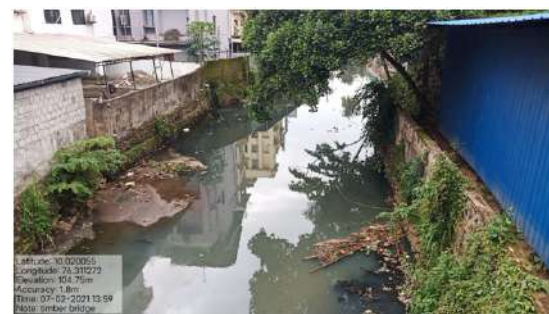
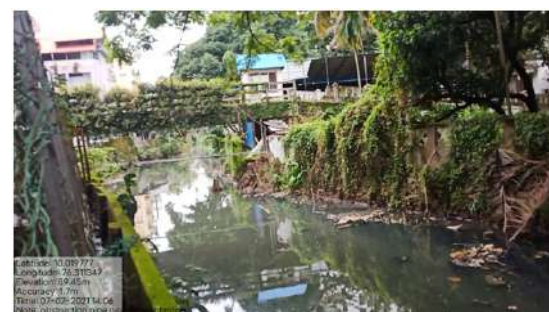
(h) Chainage 3230 :
Timber Bridge

1" water line pipe laid across the thodu is found to obstruct the flow, deposition of silt is noticed.

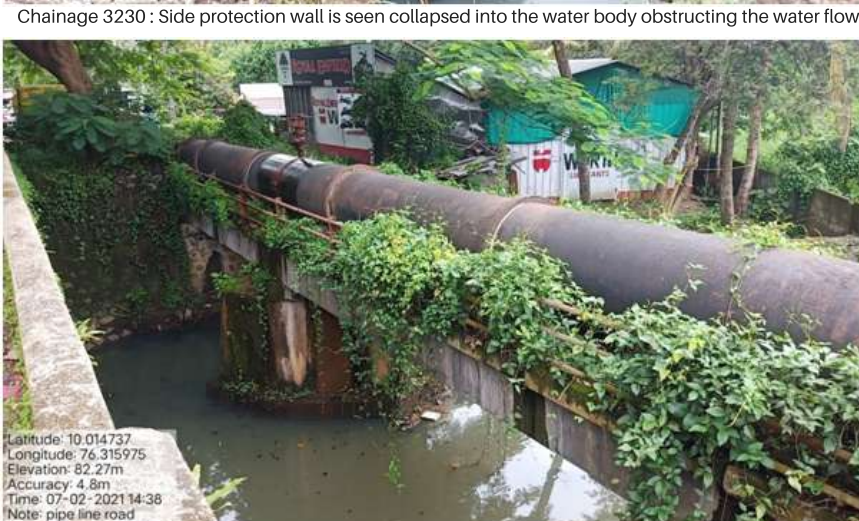
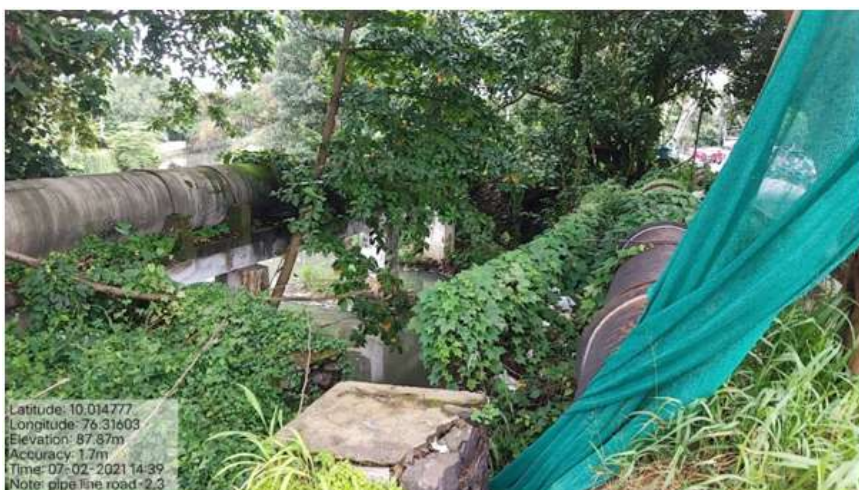
(j) Chainage 3230 : Pipe Line Road

Chainage 3230 : Covered with vegetation on both banks, accumulation of silt

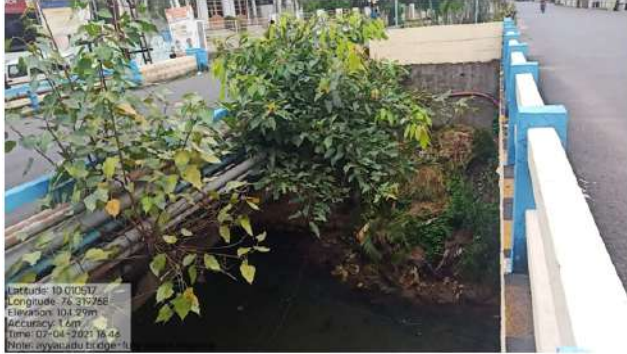
(k) Chainage 5100:
Chembumukku Bridge

Chainage 5100: Unauthorized waste disposal in between the bridges

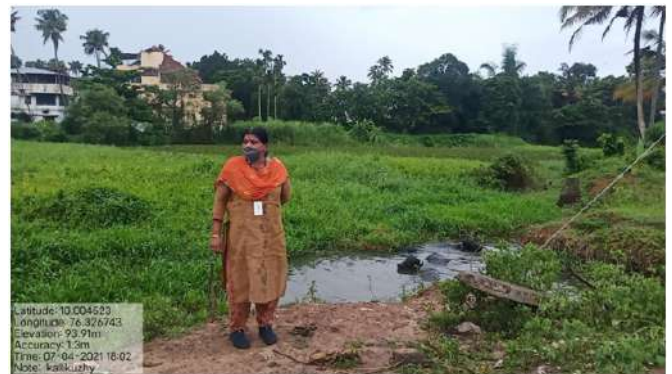
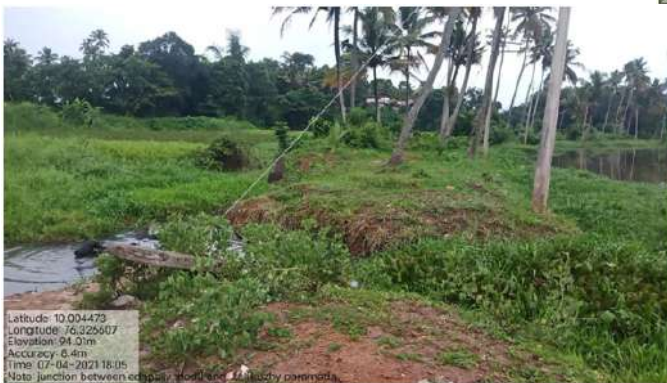
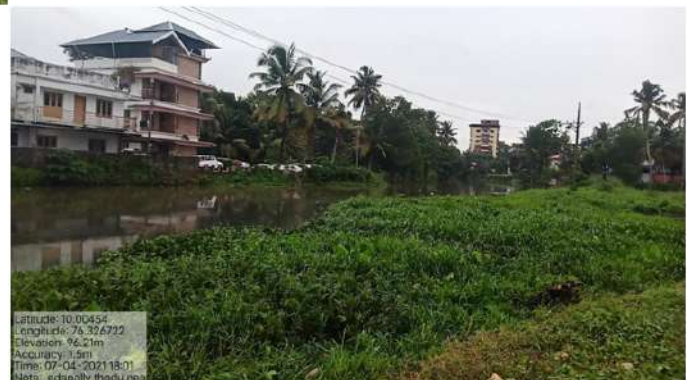
(l) Chainage 6560:
Kallikuzhy Paramada

Chainage 6560: Fully covered with hyacinth and water weeds.

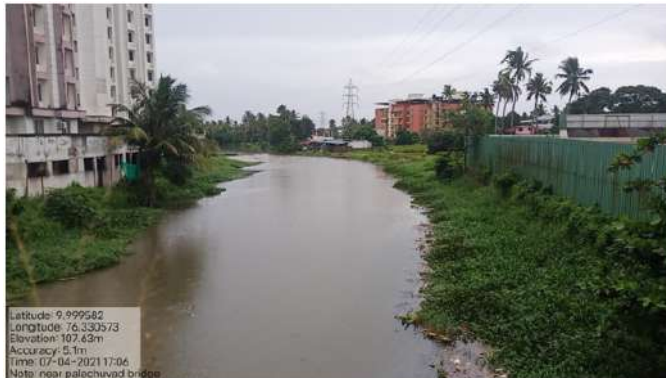
(m) Chainage 7200:
Palachuvad bridge

Chainage 7200: Vegetation on both banks, accumulated with floating wastes and is covered with hyacinth.

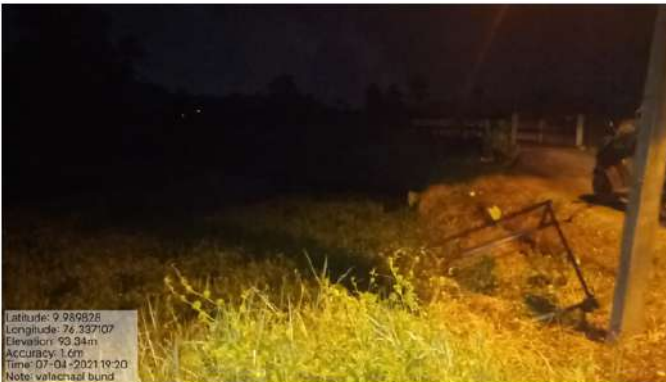
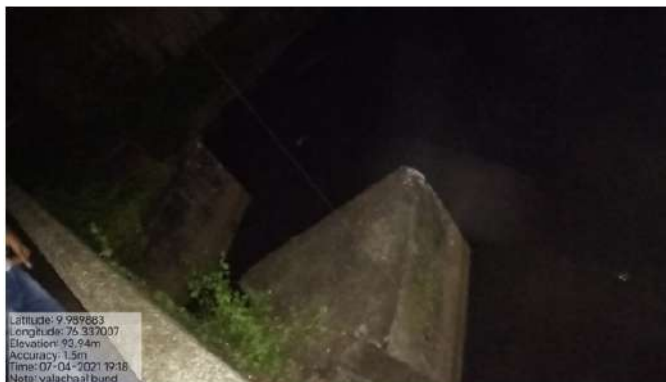
(n) Chainage 9200:
Kalachal small
culvert

Chainage 9200: Small culvert across the thodu

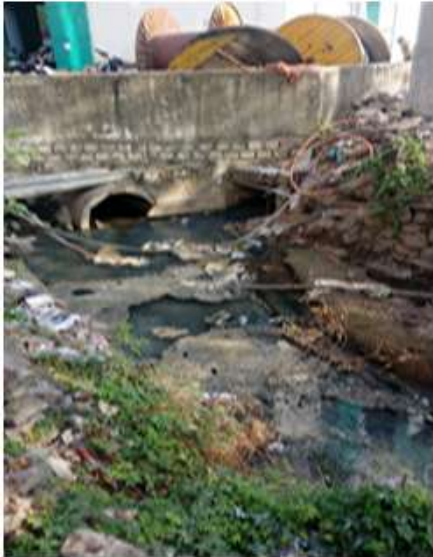
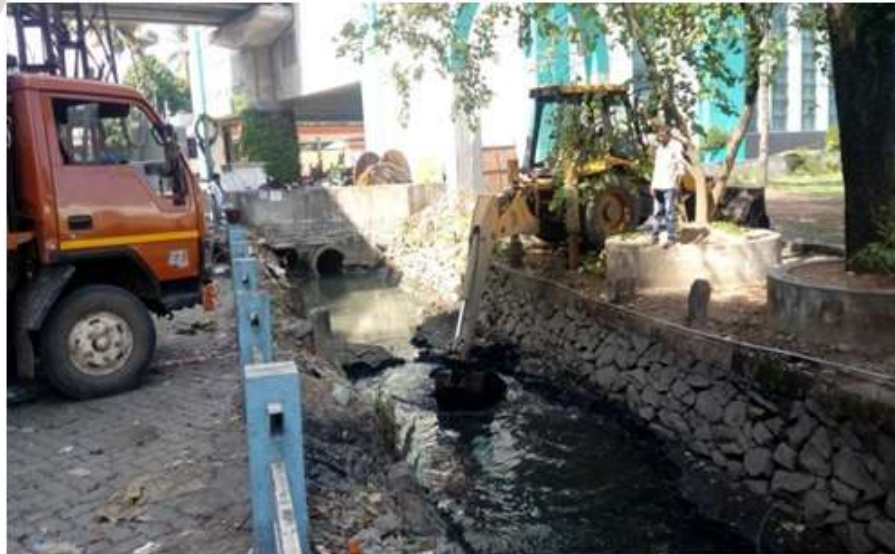
**Starting point -Near
JLN Stadium before
and after
cleaning(OBT)**

The connectivity to the Chittoor puzha via Changadampokkuthodu is seen blocked. There is a difference in bed levels of Karanamkodam and Changadampokku thodus. At the starting point 2 nos of pipes are also seen connected from the other side of the road to Karanakodam thodu.

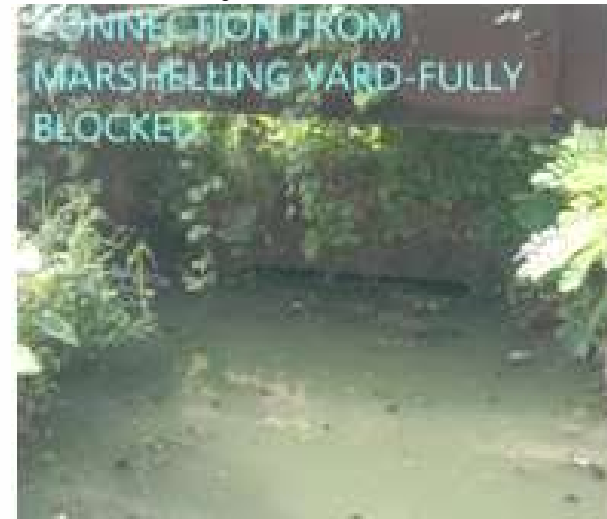
At Ch: 4006 M -Rail Nagar Area

The culverts in the V.V.Road (ch. 4068m) and St. Sebastian Road(ch. 4155m) have very low vertical clearance and a narrower water way and need to be reconstructed .The area has been subjected to flooding during heavy rains. There is an iron bridge at Ch 4408m at the downstream of Railnagararea .Waste accumulation and presence of water weeds,improperly aligned cable have been noticed here which causes hindrances to the uninterrupted flow of water.

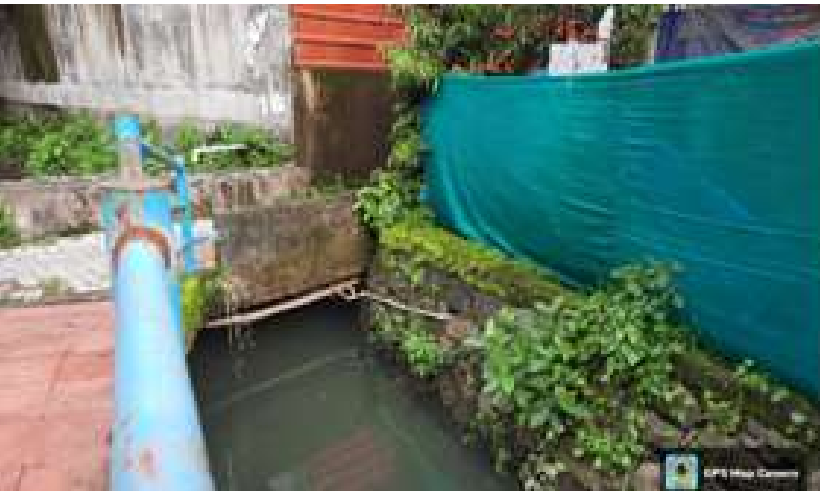
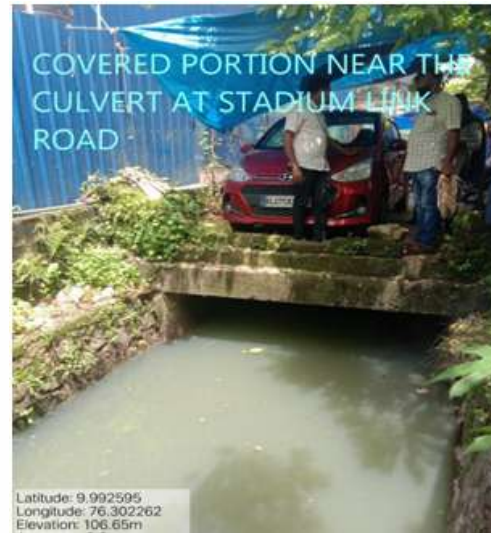
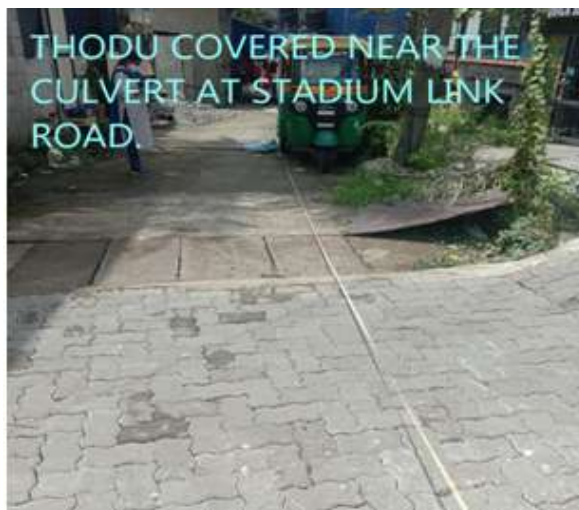
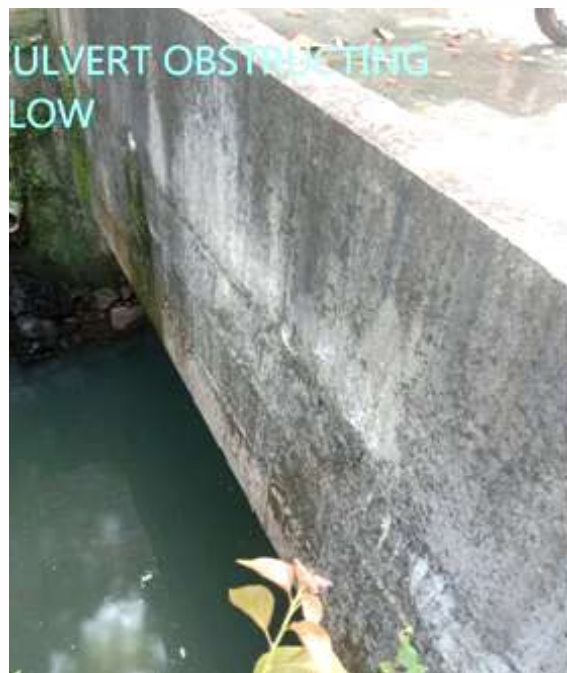
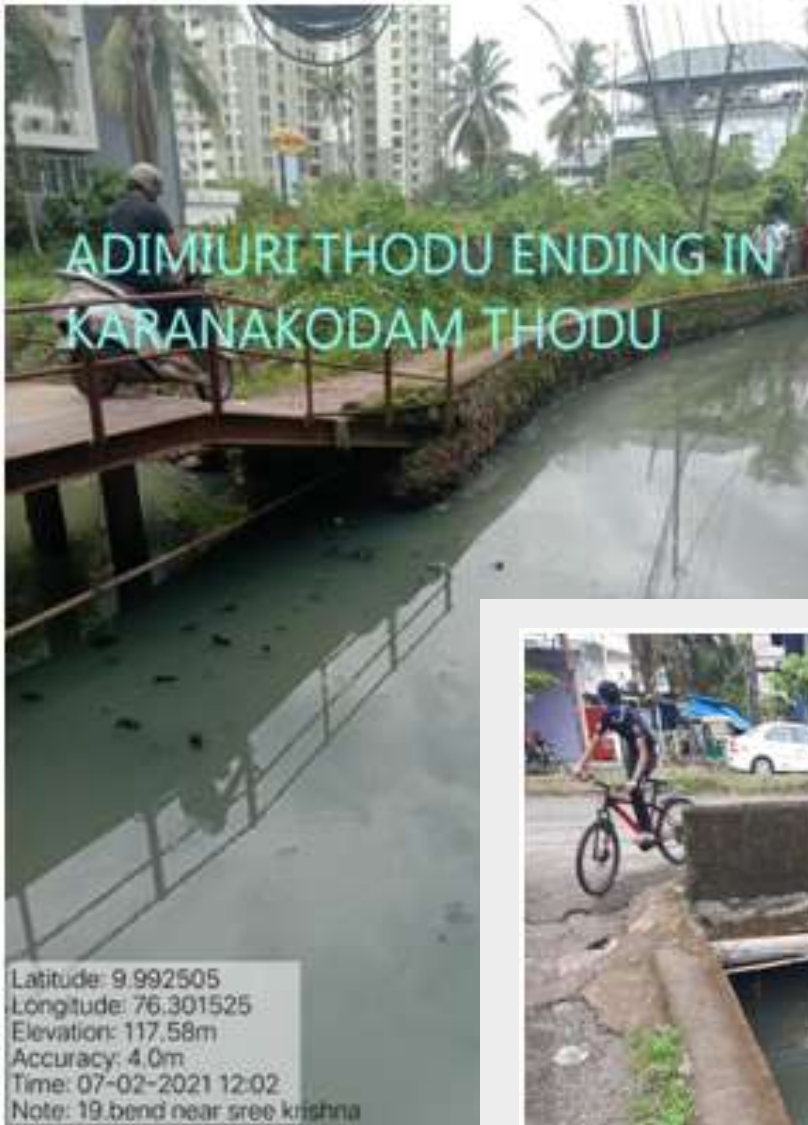
During heavy rains , the area gets water logged .Eventhough the annual desilting is being carried out in the thodu,the obstructions in the covered portionscannot be identified and cleared diligently. The drop beam of the culvert at Ch 249 m leads to the reducedvertical clearance . The culvert at Ch 338m is having insufficient vertical and horizontal clearance.causing flooding. The waters from

Adimurithodu get interrupted also in Stadium link road culvert at Ch 452 m due to the inadequate waterway.The haphazardly placed cables and utility service lines in the culverts are making the situationmore worse.The culverts, the covered portions and the improperly laid cables are causing obstruction to the smooth flow of water.

The cross structures without sufficient vertical and horizontal clearance have to be reconstructed. The covered portions shall be made open. The average width of the thodu must be made 3.5 m to receive the flood waters. The utility service lines must be properly aligned.

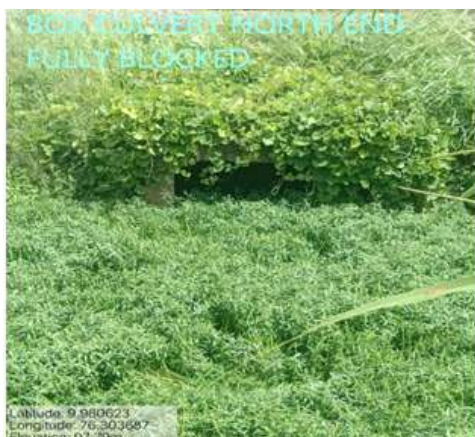
The length of this thodu is 1.451km and has an average width of 2.5m. There is a box culvert of 270 m length (approx) at Ch 719 of this thodu proceeding southward and joining Karanakodam thodu at Rail Nagar area. The flow from either sides of this box culvert is directed towards it. The connection of the thodu to the Karanakodam near the Railway crossing is fully blocked. Now the whole thodu is fully covered with thick vegetation and most parts of it are inaccessible. The box culvert joining the Karanakodam at the south end of Marshalling yard is not functional as it is fully silted up and blocked. The effluent from the yard is getting discharged to this thodu without any treatment.

BOX CULVERT - BOTH ENDS

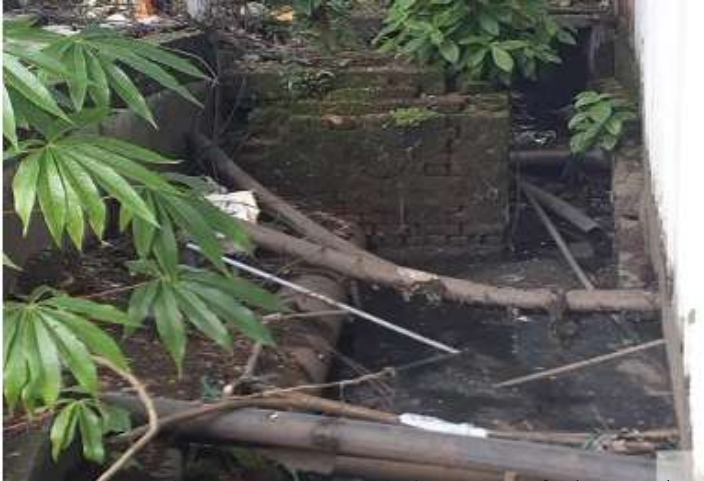
Choked leading drain outside the entrance of substation that supposed to lead water from Changadompokku to Karanakodam

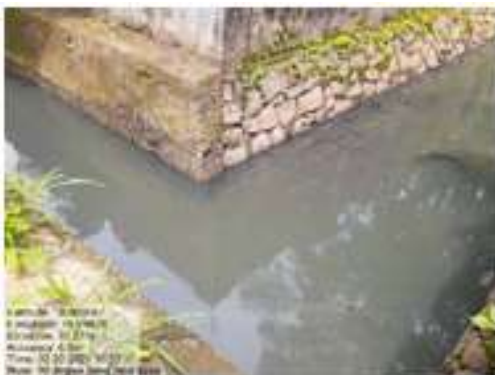
Rear side of substation

The thodu have four numbers of sharp deviations with in 350m between Ch. 265m and ch.615m .The width of thodu reduced to 2.40 m between Greenz Villa and Comrade Nagar. Frequent deposit of silt is formed at these turnings.

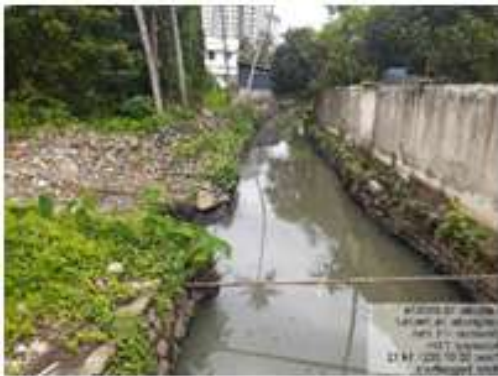
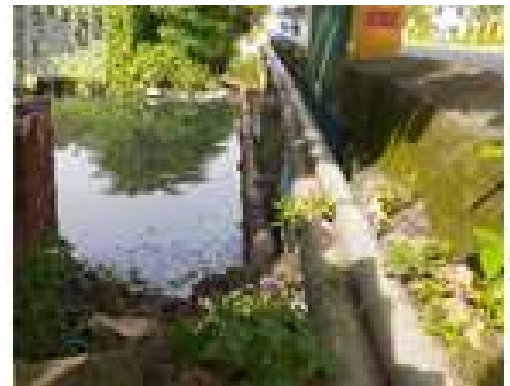
Bhagyadhara culvert

The utility pipes belongs to KSEB/ KWA/ BSNL etc.crossing the drain at different locations obstructing the free flow of water, especially during flood season. The pipes laying through the water surface of the thodu has to be lifted, leaving a clear headroom to accommodate flood water. The following locations are prone to flooding due to the obstruction of utility pipes.

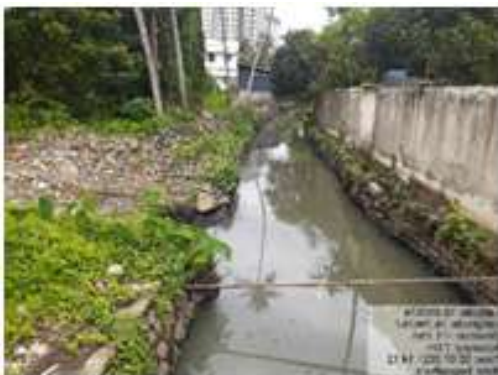
Bhagyadhara culvert 1

The utility pipes belongs to KSEB/ KWA/ BSNL etc. crossing the drain at different locations obstructing the free flow of water, especially during flood season. The pipes laying through the water surface of the thodu has to be lifted, leaving a clear headroom to accommodate flood water. The following locations are prone to flooding due to the obstruction of utility pipes

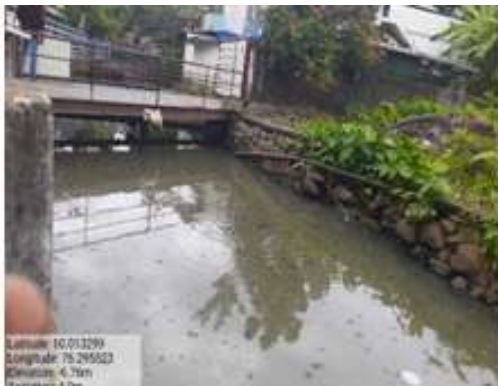
Private entry at Brush lane

Ventway of the thodu is narrowed at the existing culverts viz. Keerthy Nagar culvert, Slabs laid across the thodu for private entry at Brush lane, Elamakkara railway bridge etc., which causes accumulation of wastes and finally blocking the flow of water.

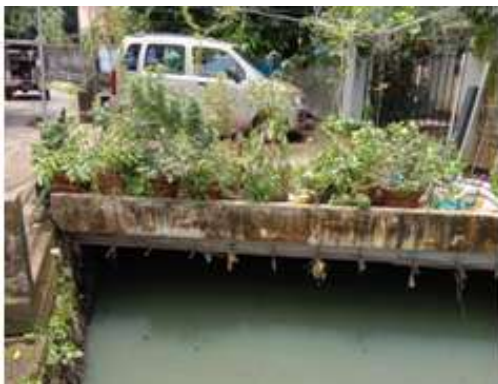
Keerthi Nagar

Encroachments of the thodu is suspected at several locations. There is a drastic reduction in water carrying capacity of thodu due to rampant encroachment. Slabs are constructed indiscriminately by the public over the thodu at several locations belongs to their premises without enough head room and utility pipes crossing under the slabs. It will be a bottle neck to the cleaning process. There are eight private entries across the thodu within 200m at Brush lane.
