REPORT ON
**FLOOD
MITIGATION
KOCHI**

IRRIGATION DEPARTMENT
ERNAKULAM
2021

EXECUTIVE SUMMARY

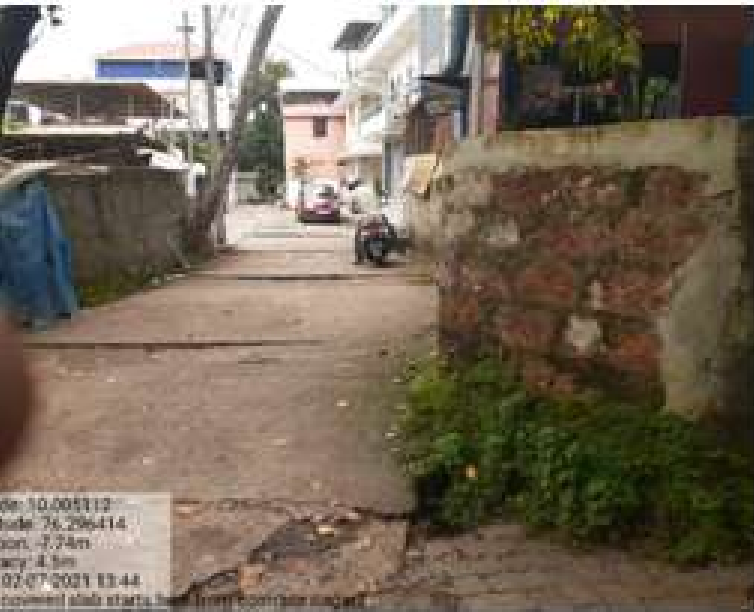
The present practice of the LSGD wing to convert the thodu to road by covering with concrete slab. This will accelerate clogging of drain, which will prevent the free flow of water. Future cleaning of thodu will be cumbersome on account of this. The concreting of bed of natural thodu is not advisable. Nearly 400m of thodu has converted to covered concrete thodu between ch.350 m and Ch.1045m. Concreting the natural bed of thodu will prevent the seepage of water through ground thus increasing the risk of flooding.

60m covered thodu at Comrade nagar

- All covered thodu portions shall be opened as the concreting the bed of natural thodu is not recommended.
- Provide high capacity pumps with shutter arrangements to drain out flood water to the lake so as to combat the tidal variations, ensuring its periodic maintenance.

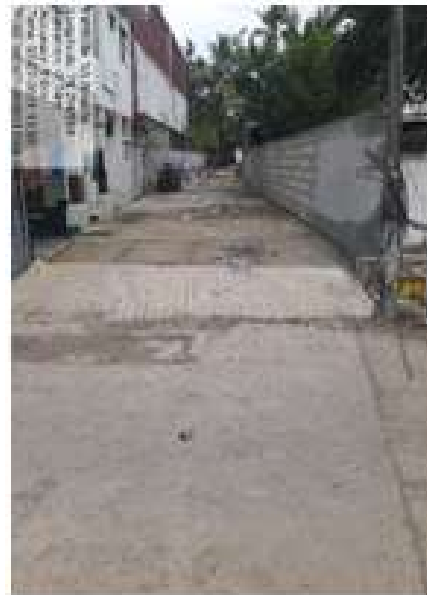
350m covered thodu (Amruth Project)from comrade nagar to Pottakuzhi Mamangalam road

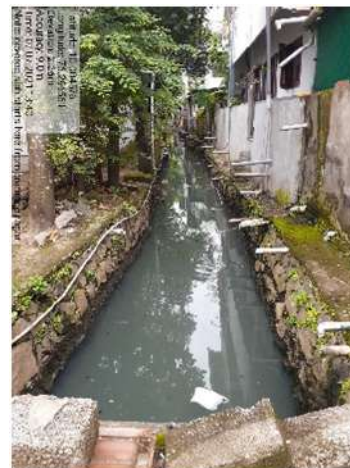
Comrade Nagar

The catchment area of this thodu is densely populated and hence the thodu is subjected to variety of pollutants such as municipal sewage, organic , plastic wastes etc. The thodu is observed to receive household sewage along its entire length. Stringent measures need to be taken to prevent discharge of such wastes and sewage to the thodu .

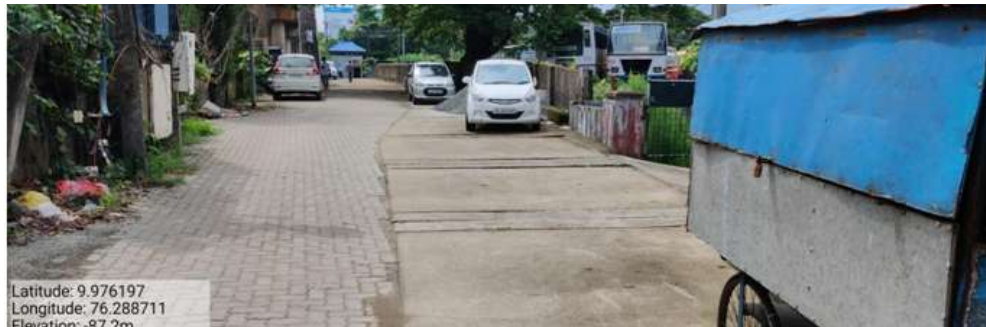
STARTING POINT OF MULLASSERY CANAL NEAR KSRTC BUS STATION

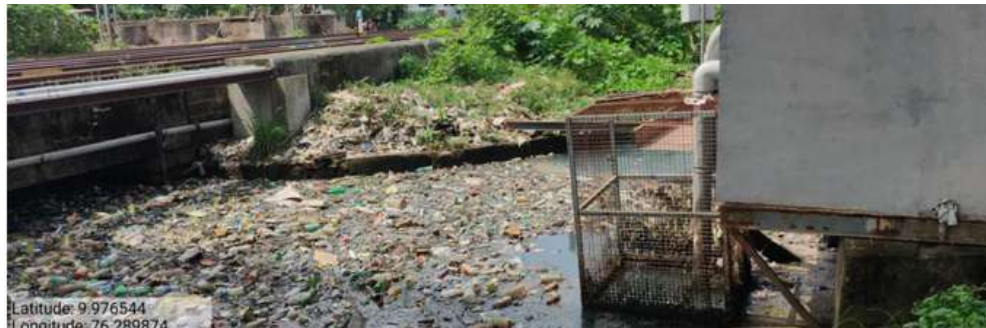
Heavy accumulation of wastes is observed in the area where Perandoor canal crosses rail line near KSRTC bus station. The clogged rail culvert aggravates the flooding problem in this area.

OBSTRUCTED RAIL CULVERT NEAR STARTING POINT OF MULLASSERY CANAL

- The open canal portion from TD road to Kayal (approx 600m) needs to be desilted for effecting speedy drainage.
- The rail culvert connecting Perandoor Canal to Mullassery canal needs to be regularly kept free of obstruction as this is a juncture point of many water bodies and drains .

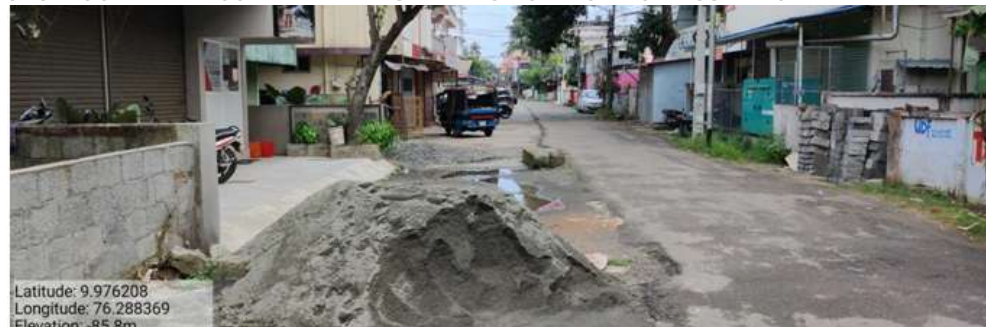
Most reaches of Mullassery canal are covered by concrete slabs. Hence entry of rainwater runoff from adjacent streets into the canal is found to be minimal. The runoff water from streets get collected in the low lying area near KSRTC bus station causing waterlogging and also increasing the load on Perandoor canal which is incapable of receiving this excess drainage.

COVERED MULLASSERY CANAL ALONG MULLASSERY CANAL ROAD

- > Major slope correction issues are observed in the initial stretch of Mullassery canal for a length of approx 810m from KSRTC bus station to TD road . It is proposed to demolish and reconstruct the canal in this stretch for an approx length of 810m. Presently the canal is covered by cover slabs and the area above canal also forms part of roadway. Mullassery canal road is used by KSRTC buses as connection between bus station and bus garage area. The road along Mullassery canal serves as an important and busy connecting link from KSRTC bus station area to major roads like Chittoor road, MG road etc. There are colony of various types of commercial establishments along Mullassery canal road, the access to which are made directly from the presently covered up stretch of Mullassery canal . While demolishing the existing bed and side walls of the canal for slope correction, the access to these commercial establishments will be lost . Cooperation from stakeholders in this regard will probably be challenging.

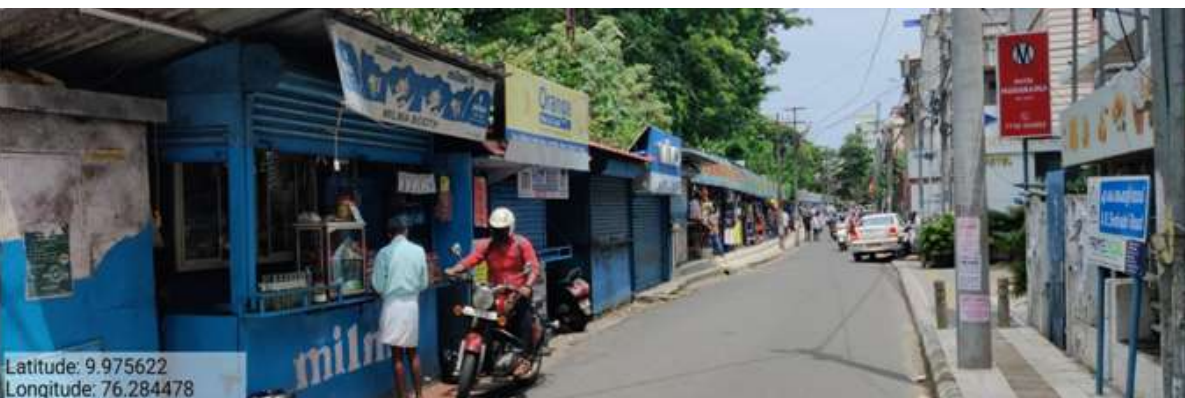
SHOPS BUILT OVER MULLASSERY CANAL ALONG A K SESHADRI ROAD

- All illegal constructions along the full reach of canal blocking the flow of runoff water along road into the canal have to be removed.

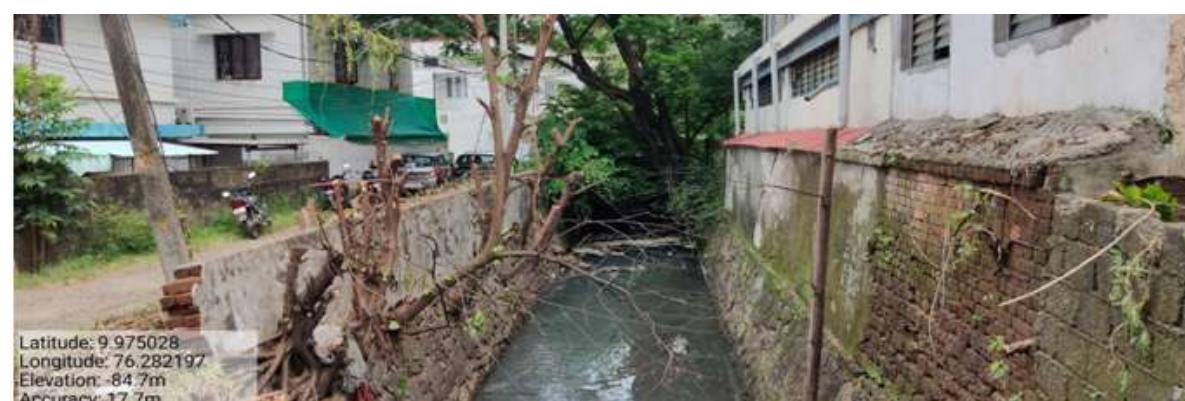
The open reach of thodu from TD road at ch 800m upto end at Kayal is found to be silted up .

OPEN CANAL STARTING NEAR TD ROAD

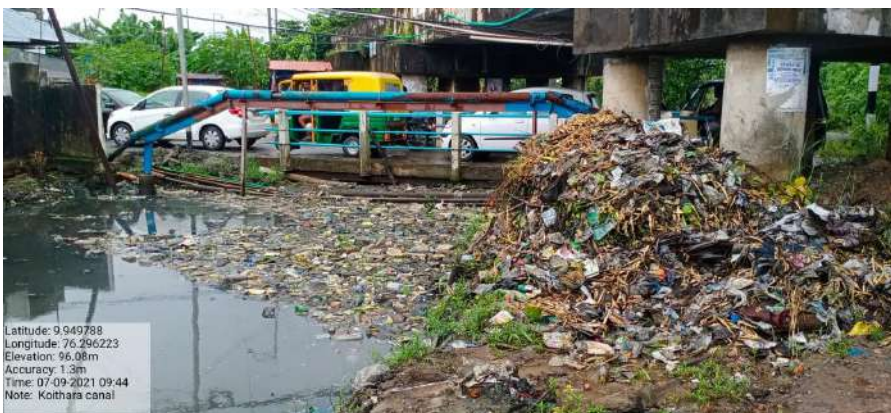
Koithara Canal near Varghese Thittayil Road

- Obstruction to free flow of water due to pipes/cables laid across the canal near culverts at Varghese Thittayil road and near culvert at Anamthuruth bridge.
- Pipes/cables laid across canal near bridge in front of IOC might cause obstruction to the free flow of water when the water level rises during continuous heavy rain.
- Reduced width of canal at some locations
- Discharge of waste water directly from the houses and disposal of solid wastes causing extreme poor water quality and unhealthy situation in the premises
- Link canal also heavily silted up and the outlet towards Perandoor Canal covered with thick vegetation
- Cables laid across the link canal near substation road causing hindrance to free flow of water

The pipes /cables under the culverts are to be realigned to avoid accumulation of solid waste and to ensure free flow of water. Regular cleaning of the canal and its link is essential. Waste deposition in the canal has to be controlled by implementing proper waste management methods and enforcing stringent measures. Discharge of wastewater directly to the canal is also to be prevented to enhance the quality of water. Surveillance cameras shall be installed near the culvert under the railway line in Varghese Thittayil road, near IOC Panampilly Nagar, near Annamthuruth Bridge and selected locations near housing colonies.

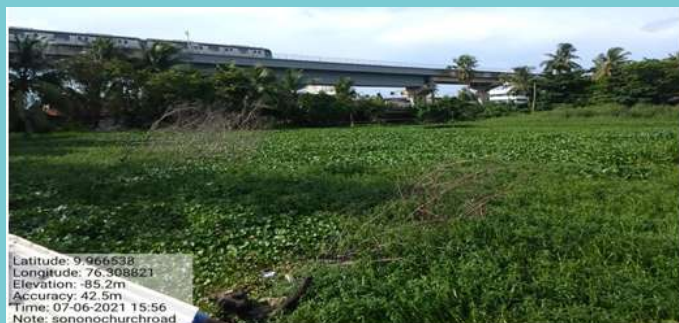
Water hyacinth near Elamkulam bridge (ch 660m)

- The portion of lake under Elamkulam bridge is heavily silted up causing obstruction to flow. This needs to be cleared.
- Water hyacinth also obstructs flow in the portion near to Elamkulam bridge.
- A link thodu joins to lake at the north-east side of SA road near Elamkulam bridge. The outlet of this thodu is blocked with thick vegetation causing obstruction to flow.

The obstructions under Elamkulam bridge and Chilavannoor bridge needs to be cleared to ensure free flow of water. The remnants of bund for formation of cycle track along western bank of Chilavannoor lake under Padmasarovaram project between Elamkulam bridge and Subash Chandra Bose bridge needs to be cleared. Desiltation of lake to be done to improve its water carrying capacity and also to effect speedy outflow. Waterlogging is experienced in certain areas adjacent to the lake especially near Gateway apartments on western bank even during high tide periods. A regulating mechanism can be provided at the outlet of the lake at Chilavannoor Tank bund road for regulating the inflow and outflow. Also the outlets of linkthodus to the lake are to be cleared to ensure speedy drainage of storm water.

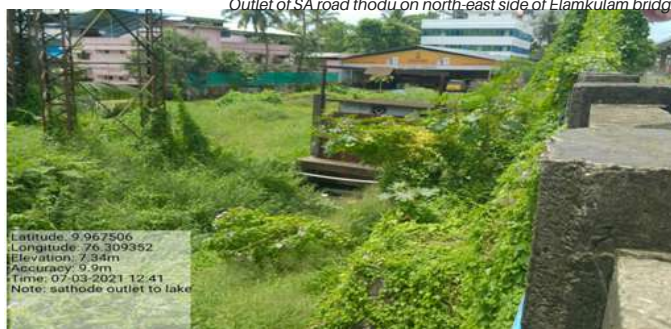
Outlet of SA road thodu on north-east side of Elamkulam bridge

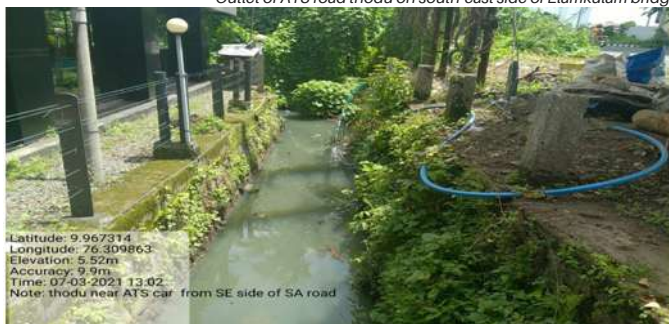
- At the south-east side of Elamkulam bridge a link thodu joins to lake near ATS vehicle service centre. The outlet of this link thodu is also completely blocked by thick vegetation.
- Delta formation is observed in lake near the south-east side of Elamkulam bridge

Outlet of ATS road thodu on south-east side of Elamkulam bridge

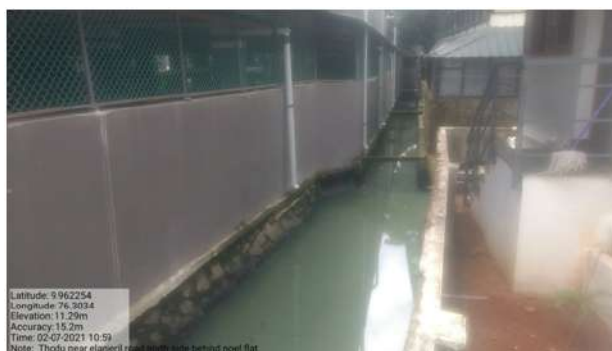
The width of the thodu at its starting portion is only 1.1 m and hence the thodu seems to have insufficient carrying capacity to accommodate the entire storm water discharge, which causes flooding in adjacent residential areas. The width of thodu from Ch 0m to 80m is very narrow (avg 1m) and passes in between compound walls which makes the thodu prone to waste deposition and also makes the thodu cleaning process tedious.

Reach behind NOEL Apartment- Insufficient width and passing between compound walls

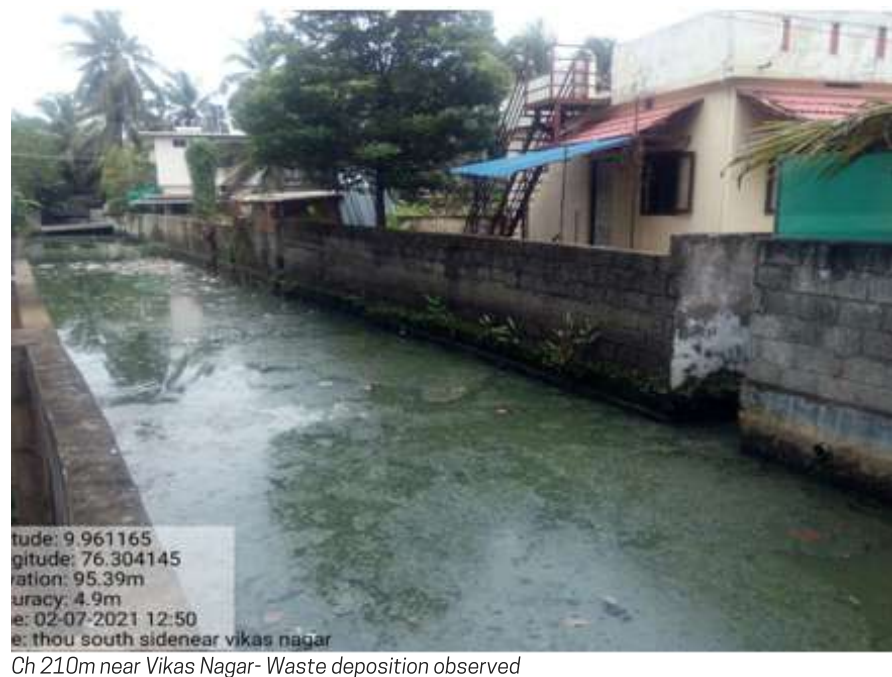
Ch 210m , Vikas Nagar

Waste accumulation in thodu is observed in this reach near Vikas nagar. Quality of water in this reach is also very poor.

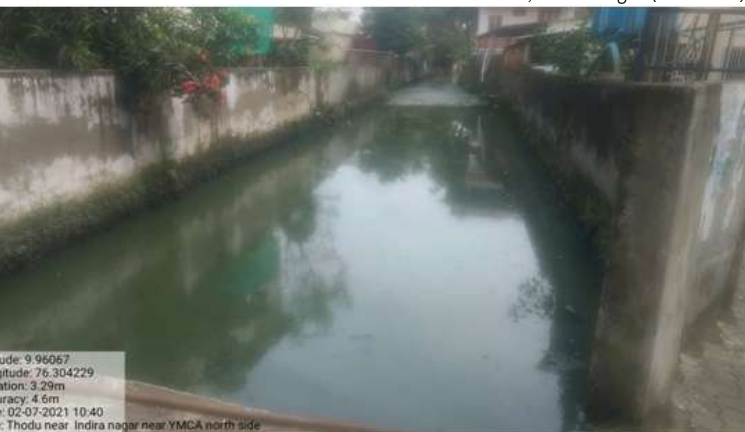
Ch. 270m Near YMCA, Indira Nagar

Waste deposition in thodu near Indira Nagar (ch 270m)

- The culvert across thodu near YMCA, Indira Nagar is not having sufficient height of vent and hence wastes tend to accumulate near this culvert causing blockage to flow. One side of the culvert is observed to have sunk reducing the available vertical clearance. In addition, there are pipes seen laid across the thodu under the culvert deck slab.

- The pipes laid across the thodu below the culvert deck slab is to be realigned to ensure free flow of water.
- Accumulation of waste is observed in the initial reaches at Elenjeril road, Indira Nagar area (especially near YMCA and iron bridge) and Vikas Nagar.

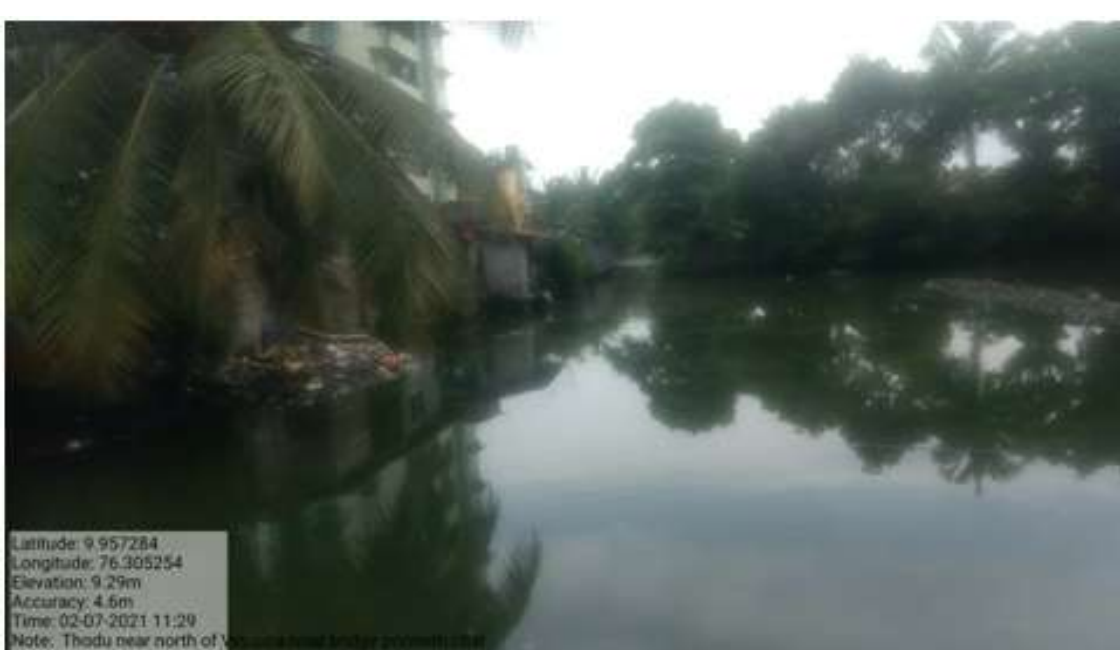
Ch 660m North side of Vinobha Nagar road

Houses located immediate close to the banks of the thodu (ch 660m) upstream of Vinobha Nagar Bridge

- Some houses situated immediate close to banks of the thodu on north side of Vinobha road bridge is affected by flooding during rainy season as well as on high tide. Waste deposition is also observed in this area.
- Reach of thodu from Ch 720m (Vinobha road) to Ch 1900m (Outlet at Kayal near Ambanattuchira)
- No flooding problem is reported in the wider reaches of thodu towards the south of Vinobha road bridge.

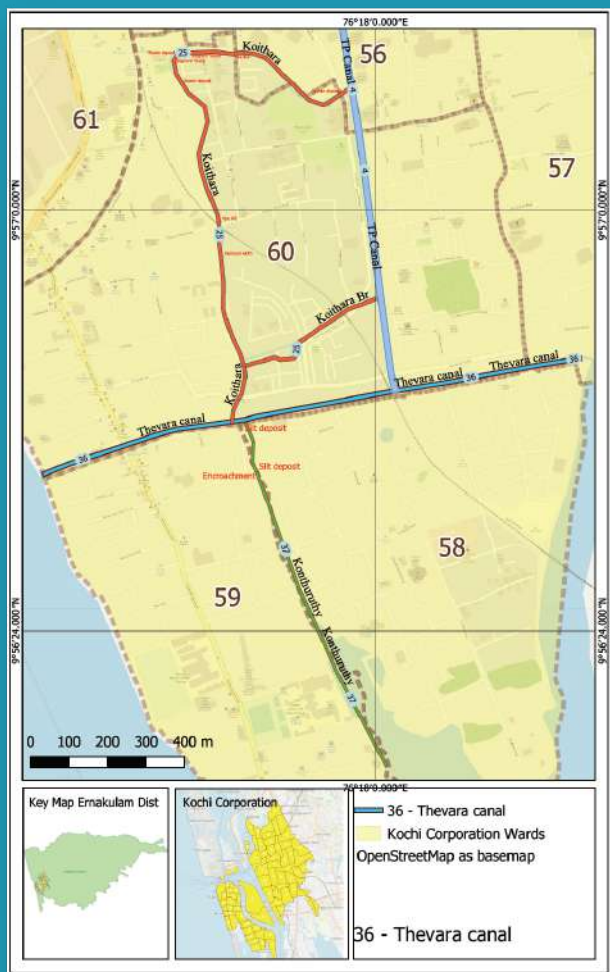
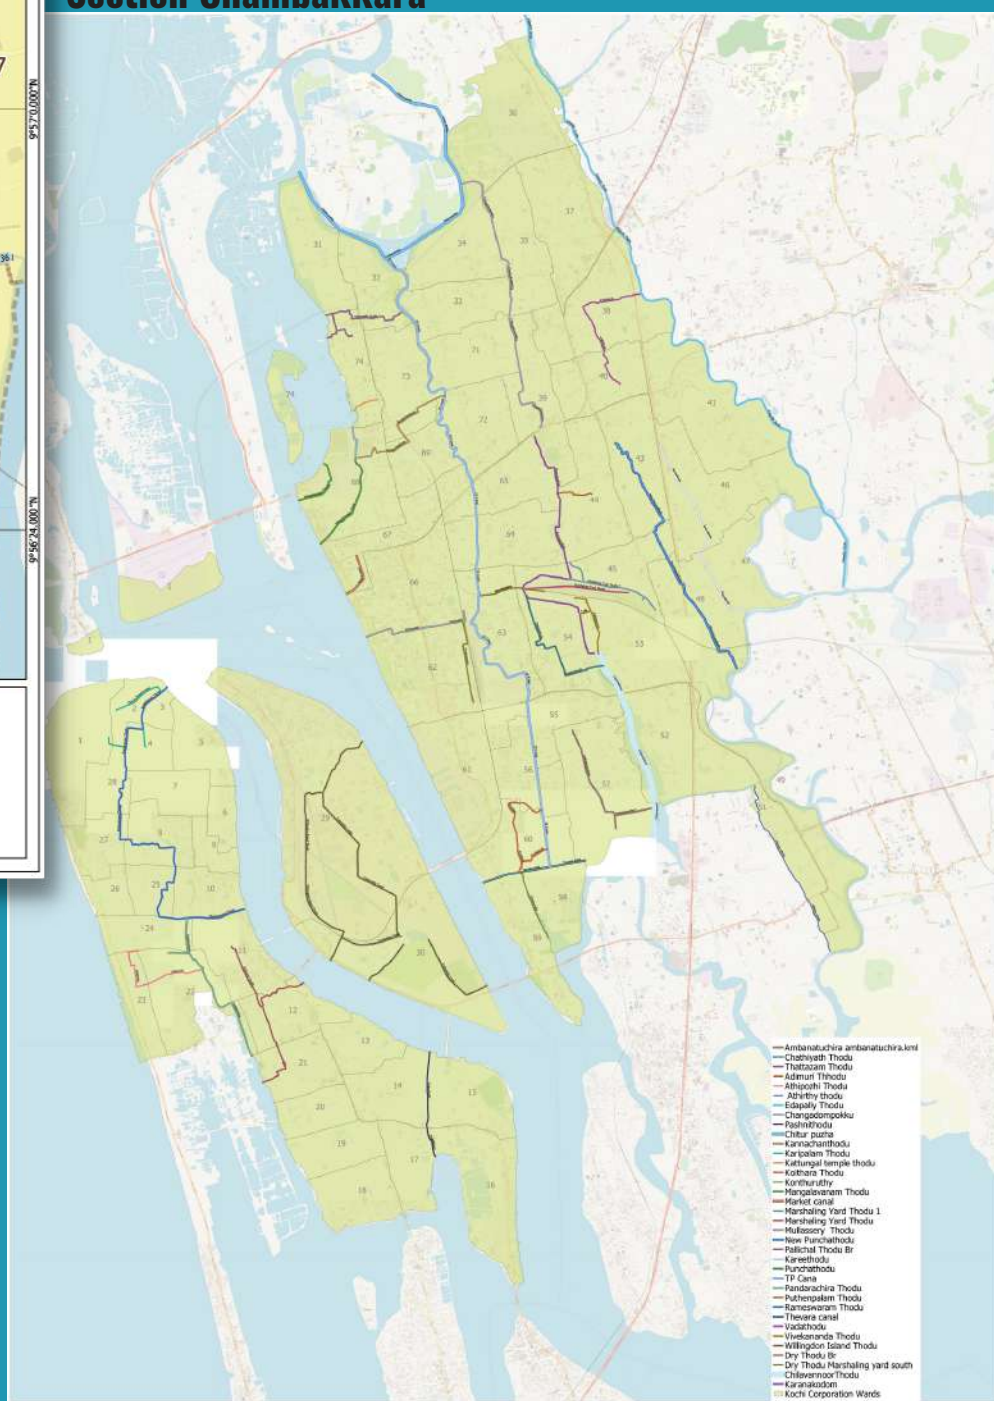
THEVARA CANAL SILT DEPOSITION AND HYACINTH

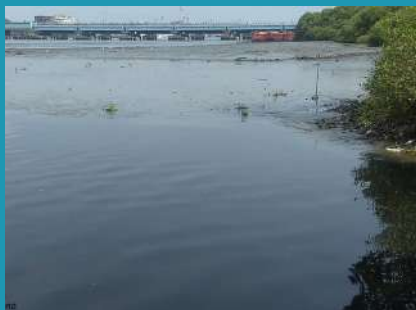
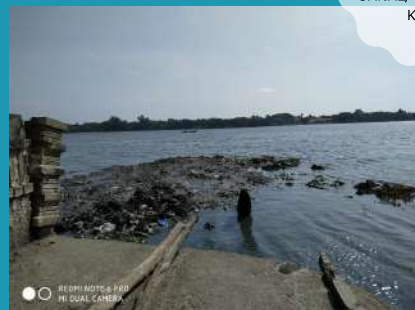
Before OBT Work

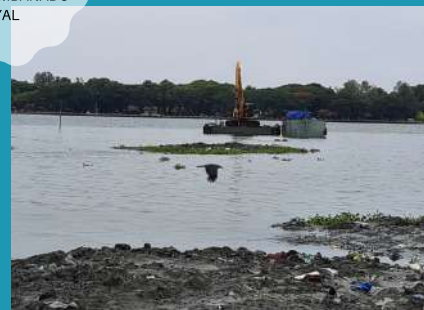
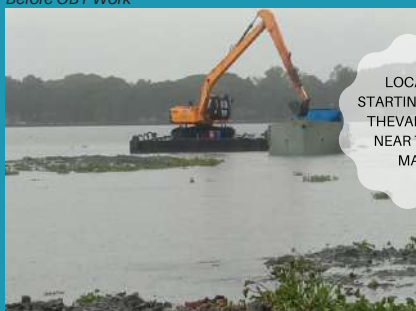
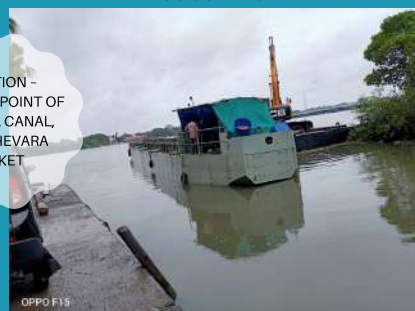
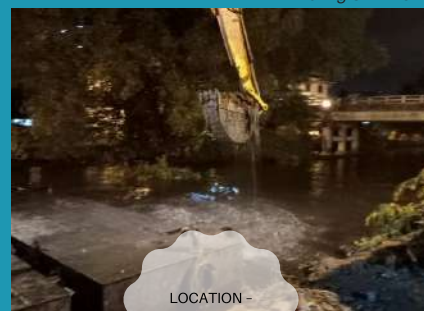
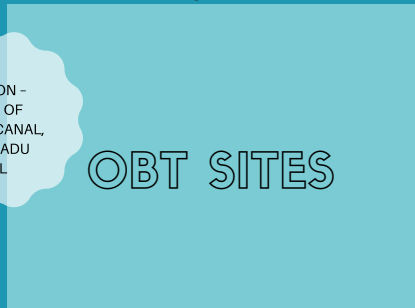
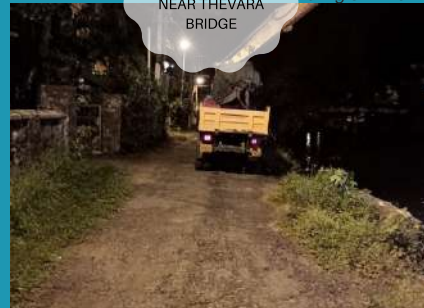
During OBT Work

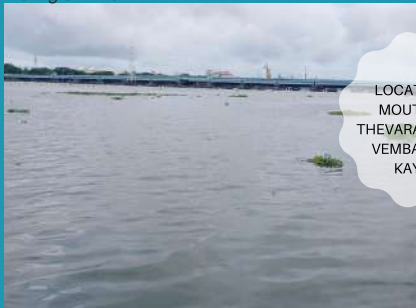
After OBT Work

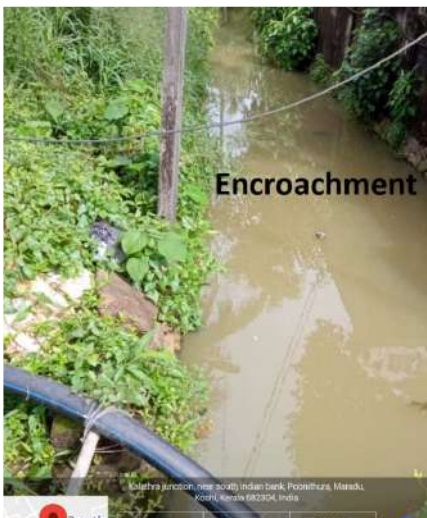
At ch: 807m, Kalathara Junction

- ❖ At ch: 351m, thodu, pipe outlet is there. Then thodu is in open condition.
- ❖ Reaching to the ch: 807m, kundannoor- petta road is crossing, here box culvert is provided. Box culvert has no sufficient clearance and also cables are passing it obstruct free flow of water.

- Eviction of encroached area is essential.
- The deposited silt should be removed. And prevent the pipe outlet provided towards thodu. For the smooth desilting process, the covered slabs need to be removed.
- The culverts provided at the kundannoor- petta road and at Thuruthy Temple road are need to reconstruct with sufficient clearance. Also, the cables passing through kundannoor- petta road should be realigned.

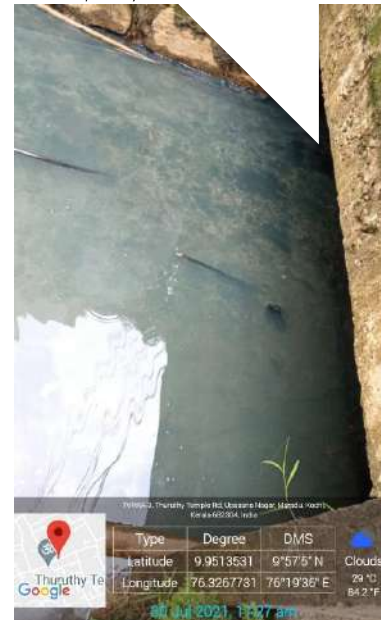
Thuruthy Temple road, Bottom of Culvert

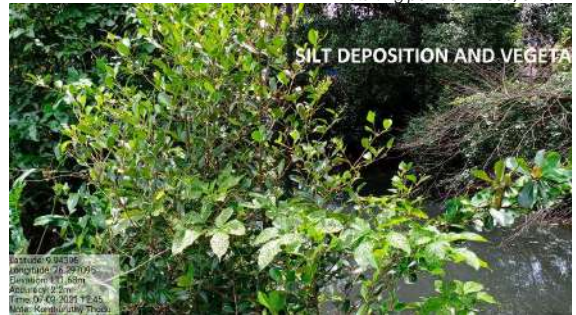
At ch: 107m Near Konthuruthy road

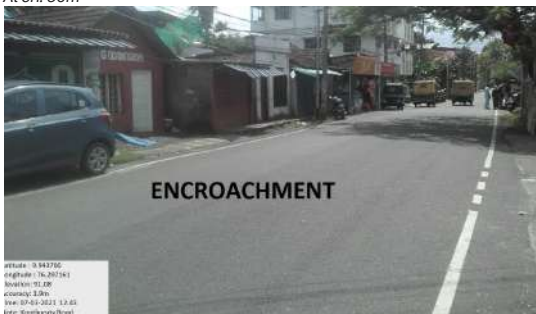
At ch: 134m, Konthuruthy road

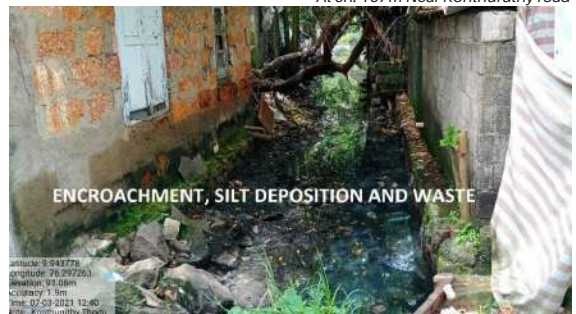
At ch: 134m, Thodu is visible after Konthuruthy road

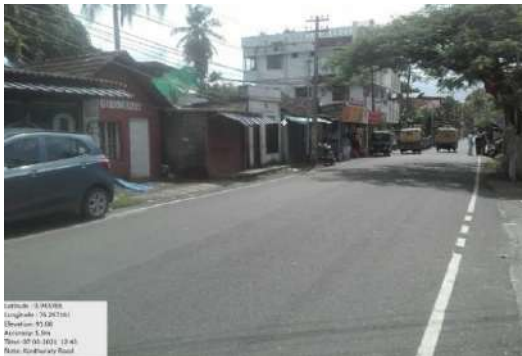
Konthuruthy Road across the thodu

- Konthuruthy road is crossing at ch: 134m and there is a pipe culvert is provided. Here thodu is not visible. it affects the natural flow of water.
- Thodu is visible after Konthuruthy road, and here width is again reduced to 2.5m, due to the encroachment. waste and silt deposition is here.

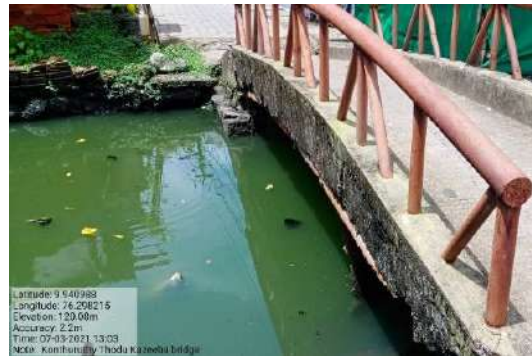
Kazeeba Bridge

- Another Kazeeba bridge is existing across the thodu at ch: 464m, here width is increased to 5m. There no sufficient vertical clearance for the bridge. Waste and silt deposition is also there.

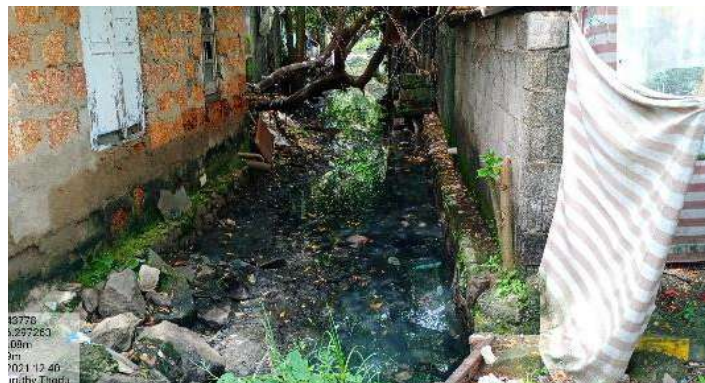
Portion of thodu after konthuruthy road

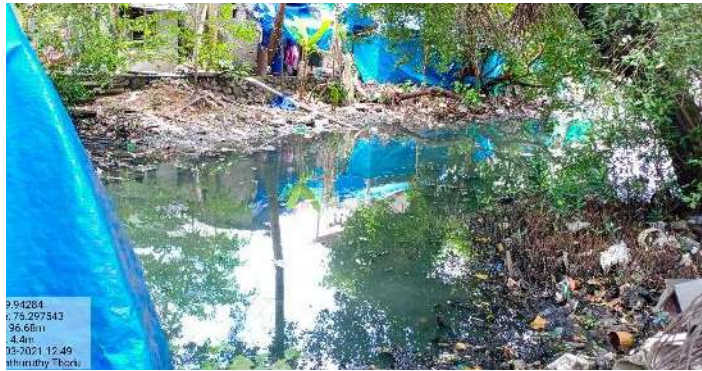
Encroachment and silt deposition

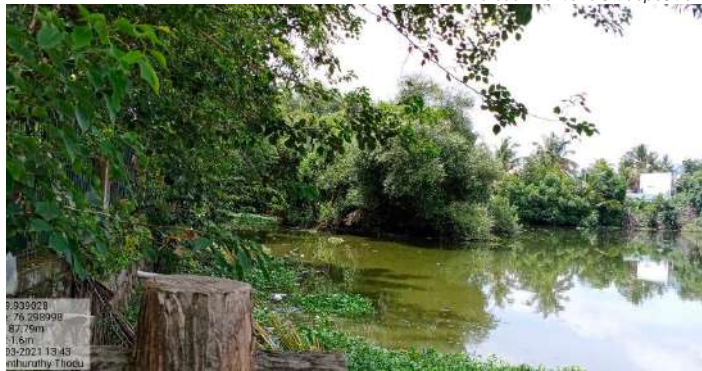
- Reaching towards the end portion, At ch: 699m there is a delta formation and thick vegetation there It should be removed for the free flow of water.

Delta formation

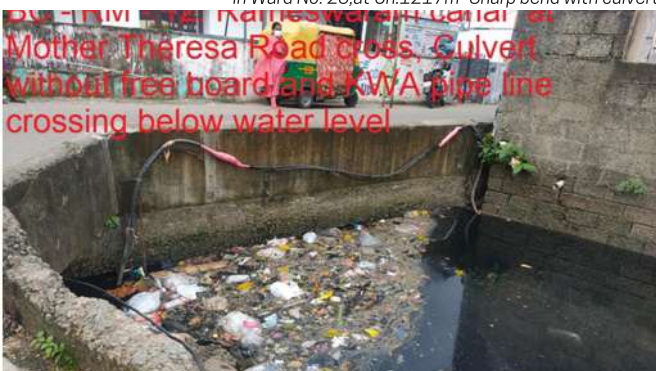
In Ward No.8, at Ch. 1758m Mother Theresa Road cross - culvert without free board and KWA pipe line crossing below water level

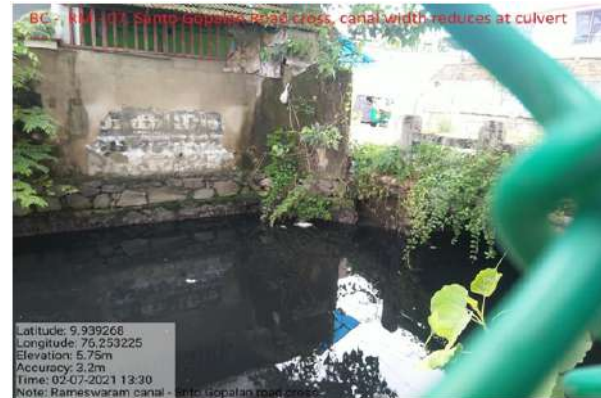
In ward No.25, at Ch. 1032m - Santo Gopalan Road cross canal width 7.50m, culvert span 5.50m

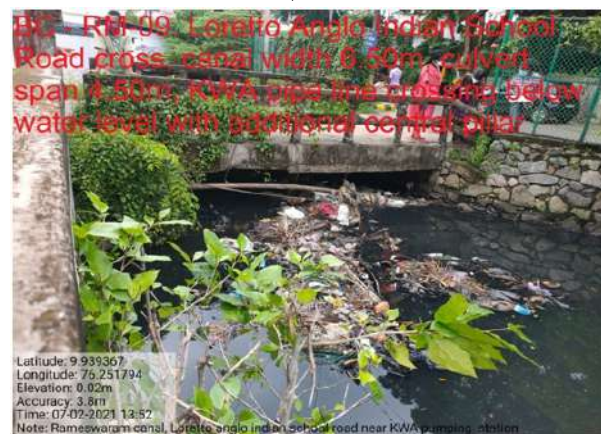
In Ward No. 25, at Ch. 1190m - Loretto Anglo Indian School Road cross, Canal width 6.50m and culvert span 4.50m

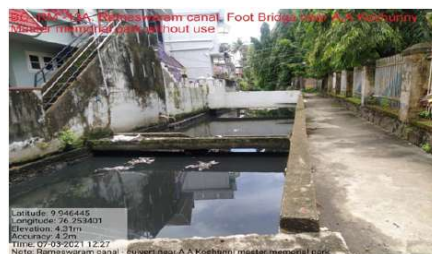
In Ward No.8, at ch.2200m- Damaged Foot bridge near A .A. Kochunni Master Memorial Park, which is not in use.

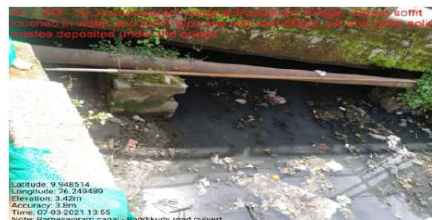
In Ward No.8, at Ch. 2873m Pandikudy Bridge , Beam soffit touching the water and KWA pipe line with additional two pillars

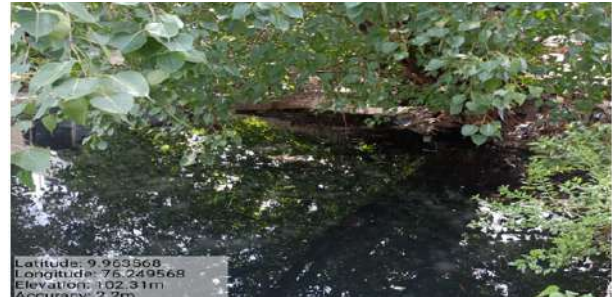
In Ward No.2, at Ch. 5427m.
Foot Bridge- canal width
13.00m, bridge span 9.00m

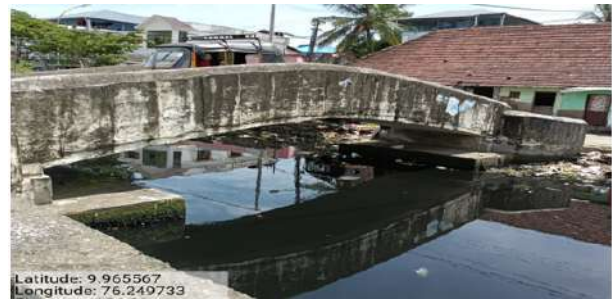
In Ward No.4, KWA pipeline
to be shifted and bridge to
be reconstructed due to
damaged condition at
ch.175m. Of Kareepalam
Branch Canal

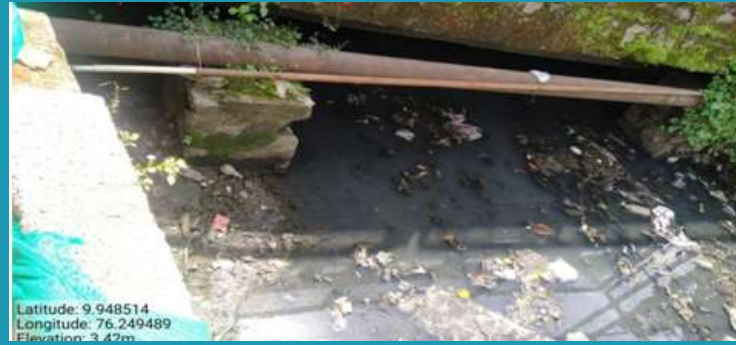
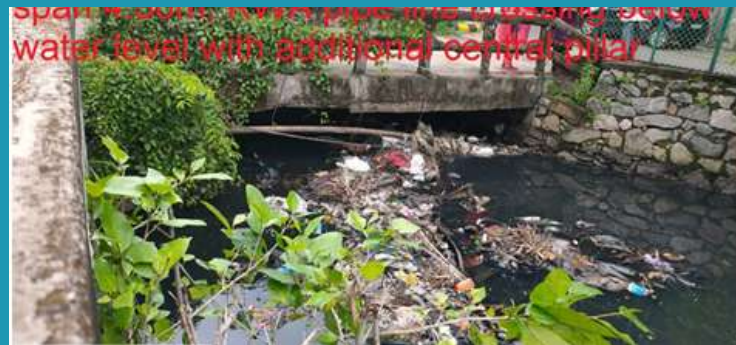
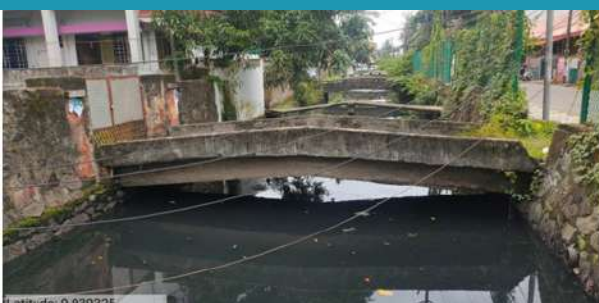
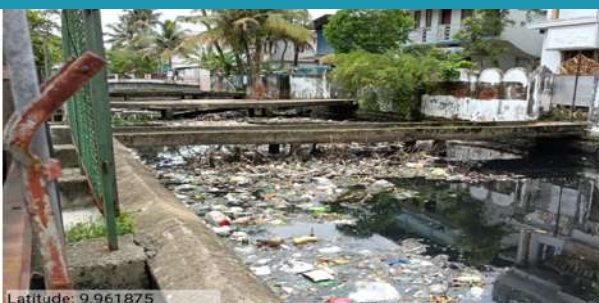
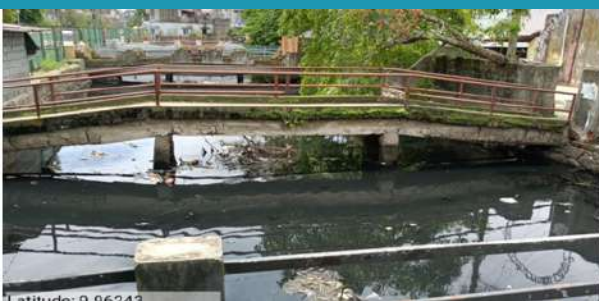
The utility pipes belonging to Kerala Water Authority, BSNL etc. crossing the canal at different locations with additional pillars and without sufficient free board, obstructs the flow of water especially during flood season. These pipe lines through the water surface of the canal have to be lifted and fixed to the culvert parapet. Following locations such as ch.467m, ch.1190m, ch.1658m, ch.1758m, ch.1935m, ch.2379, ch.2732m, ch.2873, are prone to flooding due to the obstructions of utility pipes.

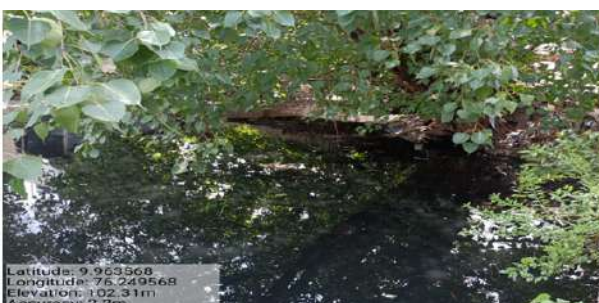
Ch.5189m Pullupalam

The vent way of the canal is narrow and without sufficient free board at existing bridges/ culverts , it causes accumulation of waste and finally blocking the flow of water at various chainage. Reconstruction of Bridge/ culvert with adequate free board and span is needed at Ch.1032m, Ch.1190m, Ch.1217m, Ch.1758m, Ch.2200m, Ch.2873m, Ch.4632m Ch.4777m, Ch.5189m and Ch.5424m and ch.175m of Kareepalam branch canal.

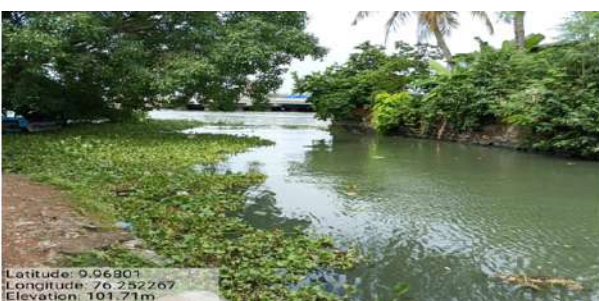
At end portion of Kalavthy canal near Fort Kochi Boat Jetty

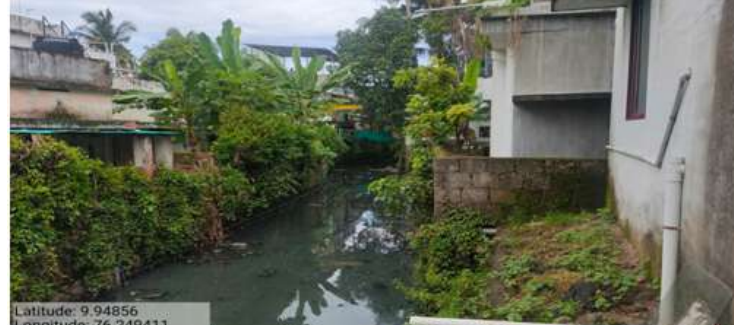
At. Ch.2972 - Heavy Silt deposit

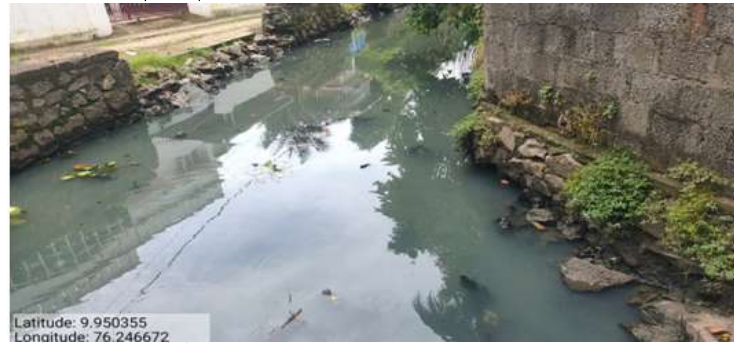
At. Ch.3599 - Heavy Silt deposit

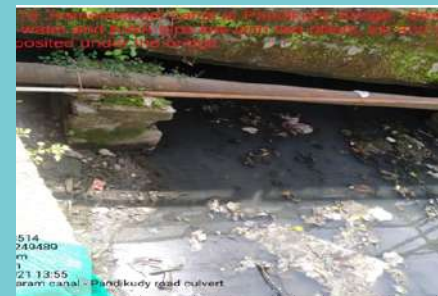
In Ward No.8, at Ch. 2873m Pandikudy Bridge, Waste deposited

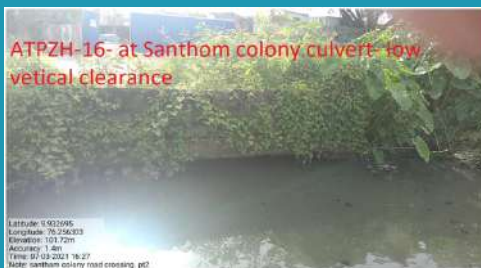
Athipozhi Thodu -Reduced width of the thodu- Near Santhom colony road at ch.1550m

The culvert constructed across the canal with projecting abutments causes the reduction in width of the thodu at ch.1550m which causes blockages of the thodu and reduces the easy drainage of water.

For avoiding blockage / flood during rainy season the following measures are required. Cleaning of thodu including deepening, Clearing vegetation , encroachment eviction, widening of thodu at narrow places and maintaining same cross -section, reconstruction of culvert with sufficient span and free board, removing waste pipe line/soil pipe from house hold directly discharging into the thodu etc.

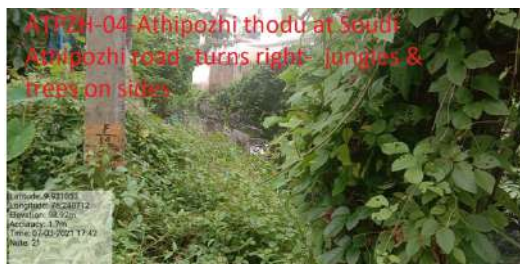
Thodu is covered with thick vegetation which obstruct free flow of water. Root growth especially from nearby trees caused drainage failure on the thodu.

Athipozhi Thodu -Thick vegetation and jungle at ch. 624m

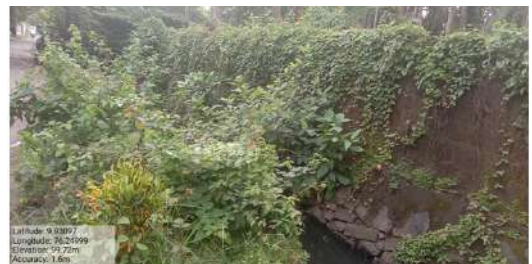
Athipozhi Thodu -Thick vegetation and jungle at ch:860m

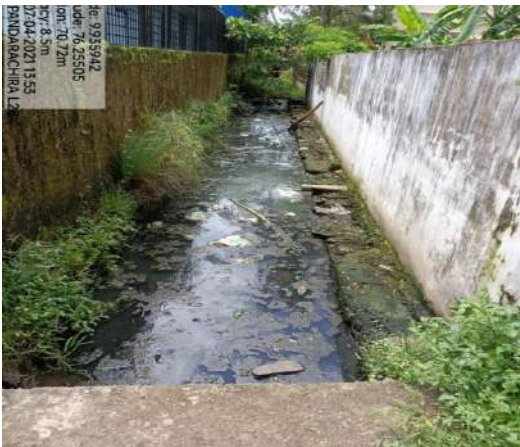
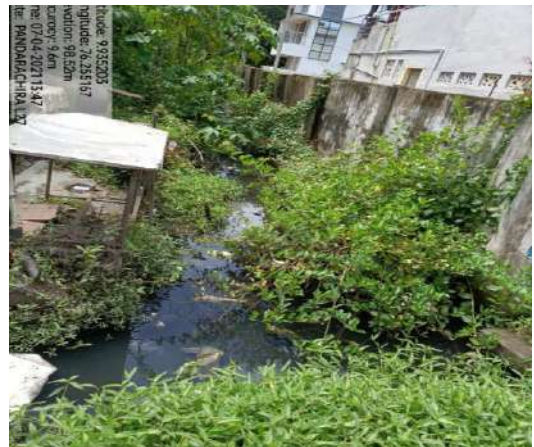
The main problem faced in this thodu and the areas in the vicinity is flooding during the monsoon season. The main reason for this is silting up of the thodu. Periodical cleaning is not done since long, hence the depth of flow is reduced considerably. Waste dumping also has lessened the quality of water in the thodu. The main problem for flooding up of water is due to blockage of flow of water in the upstream of Pandarachirathodu at the starting point itself because the thodu is covered up by slab and between Ch.490.5m and 952.1m where there is vast encroachment, waste dumping and since long no cleaning has been done. Silt is accumulated for the entire length of 3.3371km including the branches. A delta formation has taken place at Ch.1422.1m which needs urgent attention and has to be removed. In monsoon season the recession of flood water will take more time and naturally the low lying area will easily get inundated. This portion of silt accumulation has to be cut and cleaned to facilitate easy flow of water from the thodu to the Rameswaram Canal and Chirakal river

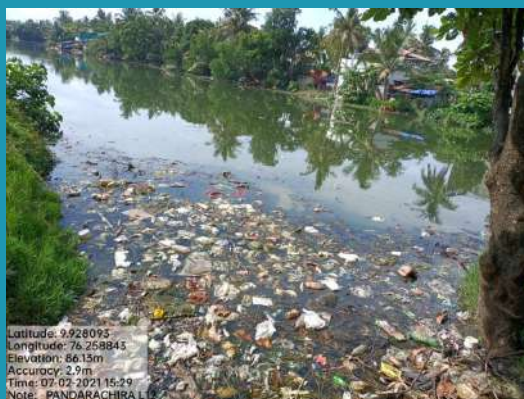
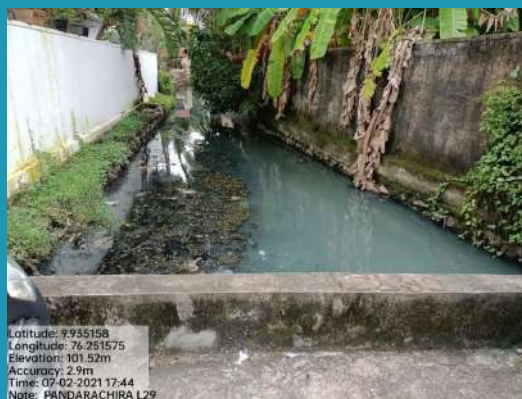
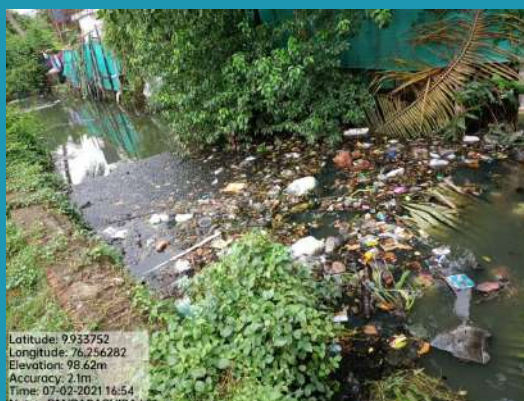
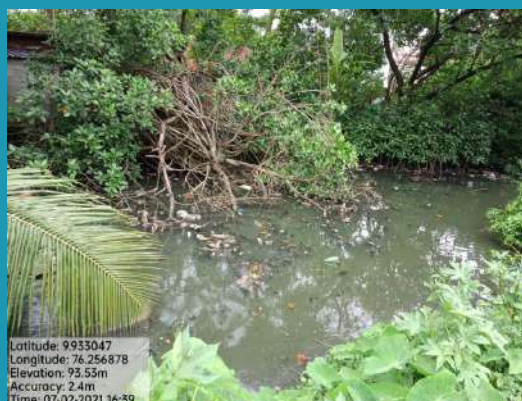
Waste pipes from houses are directly in to the thodu which also causes pollution of the waterbody. Due to the waste accumulated the flow of the thodu has been reduced drastically. This problem is seen near Chainages 920m, 790m etc. The thodu starts with a width of 2m and reduces to 1.5m @Ch:470m, then the width increases to 5m upto Ch:478.50m. In this 478.5m stretch we could find a lot of waste dumped into the thodu from houses. Water gets blocked at Ch.478.5m where the height of the culvert is insufficient and needs to be reconstructed. Near Ch. 633.5 the thodu has two 90 degree bends where massive quantity of waste has been deposited. This has to be removed at warfooting. At this chainage the Pandaraparambu branch thodu meets the main thodu. This branch is also accumulated with waste in different stretches which also has to be removed urgently. Near Ch.787.5m where the Athipuzha branch thodu meets the main thodu a large quantity of waste is deposited. Near Ch.952.1m for a stretch of 40m, Ch.1422.1m, 1597.1m 2412.1m etc large quantity of waste has been deposited. It needs urgent attention. The catchment area of this thodu is densely populated and hence the thodu is subjected to variety of pollutants such as municipal sewage, organic, plastic wastes etc. The Pandarachira thodu at the starting portion for 186 m might also have waste pipes connected, but those are not visible because most of the length of thodu is covered by concrete slabs.

The thodu is observed to receive household sewage along its entire length. The people residing nearby the thodu are also facing health hazards due to the heavy pollution of the thodu. Stringent measures need to be taken to prevent discharge of such wastes and sewage to the thodu.

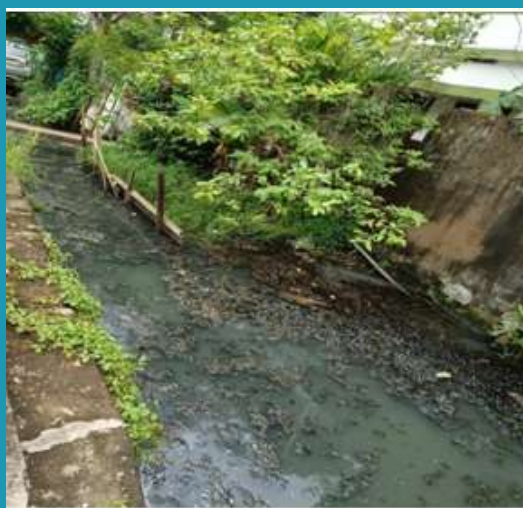
There are 9 small drains joining the Pallichalthodu at the left side and about 12 number of small drains joining at the right bank. Moreover small PWD drains also connects to the main Pandarachirathodu. The surface runoff as well as waste water flows into the main thodu also. The other drains connecting at different points to the main and branch thodu are also clogged with waste and needs thorough cleaning to make easy flow of water through the drains in to the main thodu. These channels would act as flood absorbing pockets and the run off from high intensity rain could not be drained easily now.

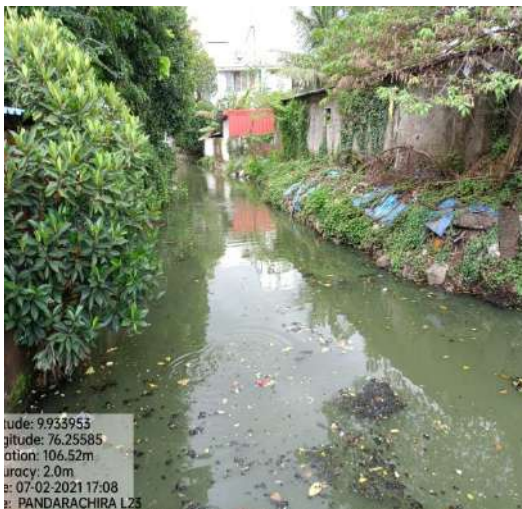
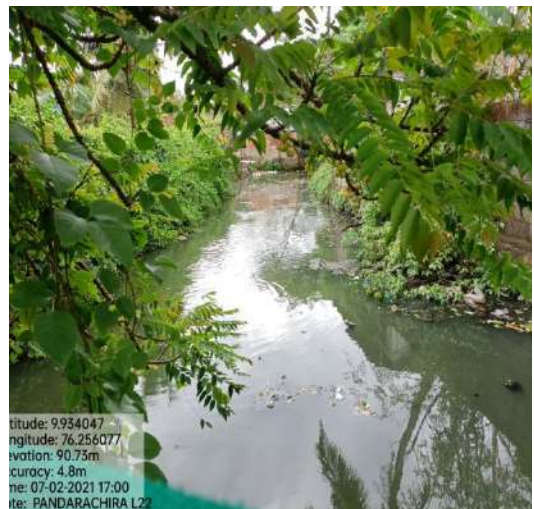
d) Reduced width of Thodu

The width of thodu is reduced at different points which causes blockages of the thodu and reduces the easy drainage of water to the Chirakal river. In the main Pandarachirathodu at Ch:0.00m the width of thodu is 2m, the width reduces to 1.5m at Ch 378m, means the thodu reduces further. This portion of thodu continues for a length of 100.5m, which finally reduces the discharge drastically. Widening of thodu in this stretch of thodu is inevitable and should be intervened urgently. The width of thodu reduces from Ch.501.50m ie from 8m to 5.5m upto Ch.633.5m which finally reduces the discharge drastically for a length of 132m. At Ch.112.5m the thodu has got 40m width. But this reduces to 12.4m at Ch.937.5m. That is for 187.6m length of thodu the width reduces gradually (27.6m). Near Santhom Colony the thodu has got 18m width at Ch.1422.1m. But at Ch.1502.10m the width of thodu reduces to only 23m and further it reduces to 8m at Ch.1637.10m. Near Neerul Iman Masjid the thodu has got 20m width only at Ch.2277.10m. But at the end Ch.2417.10m the width of thodu is 57m. As the width of thodu reduces the area of cross section of flow get reduced and drainage of water becomes blocked and wont serve the entire purpose intended.

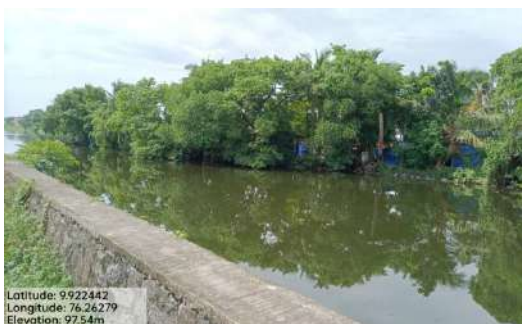
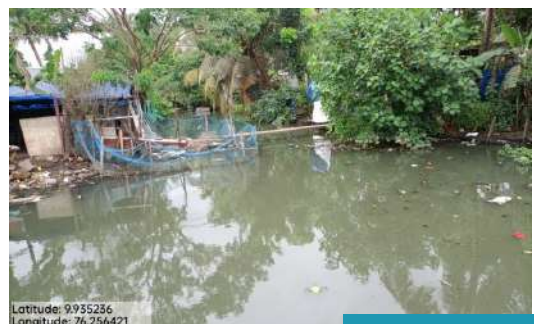
e) Encroachment:-

Encroachments of the thodu is suspected from Ch:726.5m upto Ch.787.50m where there are two sharp 90 degree bends. This encroachment continues upto Ch.937.50m where the existing width of thodu 18.4m reduces to 12.4m and in order to facilitate the water flow there is only two pipes of 1.5m dia installed which is very much insufficient for the existing width of 12.4m. The encroachment is further found from Ch.937.50m to 1125.1m and from 1552.1m to 1597.1m. Towards the end portion near Ch.2277.10m and Ch.2237.1m the encroachment is visible where the public has constructed houses into the thodu and planted small trees also. These encroachments has to be evicted strictly with the help of higher authorities and police.
