REPORT ON
**FLOOD
MITIGATION
KOCHI**

IRRIGATION DEPARTMENT
ERNAKULAM
2021

EXECUTIVE SUMMARY

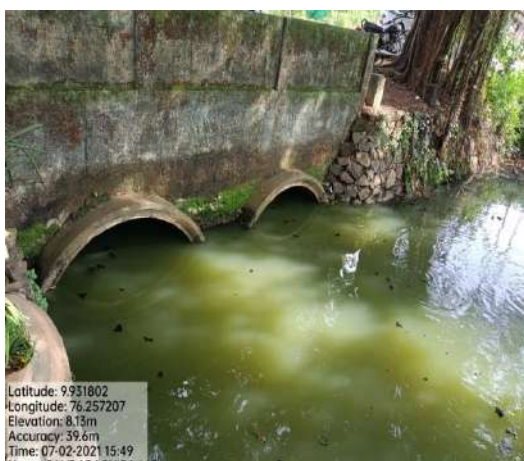
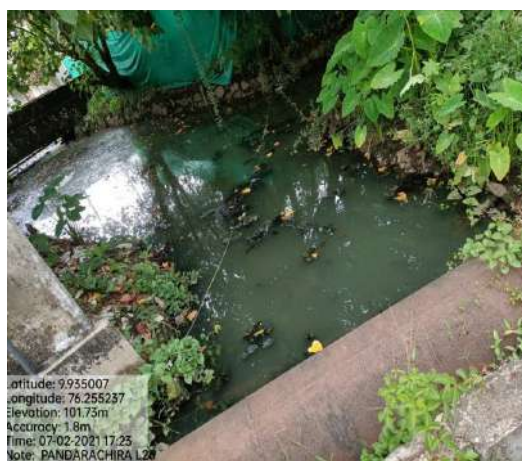
f) Existing culverts having no head room and vent way

Ventway of the thodu is narrowed at the existing culverts which causes accumulation of wastes and finally blocking the flow of water near Ch.478.50m and Ch.937.5m.

At Ch.478.5m – The height of the Culvert is not sufficient for free flow of water . This old culver has to be demolished and we have proposed reconstruction of this culvert with adequate height.

At Ch.937.50m – The existing width of thodu (18.4m) reduces to 12.4m and in order to facilitate the water flow there is only two pipes of 1.5m dia installed which is very much insufficient for the free flow of water. The area of cross section for free flow of water is reduced to 3.53m² where we need about 22.32m² area. We have now proposed to remove the existing RCC pipes and to construct a new culvert with sufficient width of flow which will bring in a massive impact and improve the continuous flow of Pandarachira thodu. Another pipe culvert is given at Ch.410m of Pandarachira branch thodu with a diameter of 30cm which is insufficient for smooth flow of water. A new culvert is proposed at this location with sufficient headroom and ventway. This work shall be done very urgently.

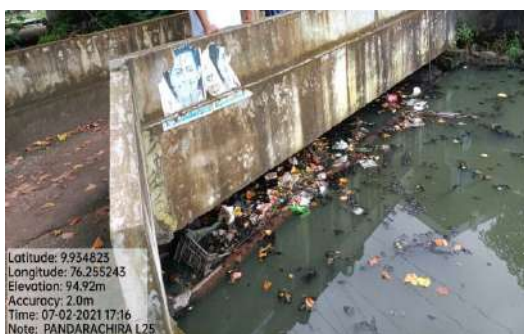
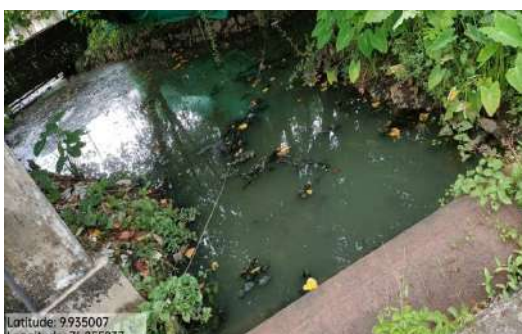
g) Utility pipes crossing drains

The utility pipes belongs to KSEB/KWA/BSNL etc. crossing the drain at different locations obstruct the free flow of water, especially during flood season. The pipes laid through the water surface of the thodu has to be lifted, leaving a clear headroom to accommodate flood water. The following locations are prone to flooding due to the obstruction of utility pipes

At Ch.478.5m near Kazhuthumuttu the thodu joins the culvert where there is huge pipe of KWA which has to be lifted up to facilitate the free flow of water.

At Ch.490.5m near Kazhuthumuttu, there is a small culvert across which a small water supply pipe passes which has to be lifted up to facilitate the free flow of water.

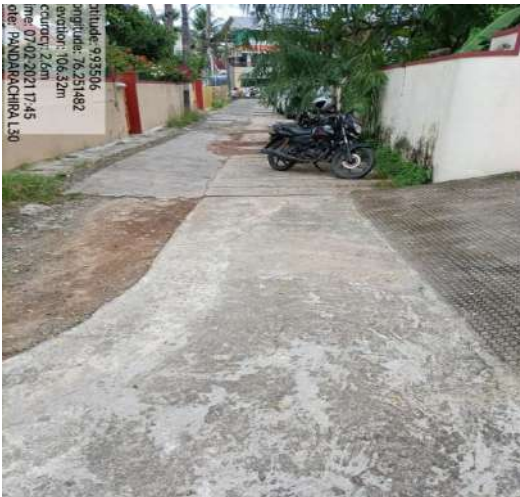
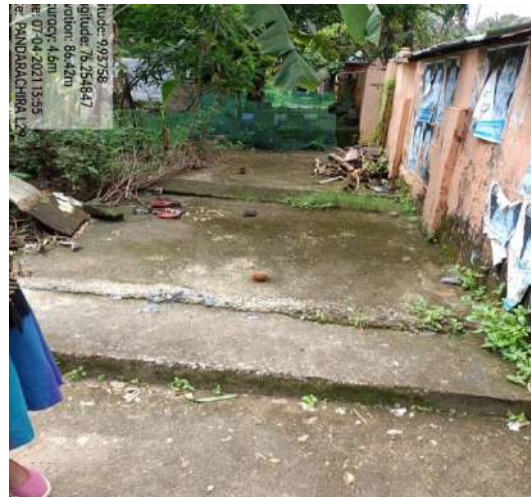
h) Conversion of thodu to road

The Pandarachirathodu is covered up with slab for a length of 186m from the starting point ie from Polakandam market in Ramavarma Canal. The thodu is covered and cleaning has not been done since years and the waste materials and silt is laying as such in the thodu which needs urgent attention.

The present practice of converting the thodu to road by covering with concrete slab has to be stopped. This will accelerate clogging of drain, which will prevent the free flow of water. Future cleaning of thodu will be cumbersome on account of this. The concreting of bed of natural thodu is not at all advisable. Concreting the natural bed of thodu will prevent the seepage of water through ground thus increasing the risk of flooding.

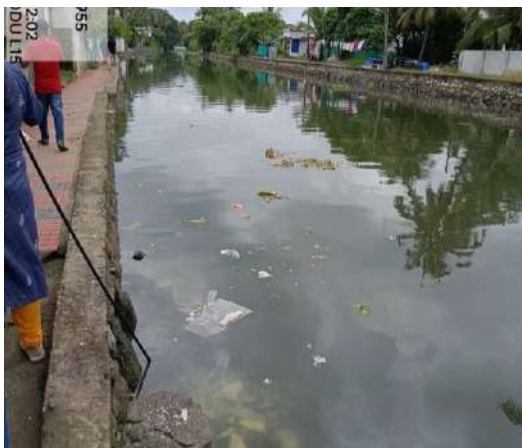
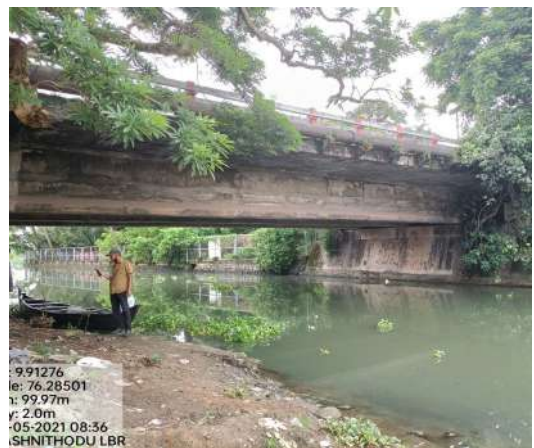
a) Silt accumulation:-

The main problem faced in this thodu and the areas in the vicinity is flooding during the monsoon season. The main reason for this is silting up of the thodu. Periodical cleaning is not done since long, hence the depth of flow is reduced considerably. Waste dumping also has lessened the quality of water in the thodu. The main problem for flooding up of water is due to blockage of flow of water in the upstream of Pashnithodu in the PerumpadappuKayal. Silt is accumulated for a length of 1km in the upstream for a width of 20m and depth of 2m. In monsoon season the recession of flood water will take more time and naturally the low lying area will easily get inundated. This portion of silt accumulation has to be cut and cleaned to facilitate easy flow of water from the thodu to the perumpadappukayal and viceversa

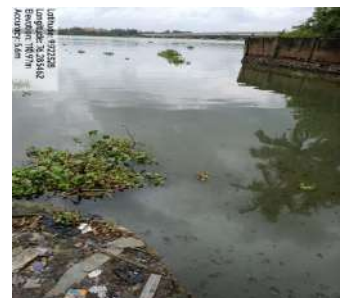
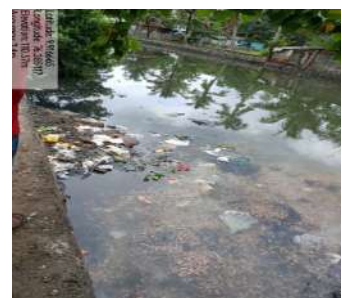
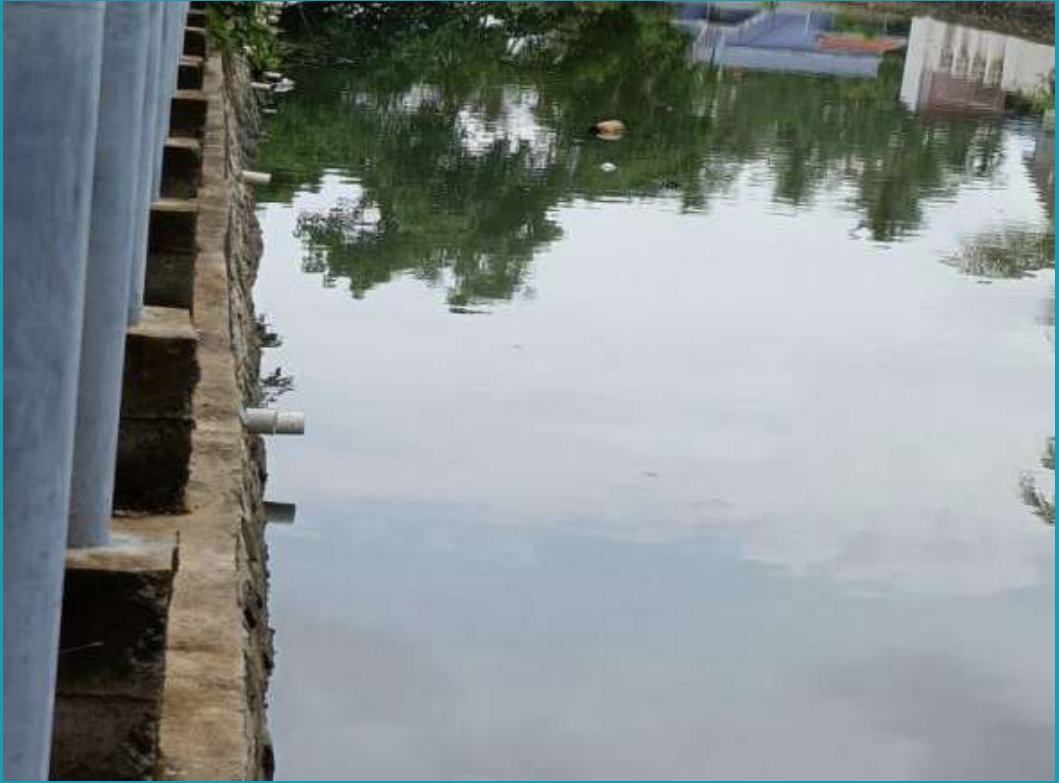
b) Disposal of waste water and solid waste into the natural drain:-

Waste pipes from houses is given directly in to the thodu which also causes pollution of the waterbody. due to the waste accumulated the flow of the thodu has been reduced drastically. The catchment area of this thodu is densely populated and hence the thodu is subjected to variety of pollutants such as municipal sewage, organic, plastic wastes etc. The thodu is observed to receive household sewage along its entire length. Some seafood companies also operate on the left bank of the thodu. Amida Peeling shed is situated at Ch:467m of the thodu, Trity exports company is situated at Ch: 1247m on the left bank. Another Company named TSS peeling company is also situated on the left bank which also drains out waste water into the thodu. These companies are letting out solid as well as liquid wastes to the natural drain. The people residing nearby the thodu is also facing health hazards due to the heavy pollution of the thodu. Stringent measures need to be taken to prevent discharge of such wastes and sewage to the thodu.

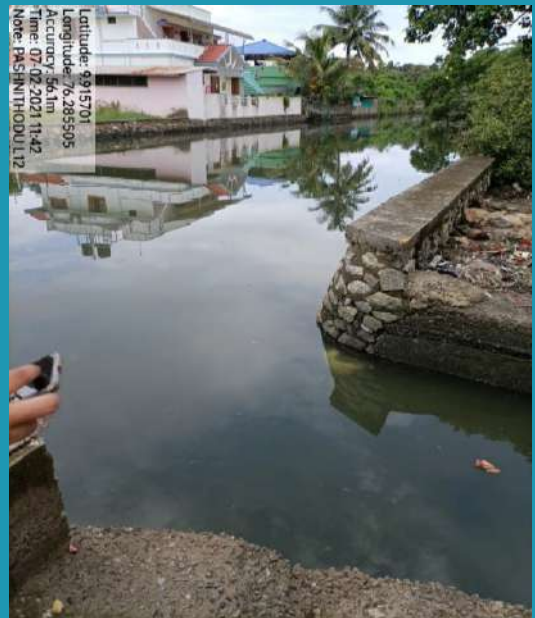
c) Blockage in small drains:-

There are 6 small drains joining the Pashnithodu at the left side and about 4 number of small drains joining at the right bank. These drains are also clogged with waste and need thorough cleaning to make easy flow of water through the drains into the main thodu. These channels would act as flood absorbing pockets and the run off from high intensity rain could not be drained easily now.

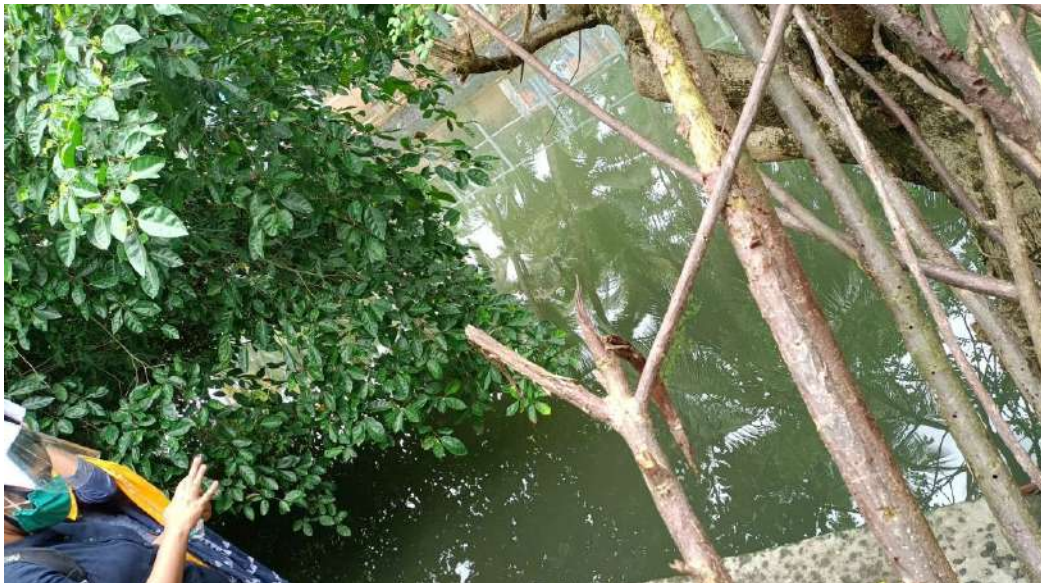
d) Encroachment

Encroachments of the thodu is suspected in between locations Ch:271m and Ch:296m. The width of thodu is seen decreasing to 12 m from 18 m in this area. These encroachments have to be evicted strictly with the help of higher authorities and police.

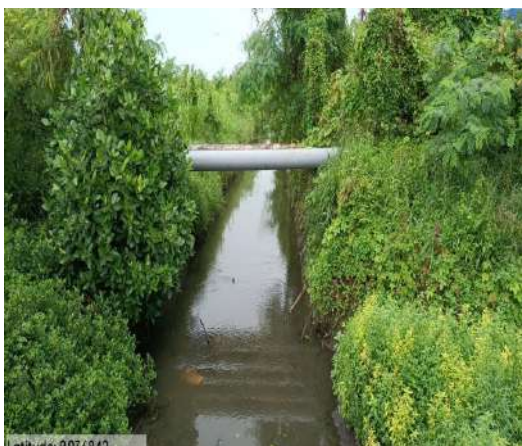
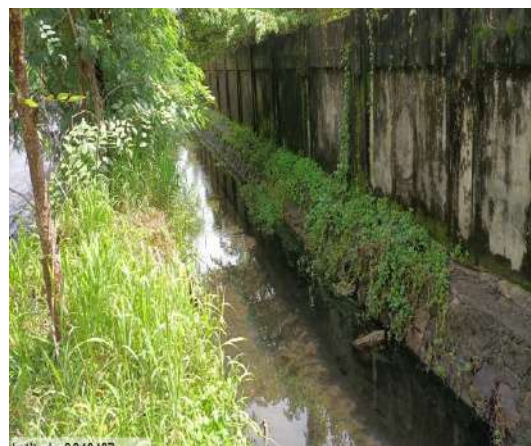
The main problem faced in the Island thodu, Vathuruthy channel and Mattanchery channel and the areas in the vicinity is flooding during the monsoon season. The main reason for this is silting up of the thodu. Periodical cleaning is not done since long, hence the

depth of flow is reduced considerably. Waste dumping also has lessened the quality of water in the thodu. Silt is accumulated for the entire length of 9.015km of Island thodu including the Vathuruthy channel and Mattanchery channel. In monsoon season the recession of flood water will take more time and naturally the low lying area will easily get inundated. This portion of silt accumulation has to be cut and cleaned to facilitate easy flow of water from the thodu to the Vembanadukayal and Thevara kayal.

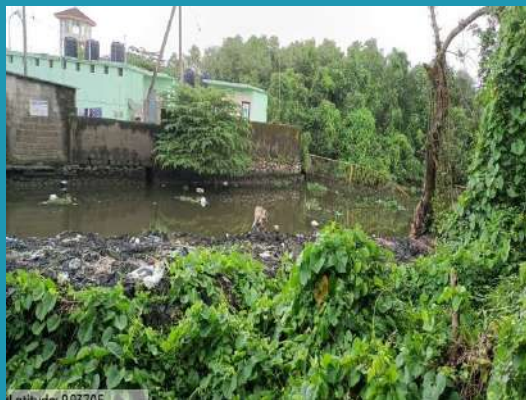
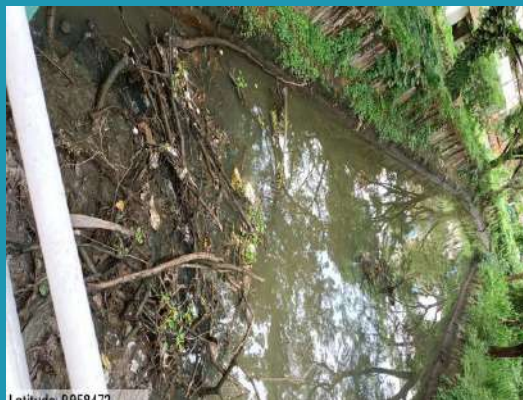
b) Disposal of waste water and solid waste into the natural drain:-

Waste is accumulated in the thodu at the Malabar Gate portion at Ch.3.28Km and at Ch.3.1Km which also causes pollution of the waterbody. Vegetation is grown in the Island thodu in between the reaches Ch.20m to ch.370m and between Ch.425m upto Ch.2600m. Due to the waste and vegetation accumulated the flow of the thodu has been reduced drastically . This problem is seen near Chainages 100m & 350m of Vathuruthy channel. The catchment area of this thodu is not densely populated and the thodu is subjected to variety of pollutants such as, organic , plastic wastes etc.

The Vathuruthy channel is observed to receive household waste along some of the portions in the entire length where there are some houses. The people residing nearby the Vathuruthy channel is also facing health hazards due to the pollution of the thodu. Stringent measures need to be taken to prevent discharge of such wastes and sewage to the thodu .

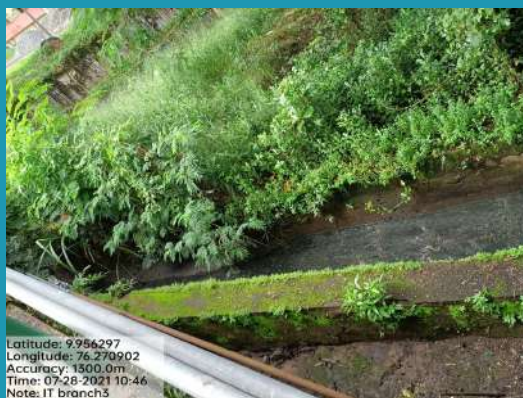
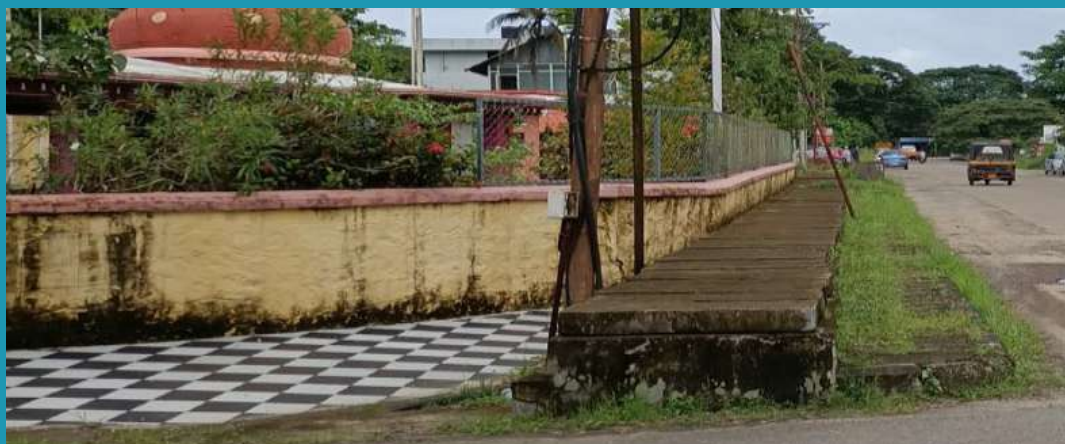
c) Blockage in small drains:-

There are 7 small drains joining the Island thodu. The surface runoff as well as waste water flows into the main thodu through the small drains. The other drains connecting at different points to the Island thodu and Vathuruthy channel are also clogged with waste and need thorough cleaning to make easy flow of water through the drains in to the main thodu. These channels would act as flood absorbing pockets and the run off from high intensity rain could not be drained easily now.

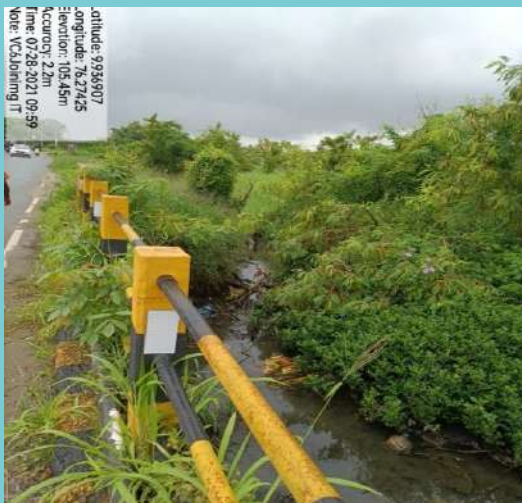
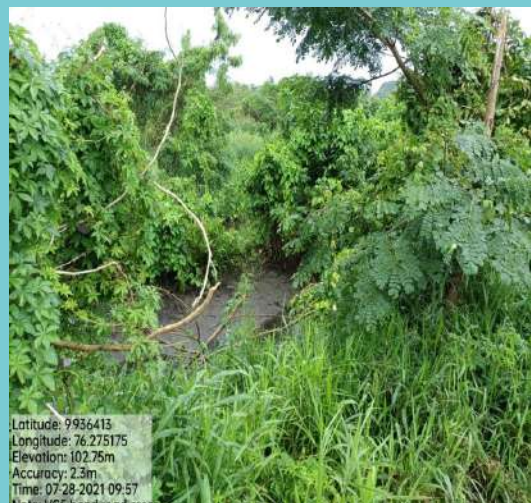
d) Reduced width of Thodu

The width of the Island thodu is reduced at different points which causes blockages of the thodu and reduces the easy drainage of water to the Vembanatt kayal & Thevara kayal. At the exit point of the Island thodu there is about 15m width. After the Malabar Gate point the width reduces considerably to 5m. At the starting point of the Island thodu is 3m which increases to 15m at Ch.425m. But the width decreases further to 5m from Ch.612m upto Ch.700m. The width of the thodu further decreases to 3m from Ch.700m to Ch.2790m. The width of the Vathuruthy channel is 20m at the starting point and further reduces to 8m to 6m at Ch.820m. The width of the Mattanchery channel is 8m at the starting point and further increases to 12m at ch.655m.

As the width of thodu reduces the area of cross section of flow get reduced and drainage of water becomes blocked and wont serve the entire purpose intended.

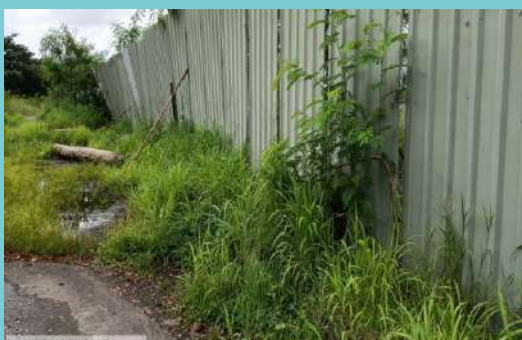
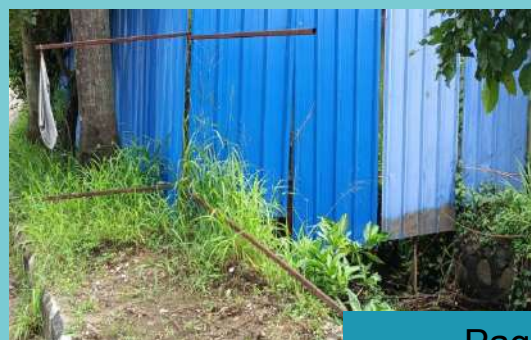
e) Encroachment:-

Encroachments of the Island thodu is suspected in the southern part between locations Ch:2600m and 2790m. The naval base Authority has covered the entire thodu with Aluminium sheets and has formed a boundary wall. Now the thodu is occupied by the Naval base authority for a length of 190m and width 5m. Encroachments is also suspected in between locations Ch:720m and 820m of Vathuruthy channel where the width reduces considerably. These encroachments have to be demolished immediately and encroachment has to be evicted, strictly with the help of higher authorities and police.

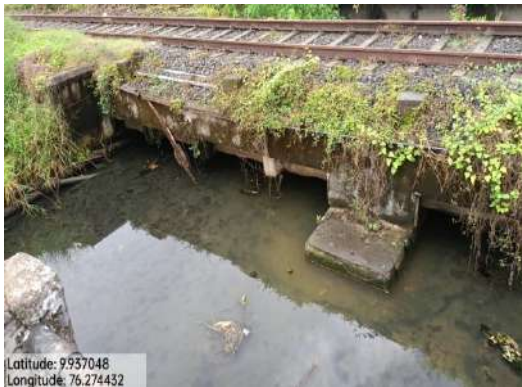
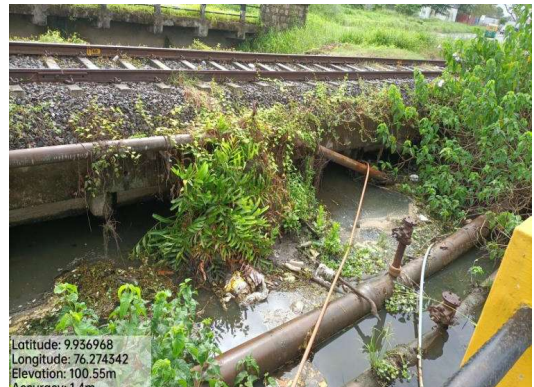
f) Existing culverts having no head room and vent way

Ventway of the thodu is narrowed at the existing railway culvert near Vathuruthy junction which causes accumulation of wastes and finally blocking the flow of water near Ch.350m, The existing culvert at this chainages has to be demolished and new culverts with sufficient vent way and head room has to be rebuilt.

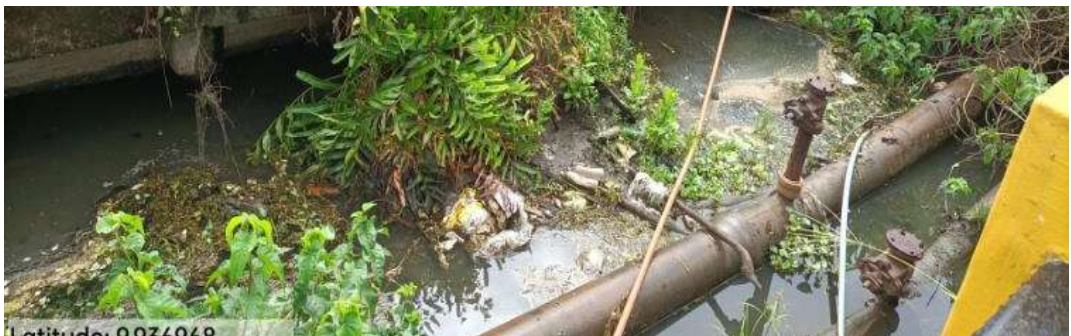
g) Utility pipes crossing drains

The utility pipes of KWA is crossing the Island thodu at Ch350m at Vathuruthy at railway crossing which obstructs the free flow of water, especially during flood season. The pipes laid through the water surface of the thodu has to be lifted, leaving a clear headroom to accommodate flood water. The following locations are prone to flooding due to the obstruction of utility pipes

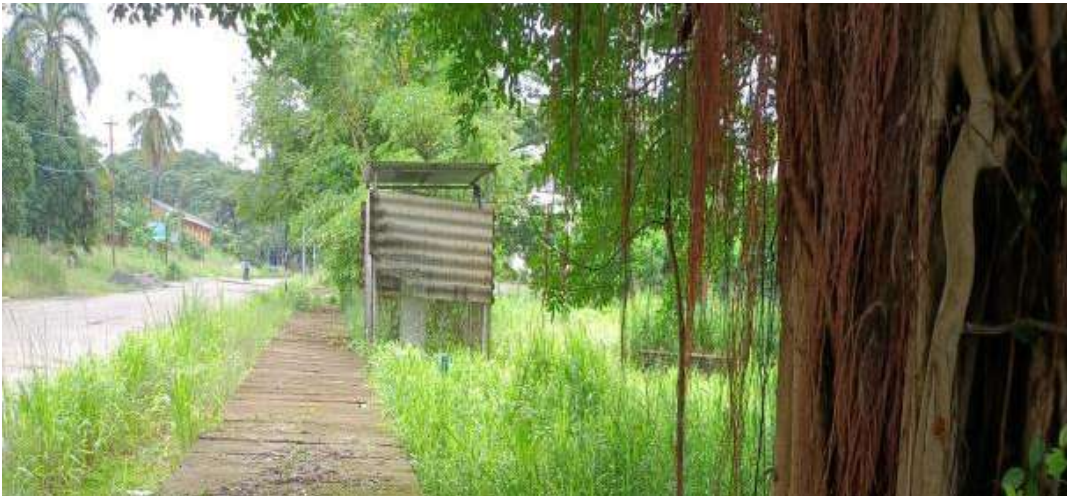
h) Conversion of thodu to road

The branches of the Island thodu is entirely covered up with slab for some length at the North side of the Naval base near the Ayyappa temple.. From this we can study that cleaning has not been done since years and the waste materials and silt is laying as such in the thodu which needs urgent attention.

The present practice of converting the thodu to road by covering with concrete slab has to be stopped. This will accelerate clogging of drain, which will prevent the free flow of water. Future cleaning of thodu will be cumbersome on account of this. The concreting of bed of natural thodu is not at all advisable. Concreting the natural bed of thodu will prevent the seepage of water through ground thus increasing the risk of flooding

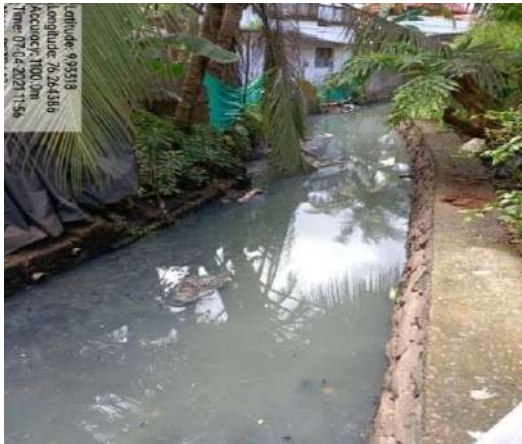
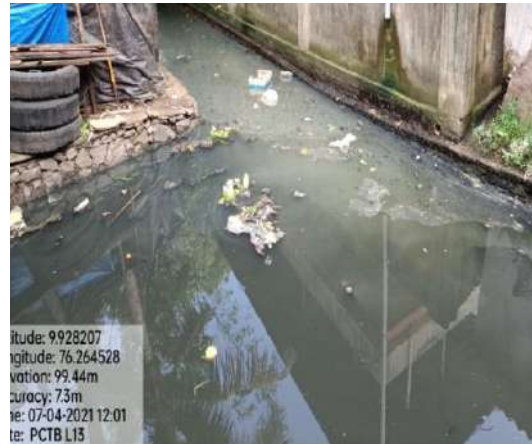
a) Silt accumulation:-

The main problem faced in this thodu and the areas in the vicinity is flooding during the monsoon season. The main reason for this is silting up of the thodu. Periodical cleaning is not done since long, hence the depth of flow is reduced considerably. Waste dumping also has lessened the quality of water in the thodu. The main problem for flooding up of water is due to blockage of flow of water in the upstream of Pallithodu at the starting point itself because the thodu is covered up by slab and since long no cleaning has been done. Silt is accumulated for the entire length of 2.9845km including the branch thodu. In monsoon season the recession of flood water will take more time and naturally the low lying area will easily get inundated. This portion of silt accumulation has to be cut and cleaned to facilitate easy flow of water from the thodu to the Vembanadukayal and Chirakal river viceversa.

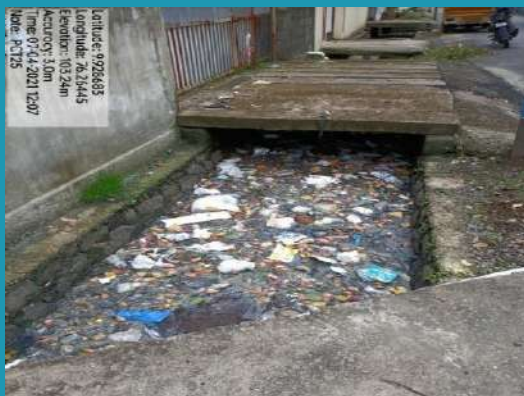
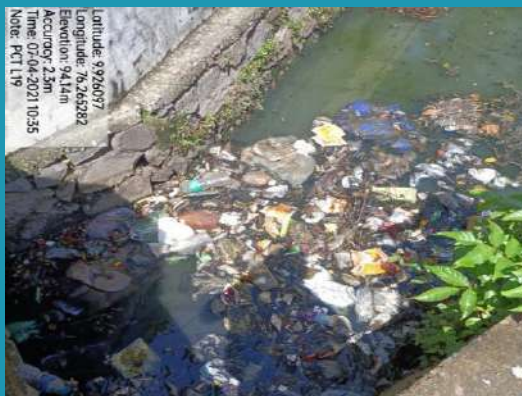
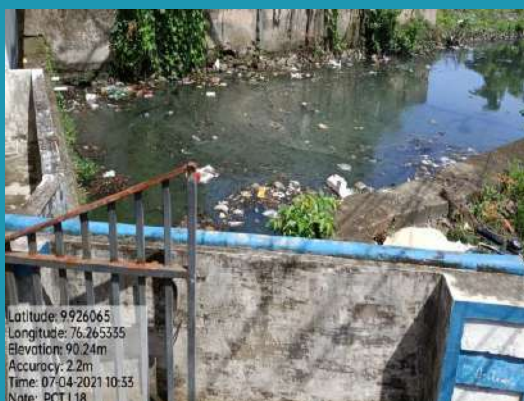
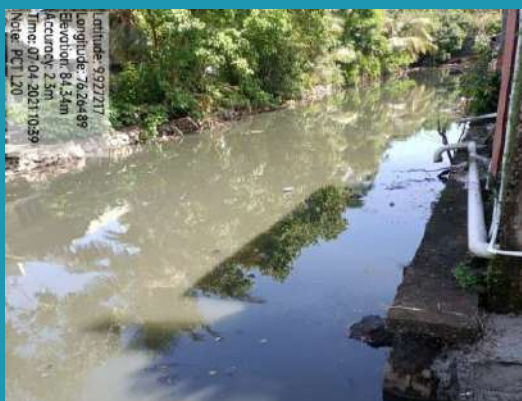
b) Disposal of waste water and solid waste into the natural drain:-

Waste pipes from houses is given directly in to the thodu which also causes pollution of the waterbody. Due to the waste accumulated the flow of the thodu has been reduced drastically. This problem is seen near Chainages 1167.50m, 1168.50m, 1299.50m, 1383.50m, 1391.50m, etc. The thodu starts with a width of 2m and reduces to 1.50 m @ Ch:1167.50m, then the width increases to 12m upto Ch:1299.50m(131m). In this 131m stretch we could find a lot of waste dumped, and waste pipes given directly into the thodu from houses. Near ch 1719.50 there exist a market (near the BOT bridge) from where immense quantity of market waste is deposited in to the thodu and that's the critical point where cleaning is immediately required. Severe pollution is happening at this point. The catchment area of this thodu is densely populated and hence the thodu is subjected to variety of pollutants such as municipal sewage, organic, plastic wastes etc. The Pallichal branch thodu might also have waste pipes connected, but those are not visible because most of the length of thodu is covered by concrete slabs.

The thodu is observed to receive household sewage along its entire length. The people residing nearby the thodu is also facing health hazards due to the heavy pollution of the thodu. Stringent measures need to be taken to prevent discharge of such wastes and sewage to the thodu.

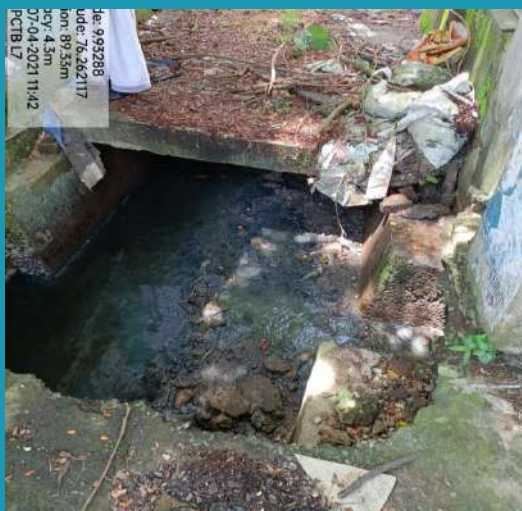
c) Blockage in small drains:-

There are 6 small drains joining the Pallichalthodu at the left side and about 9 number of small drains joining at the right bank. Moreover small PWD drains also connects to the main Pallichalthodu and branch thodu. The surface runoff as well as waste water flows into the main thodu also. The other drains connecting at different points to the main and branch thodu are also clogged with waste and needs thorough cleaning to make easy flow of water through the drains in to the main thodu. These channels would act as flood absorbing pockets and the run off from high intensity rain could not be drained easily now..

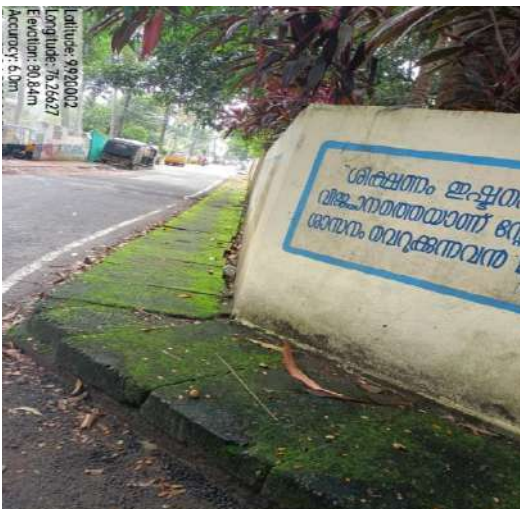
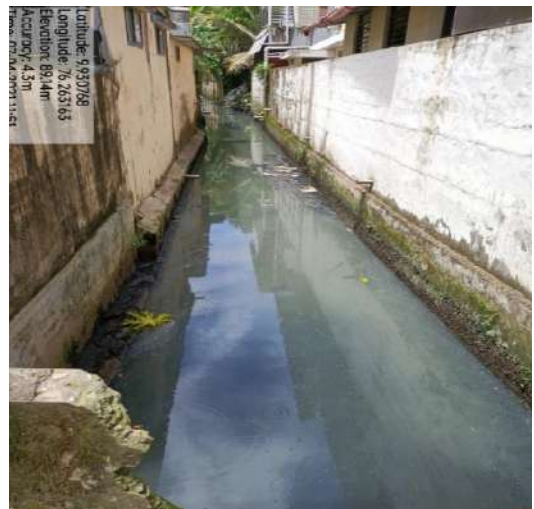
d) Reduced width of Thodu

The width of thodu is reduced at different points which causes blockages of the thodu and reduces the easy drainage of water to the Chirakalriver. In the main Pallichalthodu at Ch:0.00m the width of thodu is 2m, the width reduces to 0.60m at Ch 225m, means the thodu reduces to a small drain. This small drain continues for a length of 241m, which finally reduces the discharge drastically. Widening of thodu in this 241 m length of thodu is inevitable and should be intervened urgently. For the next 701.50 m the width of thodu maintains the width 1m -1.50m and at Ch 1167.50m there is a sudden widening of thodu to 12m. That means this 12m width need to be there until the starting point of the thodu. The thodu is having 12 m width only for the next 132m ie between Ch 1167.5 to ch 1299.50. The thodu again reduces to a width of 7 m for 92 m and again reduces to 1.50 m. At Ch 1661.50m the width again reaches 3m and increases gradually finally at the end point the width maintained is 7m. As the width of thodu reduces the area of cross section of flow get reduced and drainage of water becomes blocked and won't serve the entire purpose intended. Similarly in the Pallichal Left Branch Thodu at the starting point the width of the thodu is 1 m which is not sufficient enough to drain away the waste water. At the exit point this thodu has got 2m width.

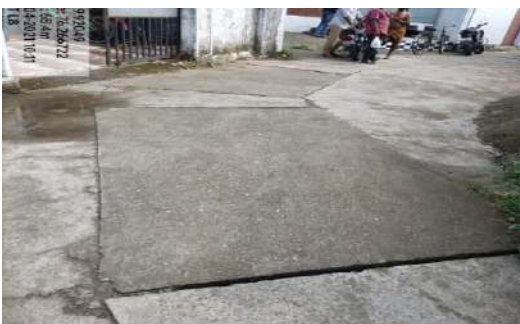
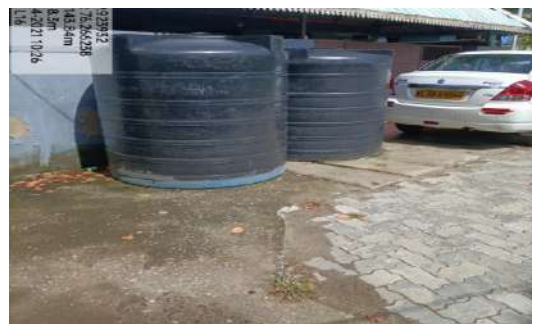
e) Encroachment:-

Encroachments of the thodu is suspected in the southern part between locations Ch:540m and Ch:1167.50m. The width of thodu is seen decreasing to 12 m from 1 m in this area. Encroachments is also suspected in between locations Ch:1416.50m and Ch:1646.50m. At Ch:2174.50m two small sheds have been erected into the thodu which cover up about 5m width of the thodu. These sheds have to be demolished immediately and encroachment has to be evicted. At this chainage abutments of an old bridge made up of random rubble masonry is protruding into the thodu which covers up almost 3m width of the thodu. These structure has to be demolished immediately. These encroachments have to be evicted strictly with the help of higher authorities and police.

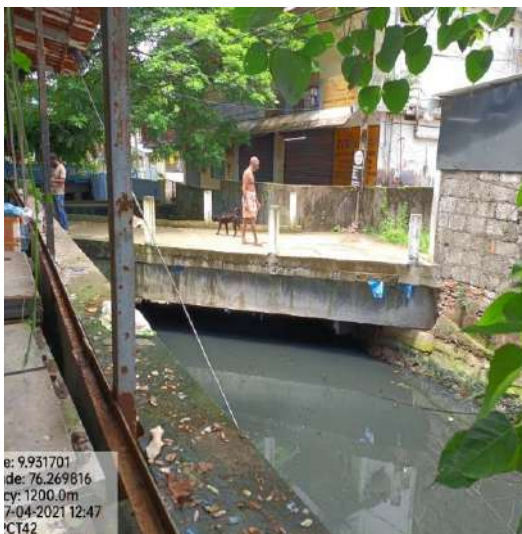
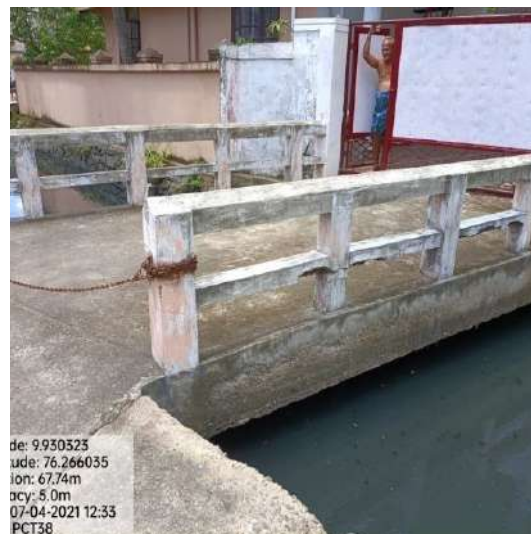
f) Existing culverts having no head room and vent way.

Ventway of the thodu is narrowed at the existing culverts which causes accumulation of wastes and finally blocking the flow of water near Ch.1938.50m, Ch.2004.5m, Ch.2009.50m and 2174.50m

At Ch.2004.50m - the beam of the Culvert is very deep and this causes hindrance for free flow of water in the thodu.

At Ch.2009.50m - the beam of the Culvert is very deep and this causes hindrance for free flow of water in the thodu.

In between Ch.1661.5m and 1938.5m (277m) the number culverts have been built for access to individual houses. These culverts can block water in the thodu during the time of flood and incessant rains. It would be better to increase the height of the culvert and can be taken as a long term measure.

The existing culverts at these chainages has to be demolished and new culverts with sufficient vent way and head room has to be rebuilt.

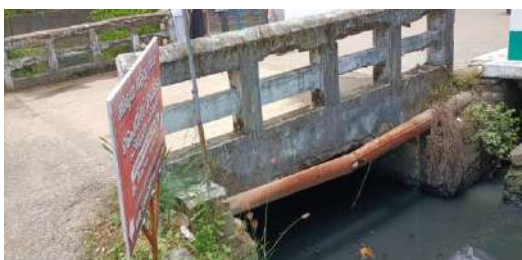
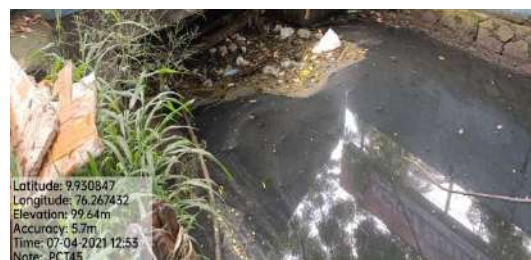
g) Utility pipes crossing drains

The utility pipes belongs to KSEB/ KWA/ BSNL etc. crossing the drain at different locations obstruct the free flow of water, especially during flood season. The pipes laid through the water surface of the thodu has to be lifted, leaving a clear headroom to accommodate flood water. The following locations are prone to flooding due to the obstruction of utility pipes.

At Ch.2036.5m bridge at NH Crossing near BOT bridge

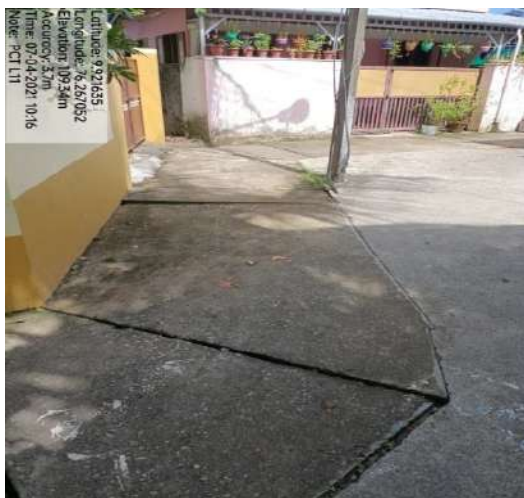
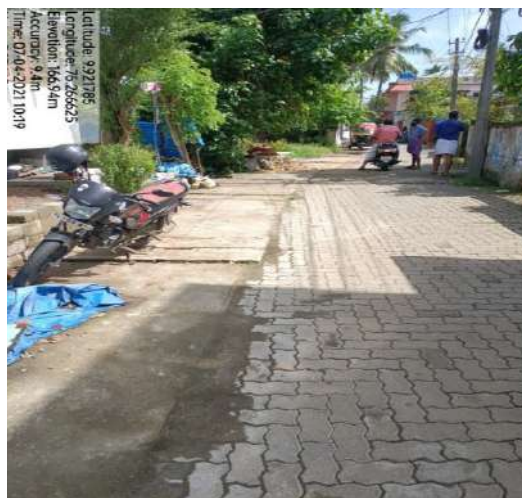
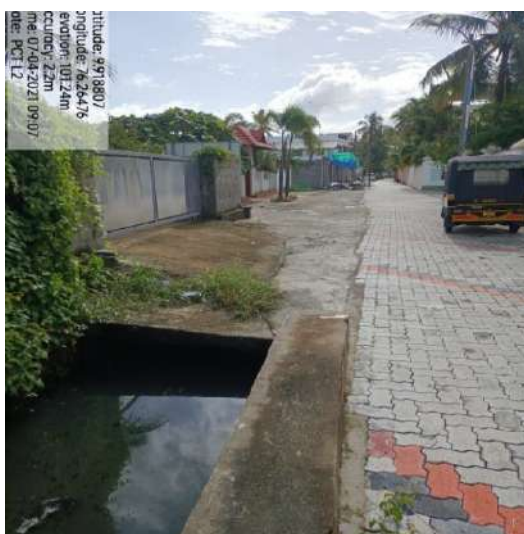
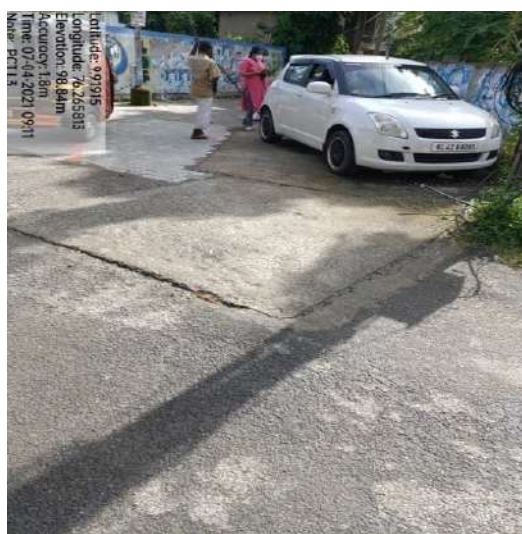
h) Conversion of thodu to road

The Pallichalthodu is entirely covered up with slab for the starting length of 466m. In the second stretch at Ch:622 to Ch:884.50m (262.50m) the Pallichalthodu is also entirely covered with slab. The branch thodu is also covered up with concrete slabs from Ch:0m to Ch:626m. So we can see that out of 2.9845Km stretch of the entire thodu 1.3545Km length of thodu is covered by slab. This is almost 45% of the total length of the thodu. From this we can find that almost half portion of the thodu is covered and cleaning has not been done since years and the waste materials and silt is laying as such in the thodu which needs urgent attention.

Near Pyary junction in the Pallichal branch thodu, M sand and water tanks has been stacked on top of the covered slab. This is not at all acceptable. The present practice of converting the thodu to road by covering with concrete slab has to be stopped. This will accelerate clogging of drain, which will prevent the free flow of water. Future cleaning of thodu will be cumbersome on account of this. The concreting of bed of natural thodu is not at all advisable. Concreting the natural bed of thodu will prevent the seepage of water through ground thus increasing the risk of flooding

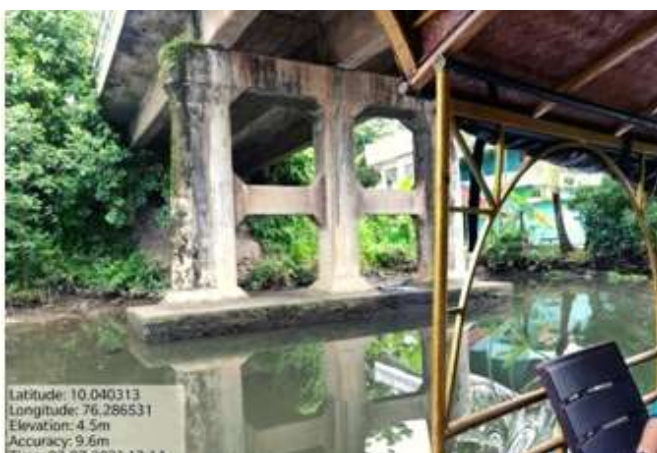
Ch : 2130m

Siltation beneath Edayakkunnam bridge

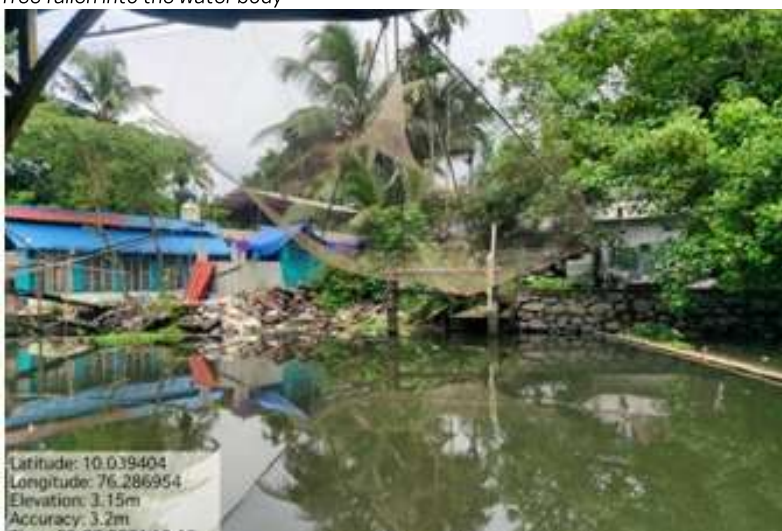
Waste disposed

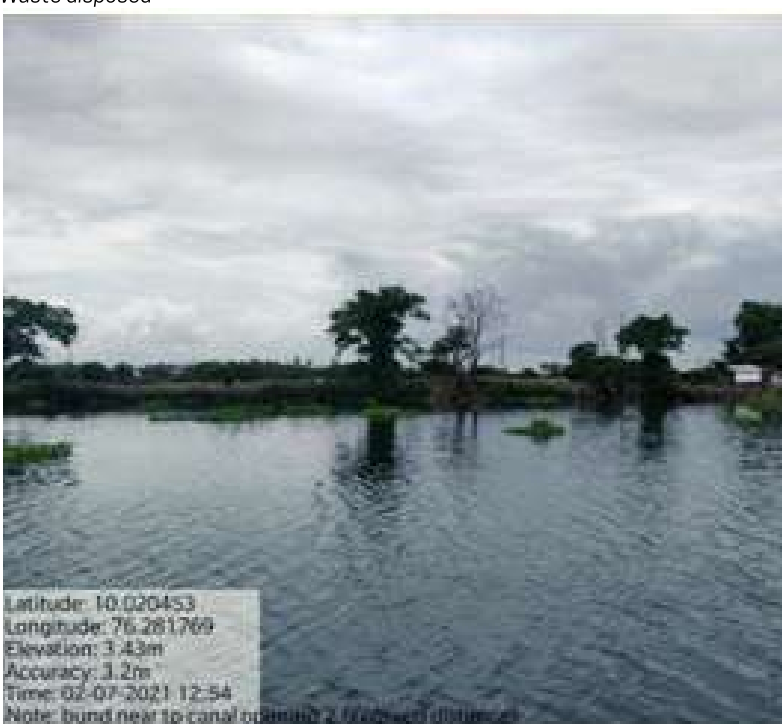
Delta formed in the water body

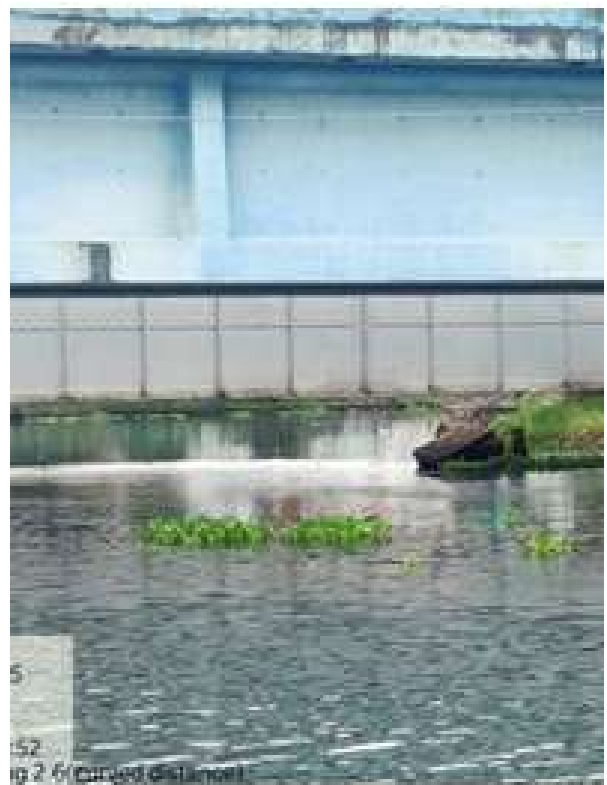
Debris beneath Perandoor railway bridge

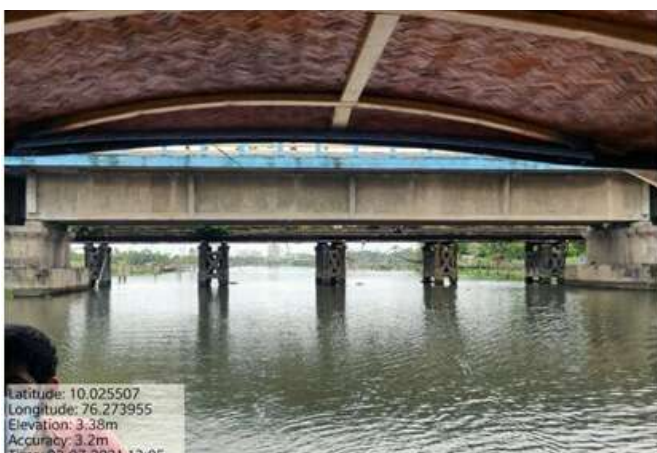
Ch : 5500m

The old bridge connecting Chittoor and Vaduthala has not yet been demolished. The piers of the bridge, along with approach roads is a huge obstruction to the water flow.

Old Chittoor-Vaduthala Bridge not Demolished

1. Desiltation is to be done at various regions of the Chittoorpuzha, especially at the outlet of TP canal and nearby areas, and the area behind Amrutha Hospital.
2. Obstacles in Chittoorpuzha between Amrutha hospital and Aster Medcity are to be removed for free discharge.
3. Action is to be taken to demolish the old bridge connecting Chittoor and Vaduthala.
4. Action is to be taken to ensure that waste disposal into the puzha is prohibited.
5. Action is to be taken to identify encroachments along the sides, and take steps for eviction of the same.

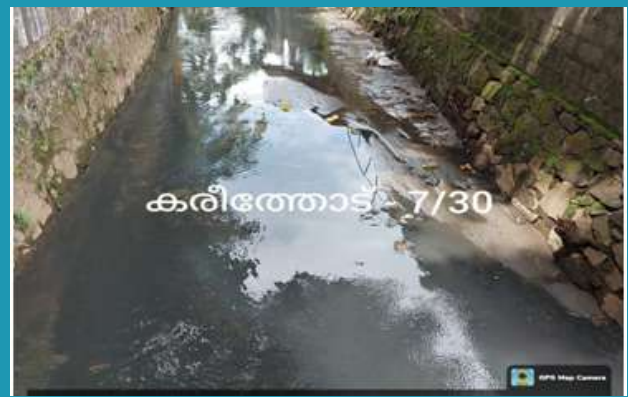
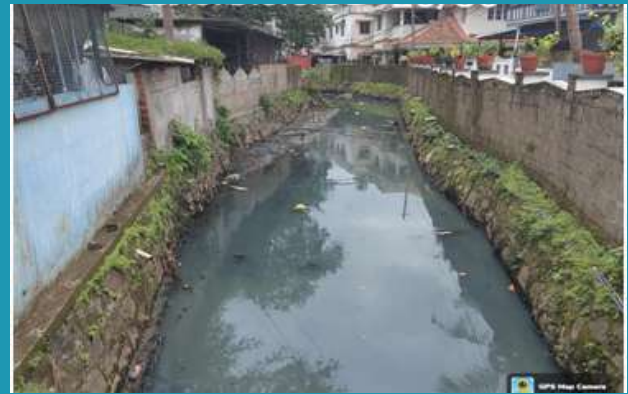
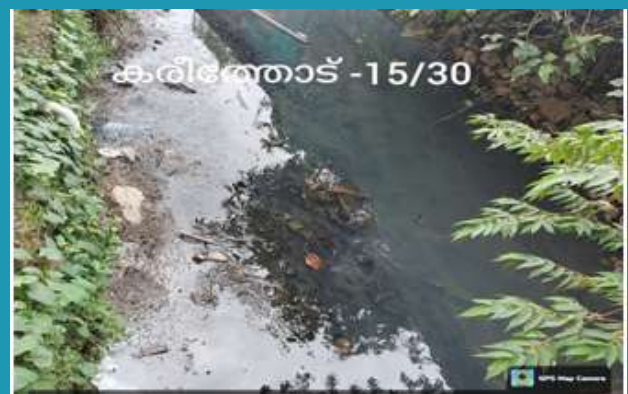
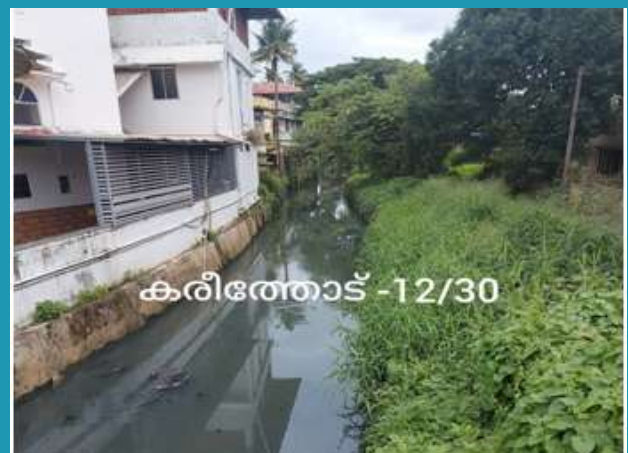
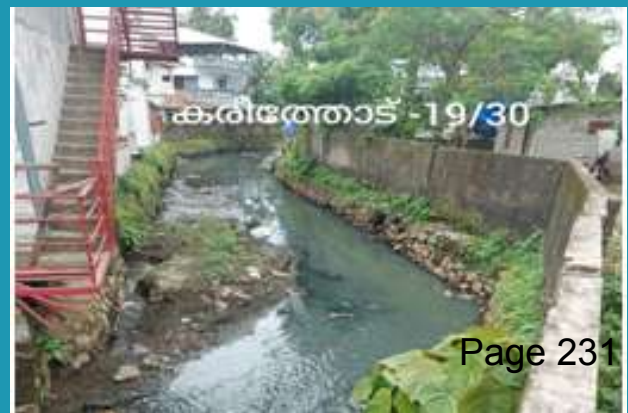
The thodu has need to be deepened for the proper flow of water in the rainy season

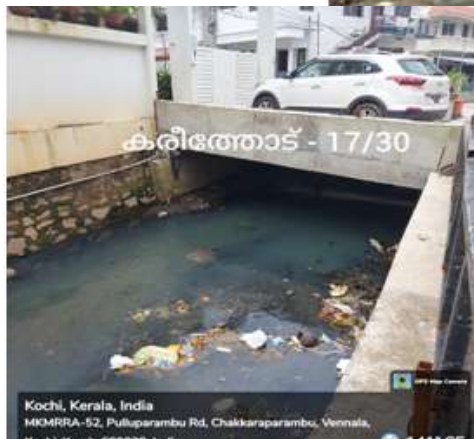
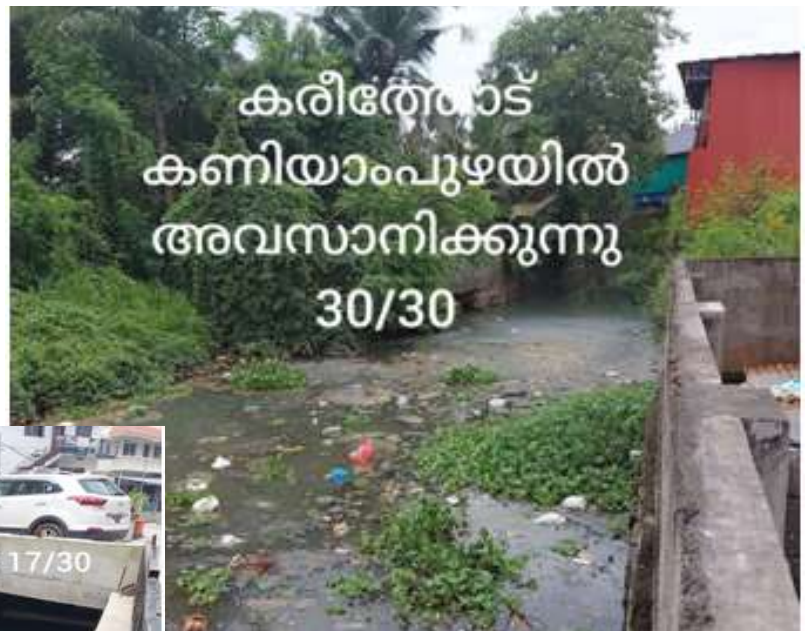
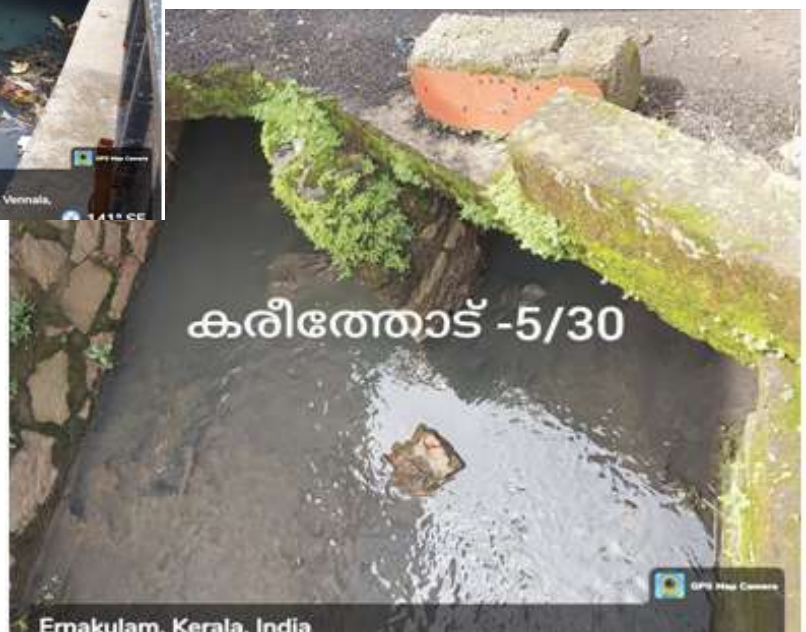
The residents of slums and houses situated near by dispose off their waste as well as septic tank waste in to the thodu. This shall be removed by the proposed deepening.

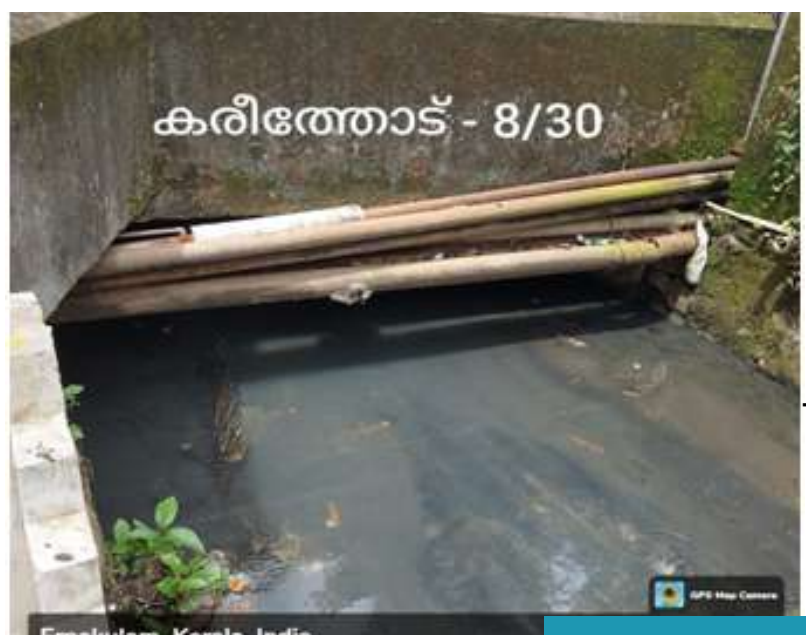
In this thode 11 numbers of main culverts. Several no. of KWA pipe lines are crossing across the thodu along with the culvert.
