REPORT ON
**FLOOD
MITIGATION
KOCHI**

IRRIGATION DEPARTMENT
ERNAKULAM
2021

EXECUTIVE SUMMARY

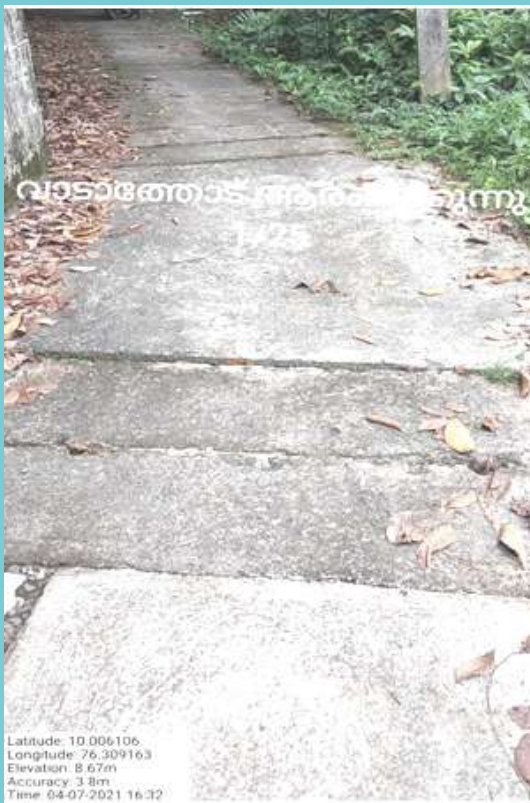
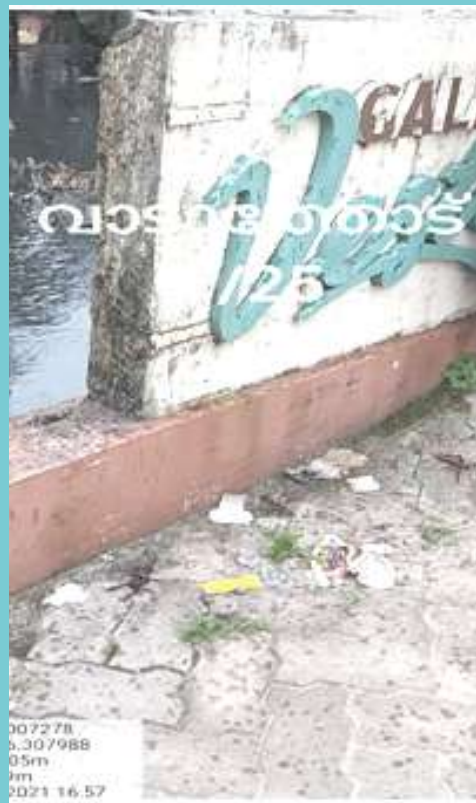
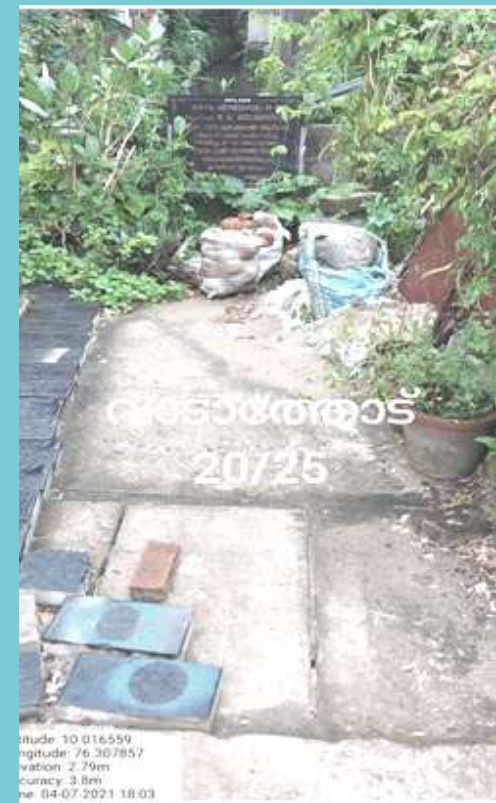
This is the main drainage in the southern part of Edappally area in Cochin Corporation. It has a length of 2.20km and width varies from 1.5m to 3.30m. The main purpose of this thodu is drainage of water. There are a number of smaller drains discharging in to this thodu. The thodu is silted up at several places. This results in stagnation of water. And practically this thode is not for much use because it is silted up. Moreover this thodu is filled with aquatic plants and grasses at some places.

Proper maintenance and clearing of the canal are required as a corrective measure along with cleaning the silt and debris. The drainage outlets are urgently need to remove which is coming from houses to the thodu have also to be cleaned by removing blockages and easy flow of water. Deepening the thode throughout the whole length is inevitable for maintaining smooth flow

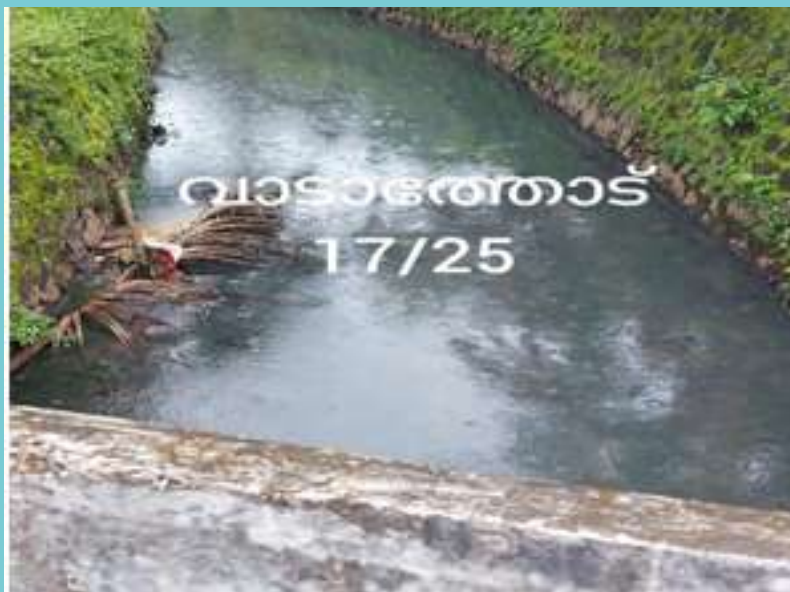
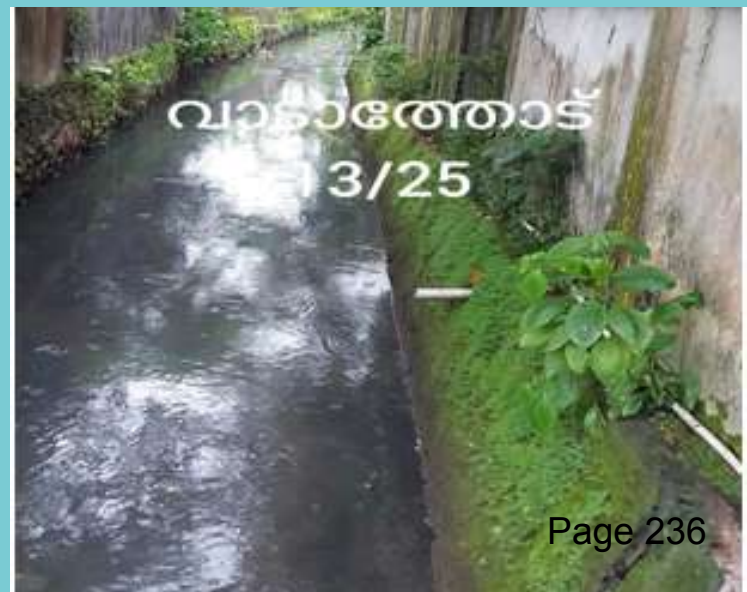
Some areas are seen encroached on conducting survey on this thodu. The details of encroachments can be ascertained only after conducting the demarkation survey by revenue department.

The sides off the thodu are seen presently protected all most all length. wherever the protection works are seen partially damaged and it should be rectified by dismantling and reconstructed..

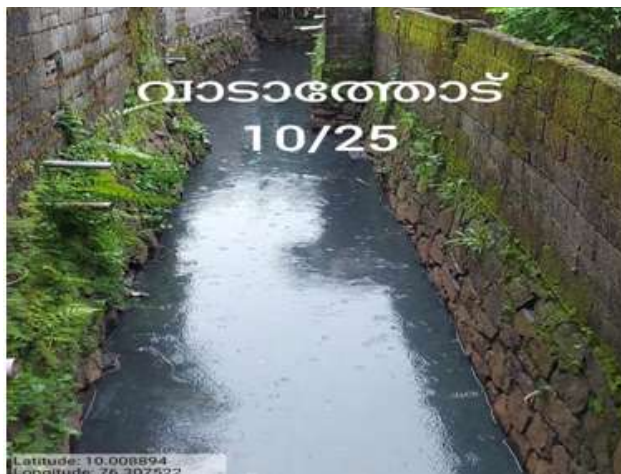
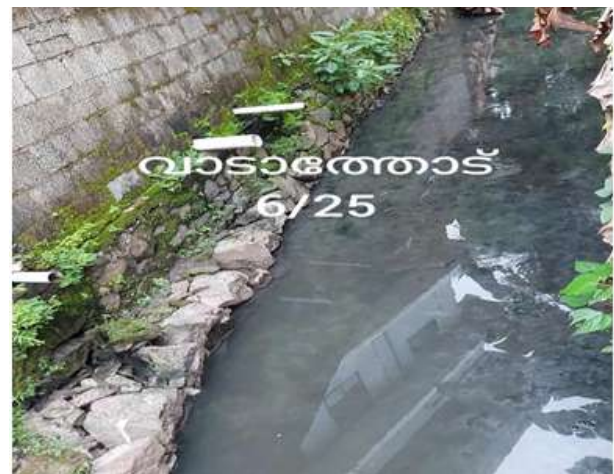
The thodu has need to be deepened for the proper low of water in the rainy season

The residents of slums and houses situated near by dispose off their waste as well as septic tank waste in to the thodu. This shall be removed by the proposed deepening

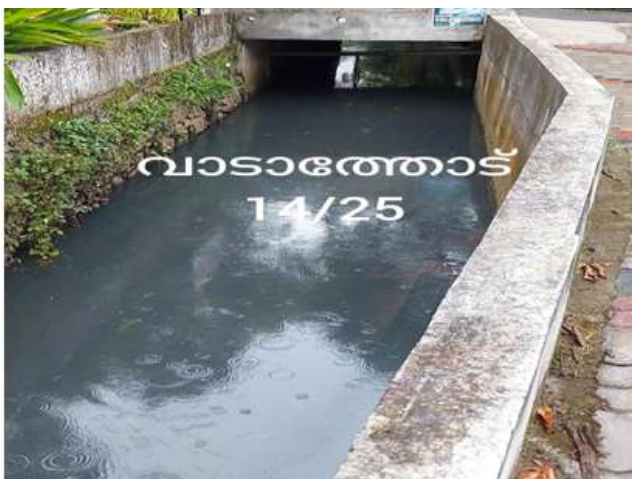
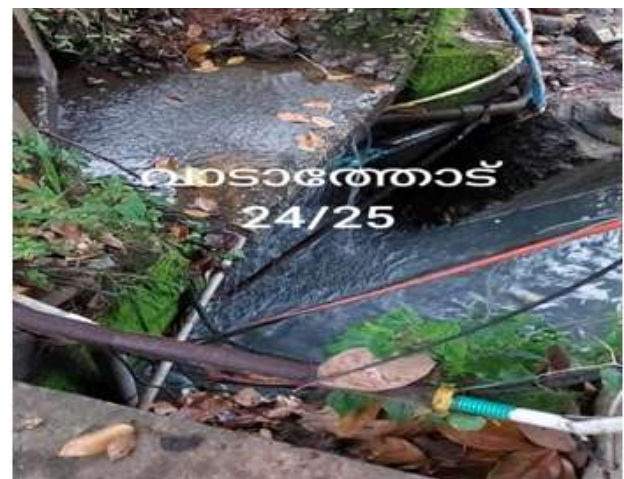
In this thode 5 numbers of main culverts and 1 NH crossing culvert in this thode. The entry point of the NH culvert were seen a main blockage noted during the survey.

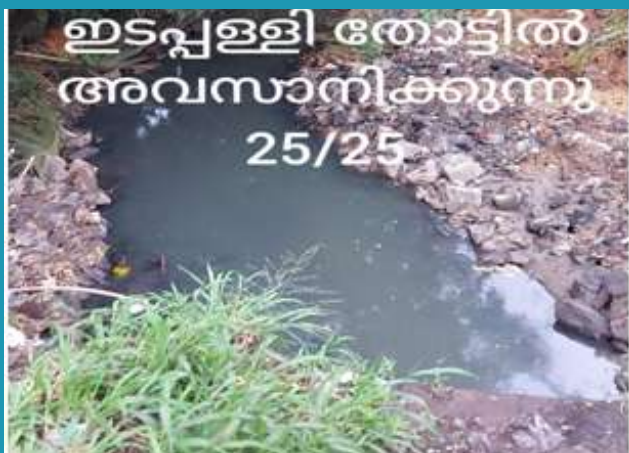
AQUATIC WEEDS

Some area of the canal filled with debris and water grass were partially obstructed the flow of water.

Due to the presnce the above grass considerable depth reductions were noticed during the survey. For removing this shall be included in the deepening works.

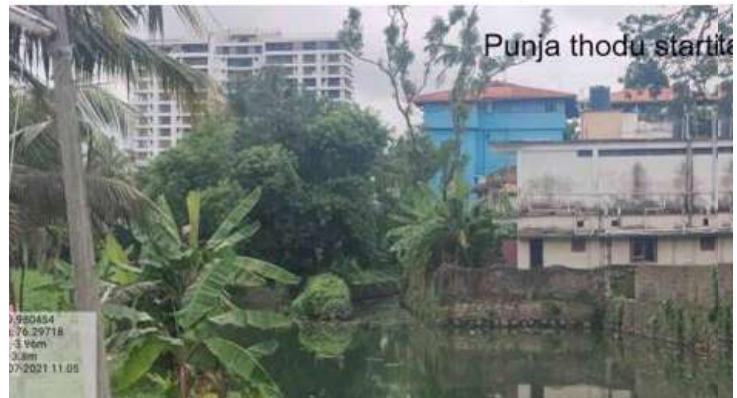
Presently as the width of punja thodu is reduced to 3 metres, the mouth of Punja thodu is very much silted up. Hence the encroachment at the starting point should be immediately cleared and removal of slit is very much required.

Punja thodu starting- lesser width and encroachments

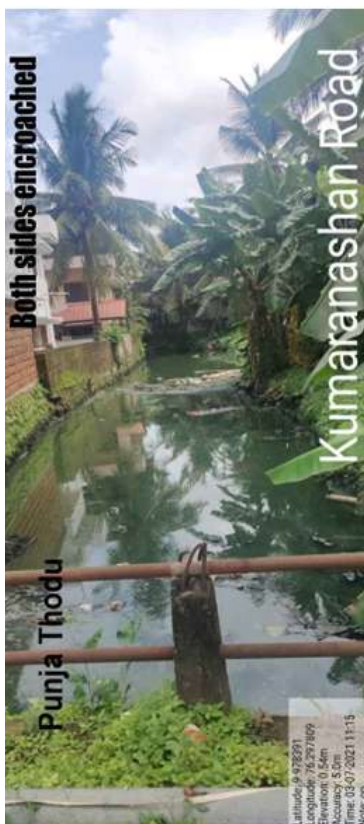
At Ch:0/220 the present culvert obstruct the flow and at upstream, walls are constructed encroaching the thodu. Since the thodu is included in the title deeds of the land owners residing along the sides of the the thodu the boundaries while demarcating by the village authorities fall inside the thodu . And people used to remit land tax for the thodu portion as well .Similar cases are noticed between Ch: 0/00- 0/400 .

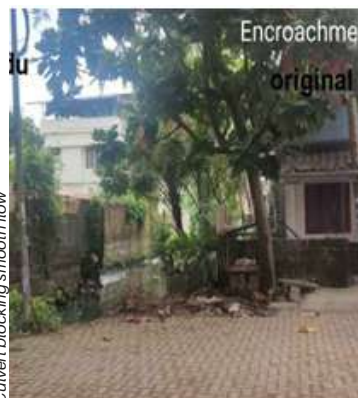
Approach road constructed encroaching thodu for flats

At ch: 0/450 approach road to some flats namely SFS and Casino is constructed encroaching thodu . The width of approach road is 7 m whereas the width of the thodu is 2.50 m .

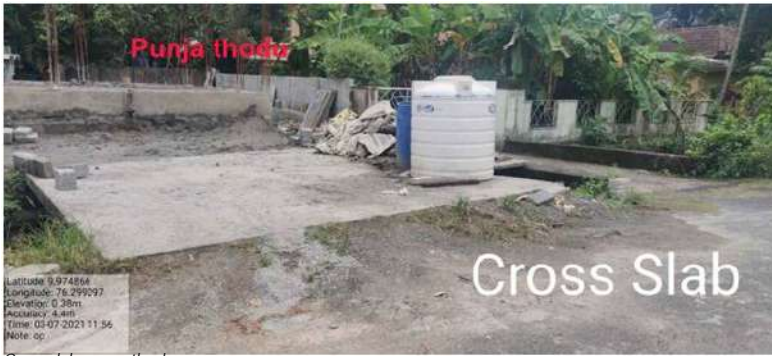
Cross slab across thodu

Between Ch: 0/600 to 0/780 slabs are seen constructed across the thodu as entrance to the houses which hindered the cleaning of thodu .

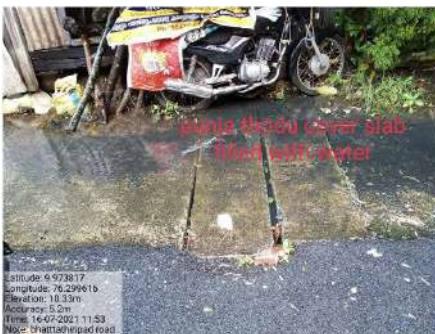
Water stagnation and overflow

From Ch:0/810 - 0/920 the thodu is covered with slab , Ch: 0/920 - 0/940 inside houses and from Ch: 0/940 - 1/100 the thodu is reduced to a drainage with C/S 60cm x90 cm. Water stagnation can be seen here during rains. All the wastes, organic and inorganic got silted up here causing hazardous situation. Since the drains are covered with slabs, it is not able to carry out the cleaning properly.

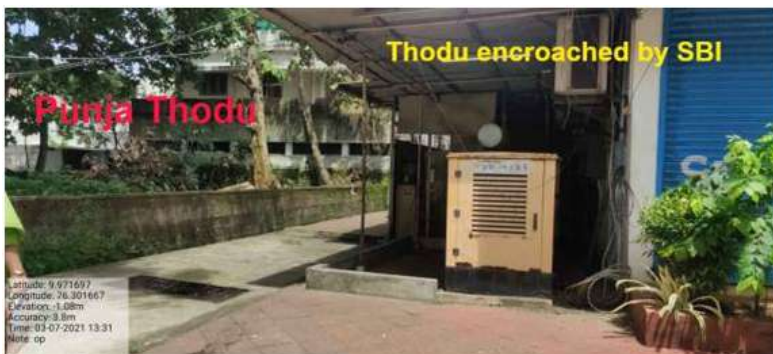
Encroachment by SBI building

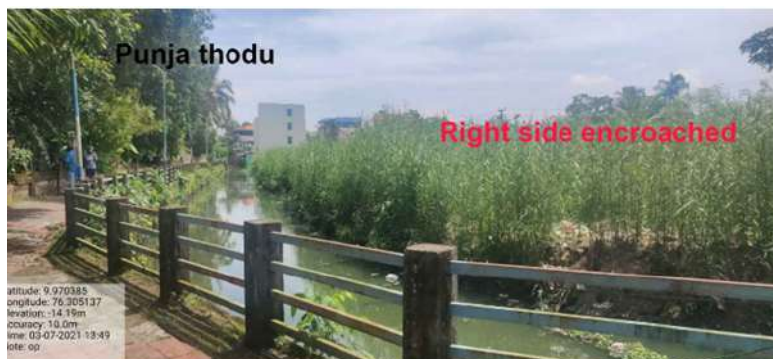
Between Ch: 1/790 and 1/910a walkway is constructed (old is gold road) by the corporation , encroaching the thodu.

Old is Gold road

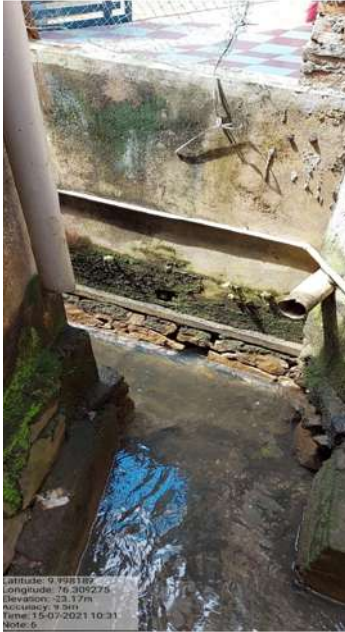
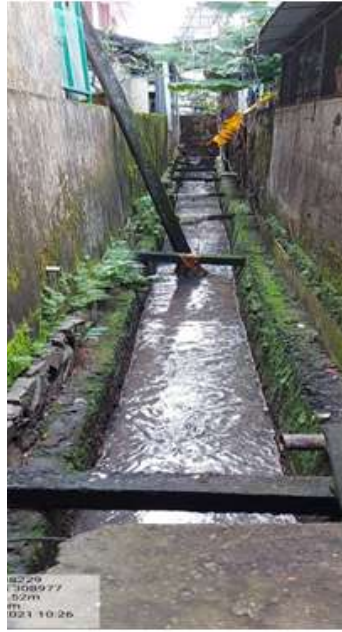
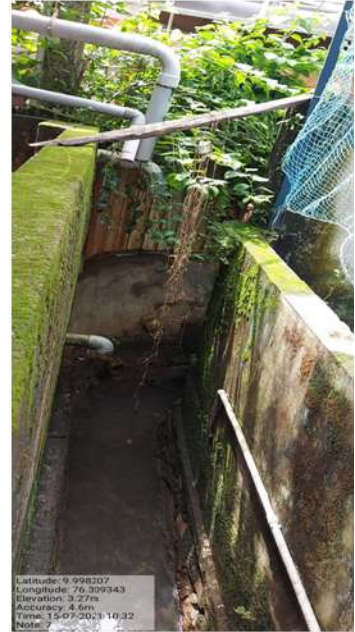
1. ENCROACHMENTS AND COVERED AREA

Some areas are seen encroached on conducting survey on this thodu. The details of encroachments can be ascertained only after conducting the demarcation survey by revenue department.

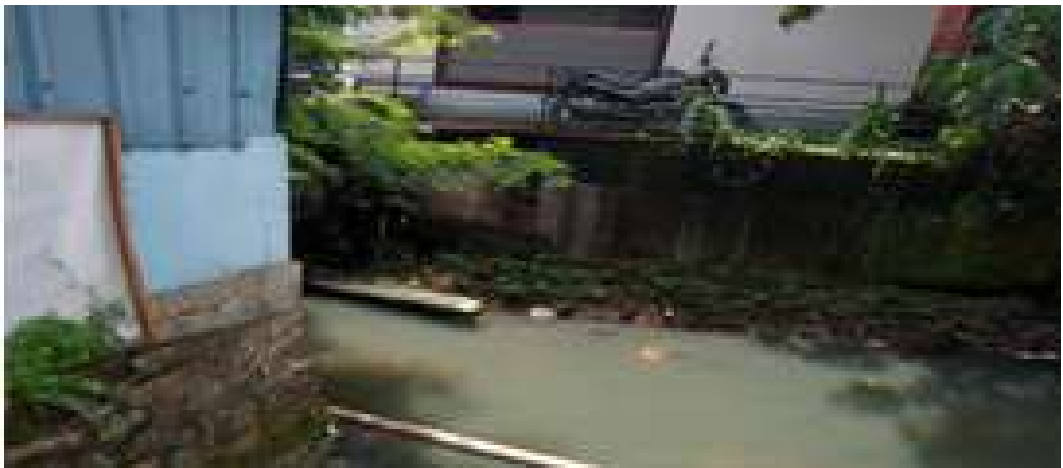
2. SIDE PROTECTION

The sides off the thodu are seen presently protected all most all length. Wherever the protection works are seen partially damaged and it should be rectified by dismantling and reconstructed.

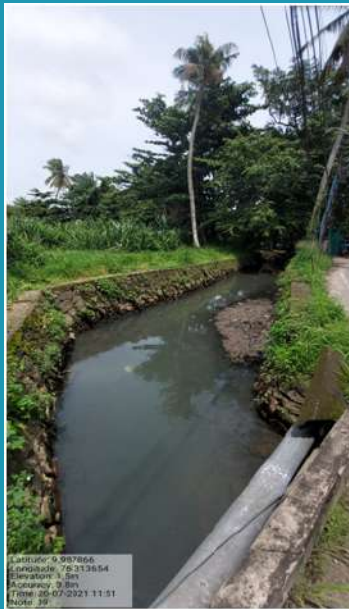
3. DEEPENING

The thodu has need to be deepened for the proper flow of water in the rainy season.

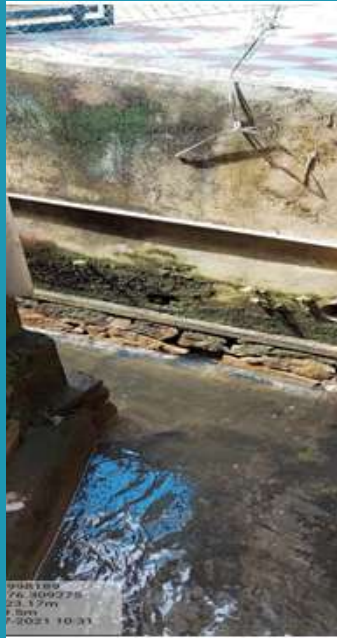
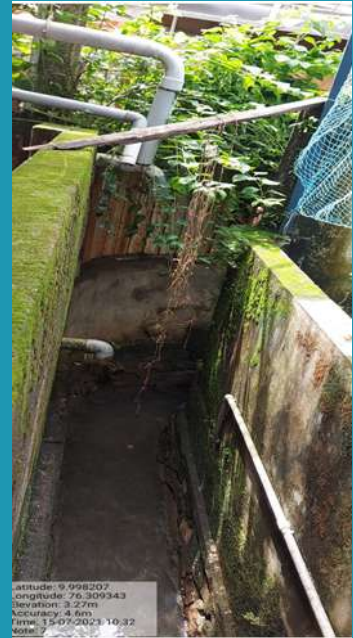
4. PROBLEMS WITH HOUSEHOLD WASTE/SEPTIC TANK WASTE

The residents of slums and houses situated near by dispose off their waste as well as septic tank waste in to the thodu. This shall be removed by the proposed deepening.

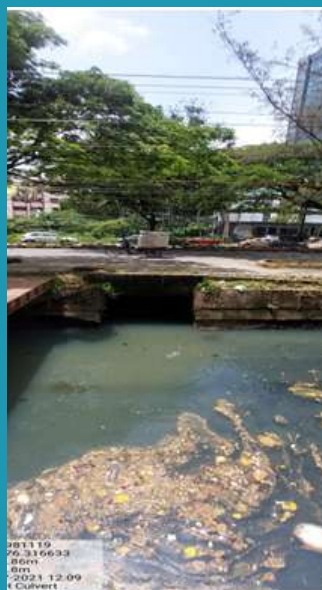
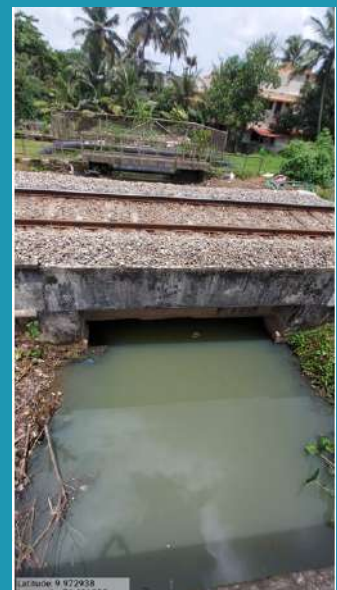
5. CULVERTS AND BLOCKS

In this thode 12 numbers of main culverts, 1 NH crossing culvert and One Railway line crossing culverts are in this thode. The entry point of the NH culvert was seen a main blockage due to less width, noted during the survey.

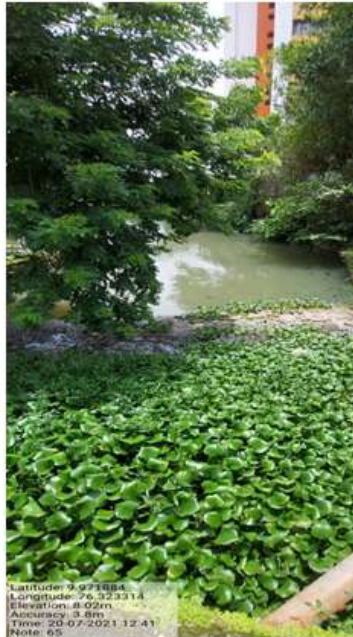
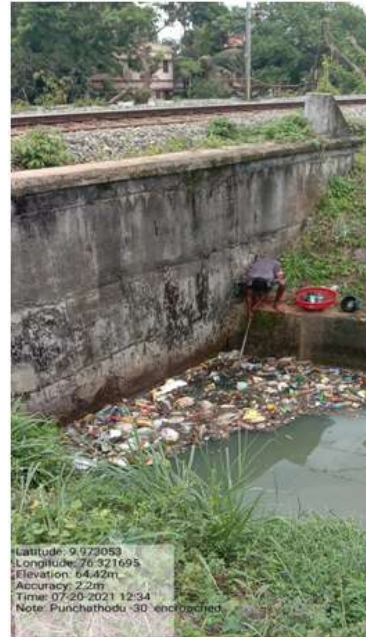
6. AQUATIC WEEDS

Some area of the canal filled with debris and water grass were partially obstructed the flow of water.

Due to the presence the above grass considerable depth reductions were noticed during the survey. For removing this shall be included in the deepening works.

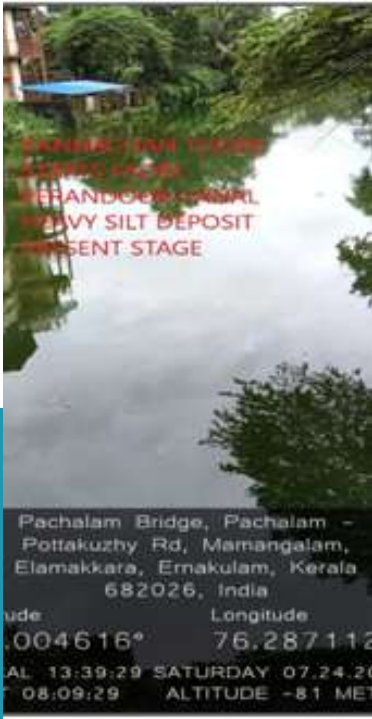
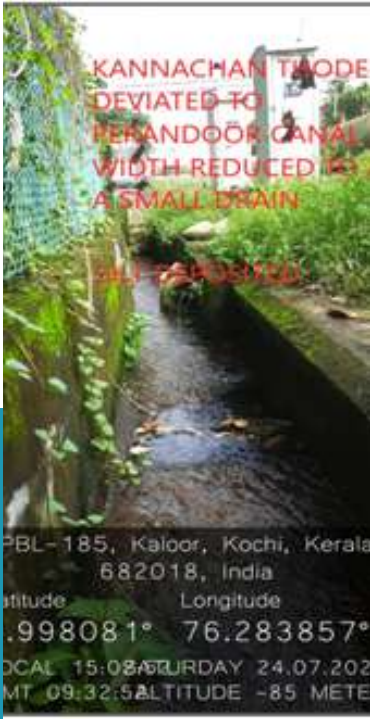
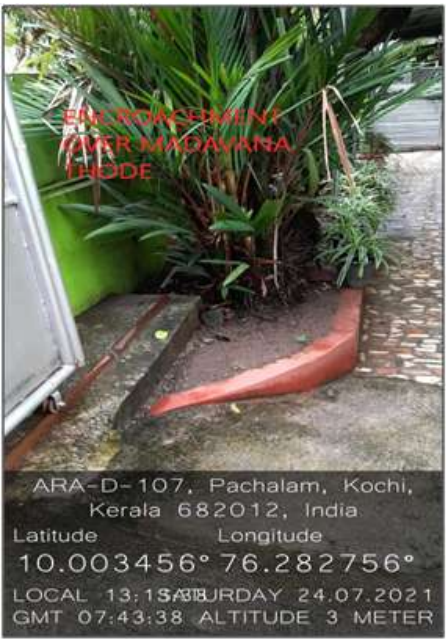
1. At chainage 0m – thode is converted to drain - no flow.

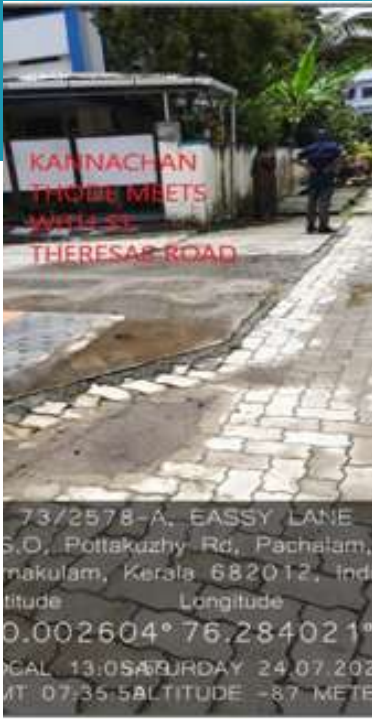
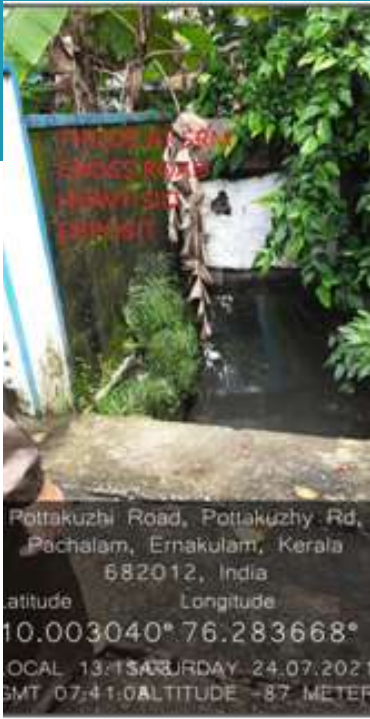
2. At Ch 380 m- a small drain, Madavana thode meets with Kannachan thode. Encroachment over Madavana thode.

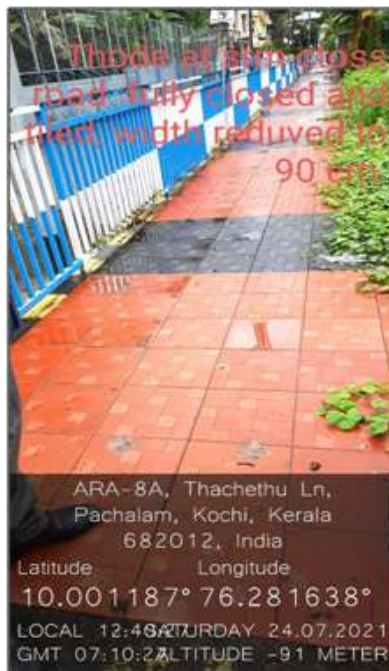
4. From Ch 655m to 693 m –
thode fully
covered and
tiled.Width
reduced to 90 cm.

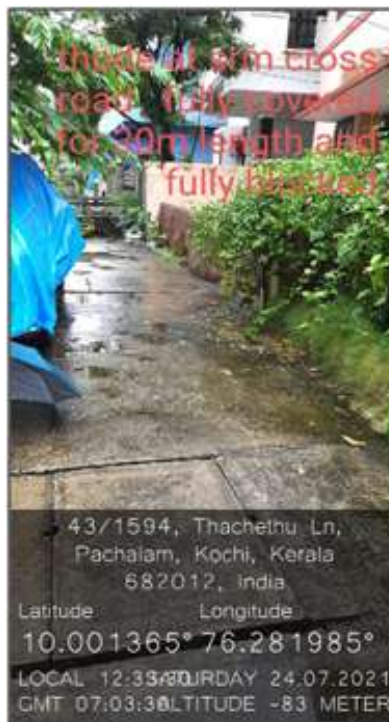
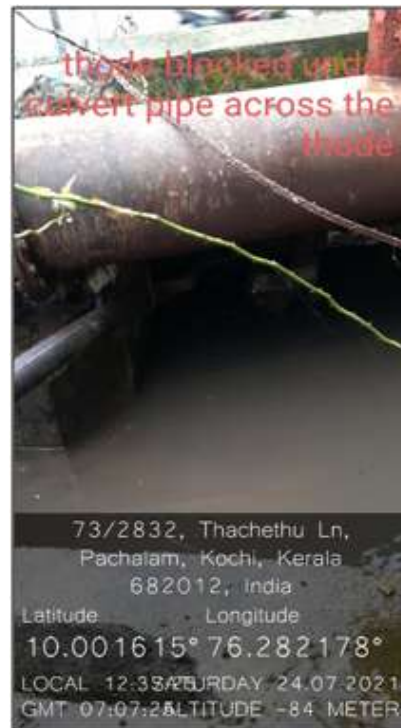
6. At Ch 788m
– thode fully
covered and
fully blocked.

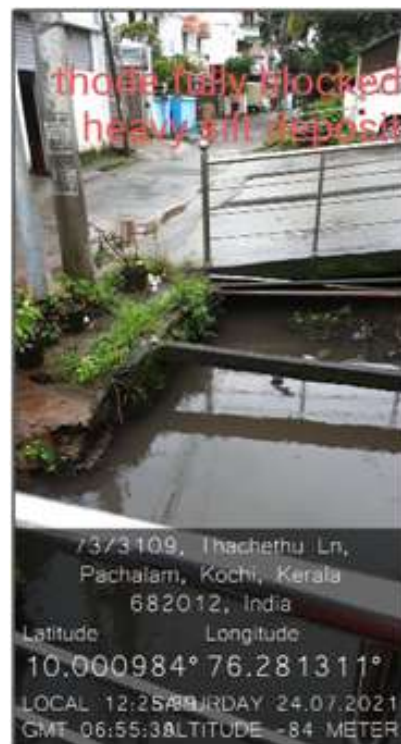
5. At Ch 731
m- thode fully
covered and
blocked

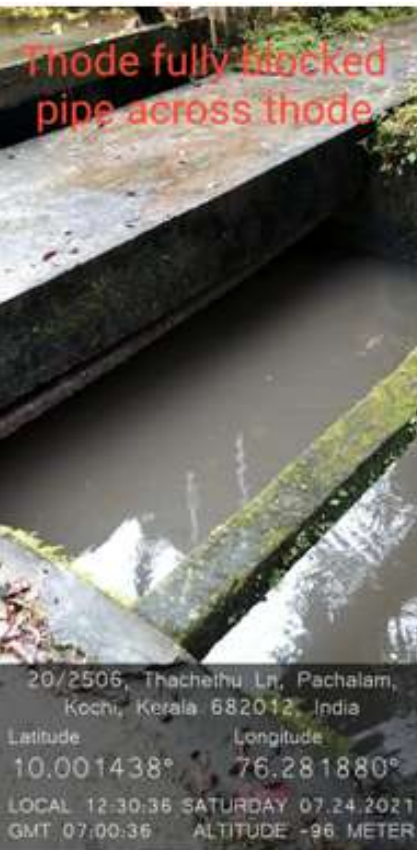
7. At ch
815m - Thode
fully blocked

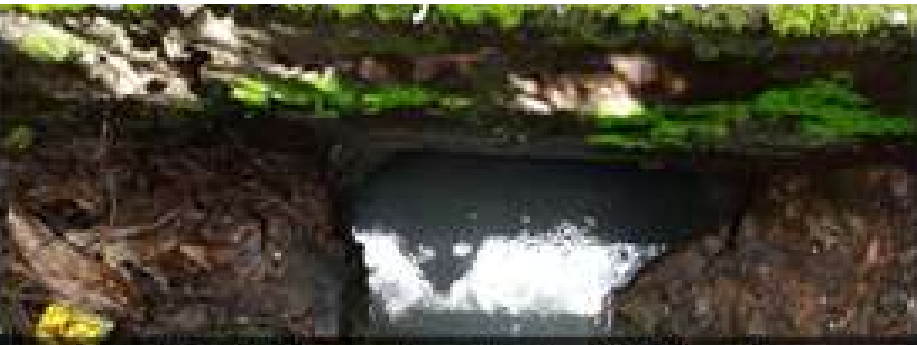
13. At Ch 1110 m -
Railway culvert at Justice
K K Mathew Ln to
Tatapuram- leading
channel fully encroached.

Railway culvert fully blocked

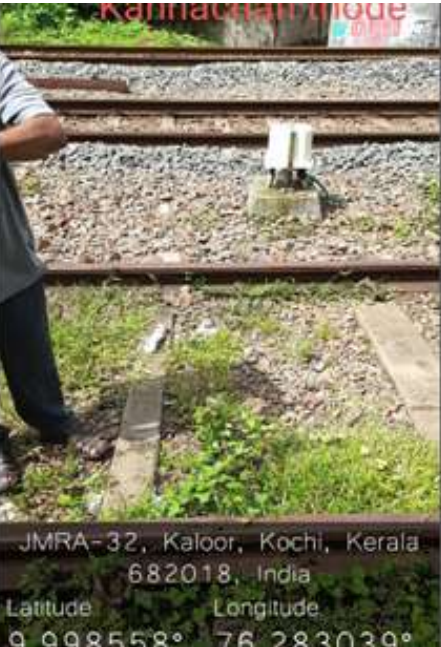
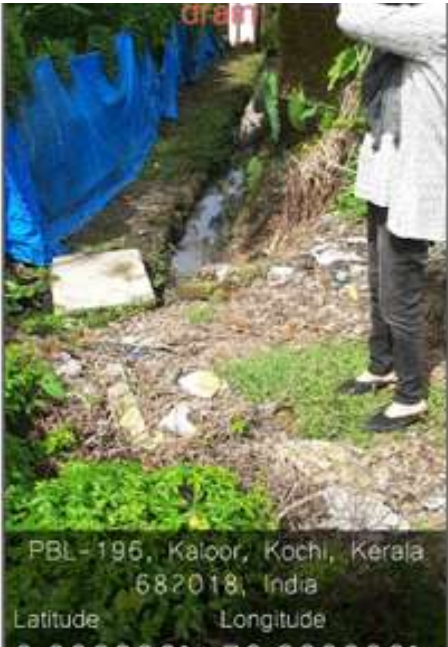
Water logged area east side of railway line.

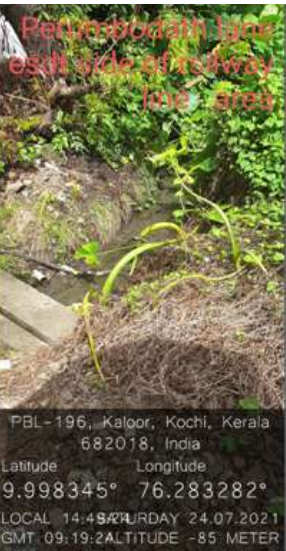
Water logged area east side of railway line, No flow

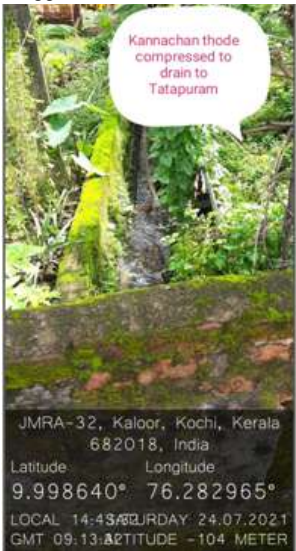
Leading channel to Tatapuram- encroachment

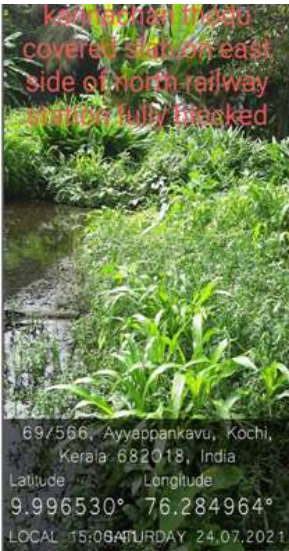
Water logged area east side of railway line.

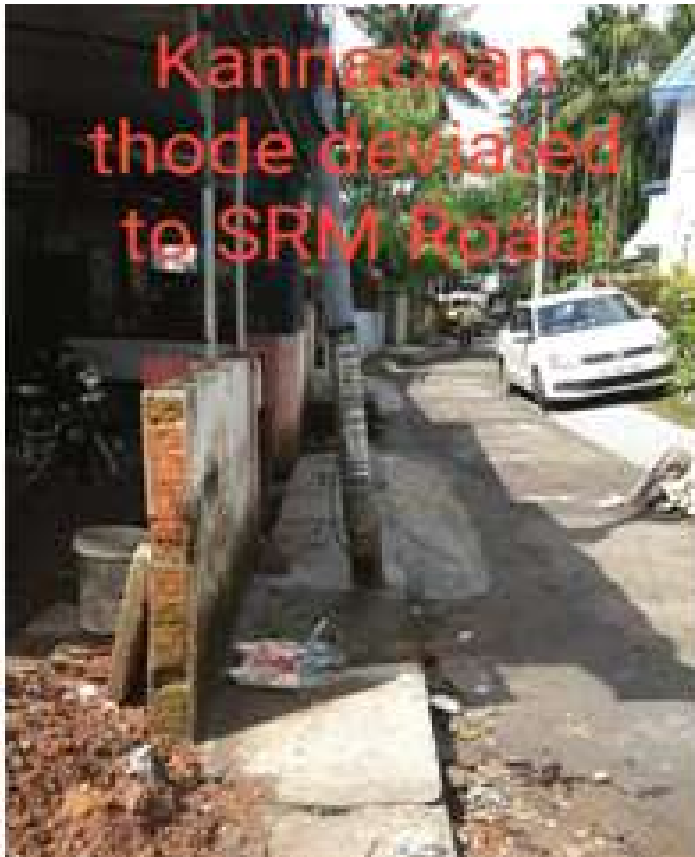
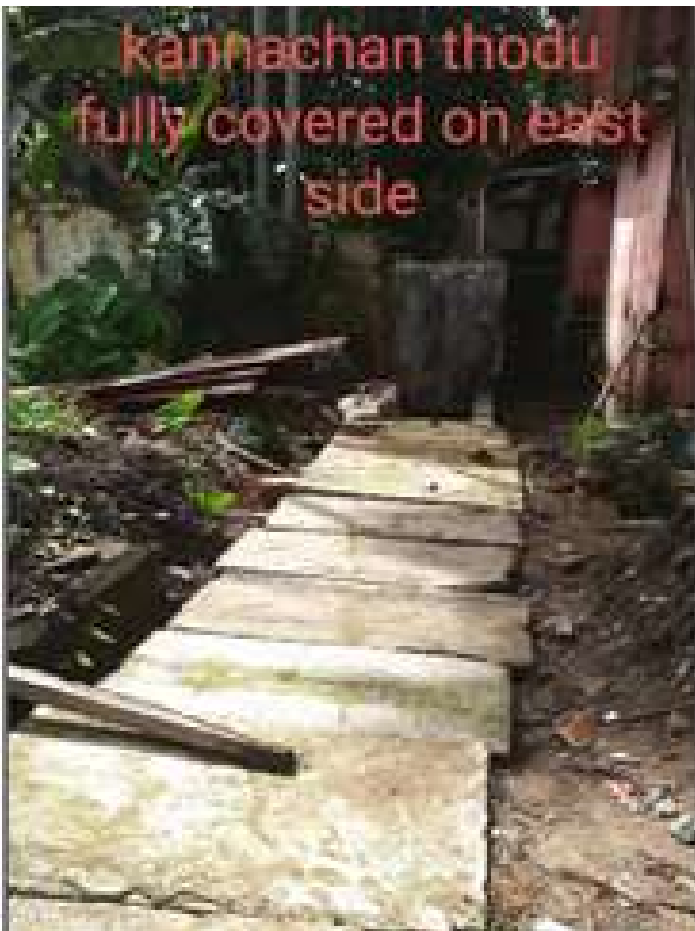
14. At Ch 1260m- toward North railway station, Kannachan thode deviated to SRM Road at Tagore Ln- fully covered and encroached.

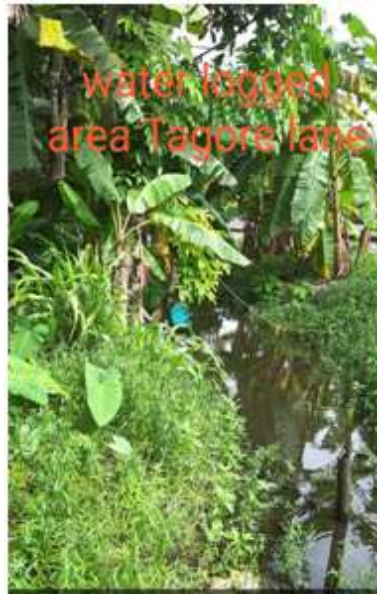
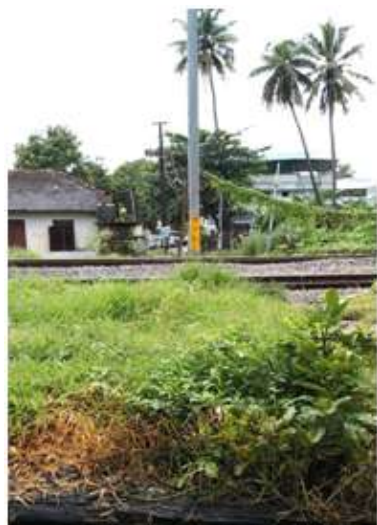
18. At ch.1110m
Kannachan thode
obstructed by
railway line

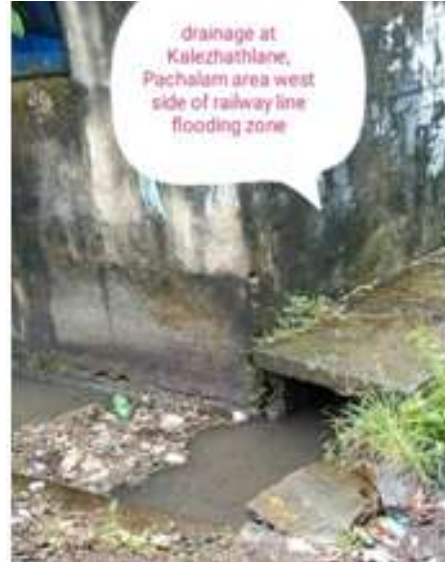
16. West side of
railway line at
Kalezhath
Ln. Railway culvert
blocked Kalazhath
Ln. flooding area
near Pachalam
market

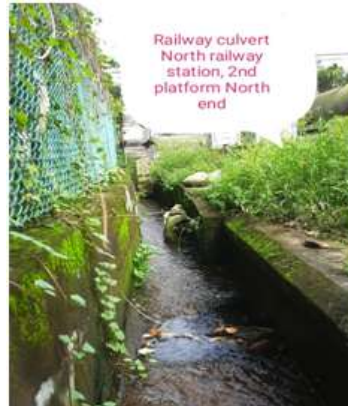
17. At ch 1400m
towards north
railway station. Not
functioning

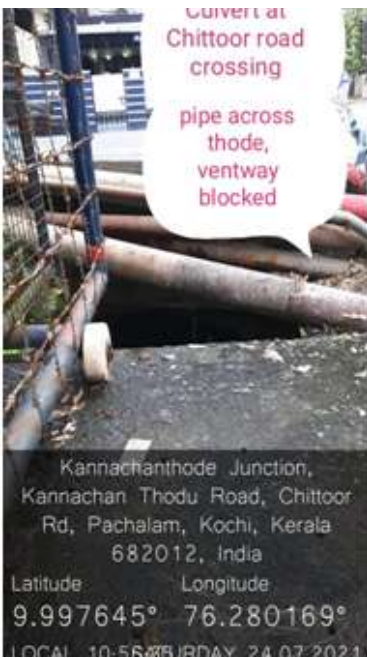
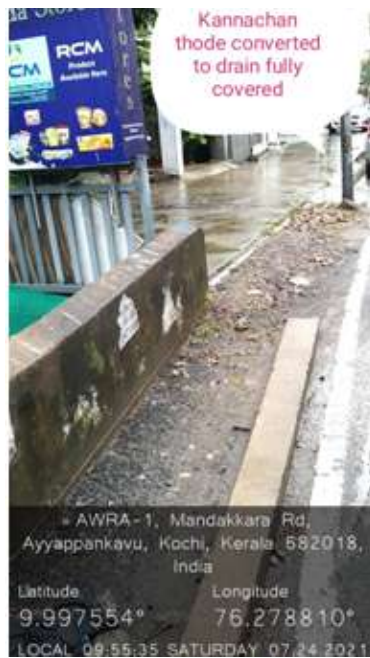
19. At ch1412m-
Thode fully covered
and encroached.

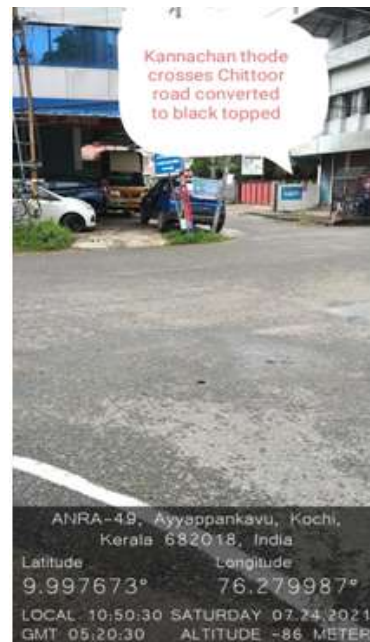
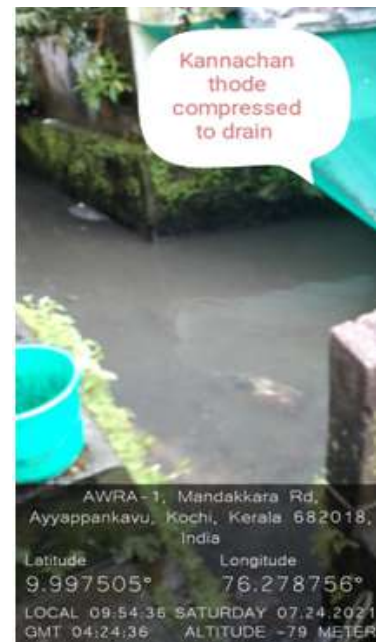
20. At ch.1755m Kannachan thode
meets with Mathai Manjooran road fully
covered.
(Diversion point of Kannachan thode
completetly covered by black topped
surface. Hence drain blocked)

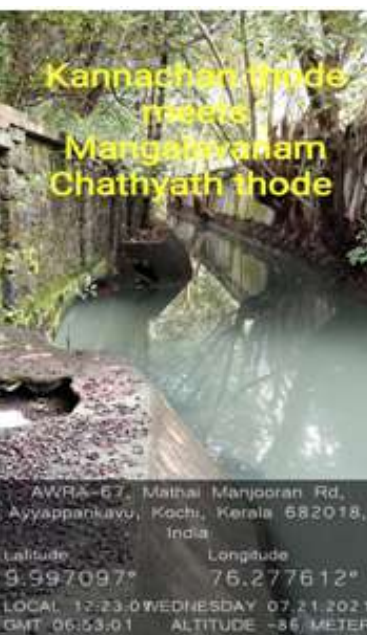
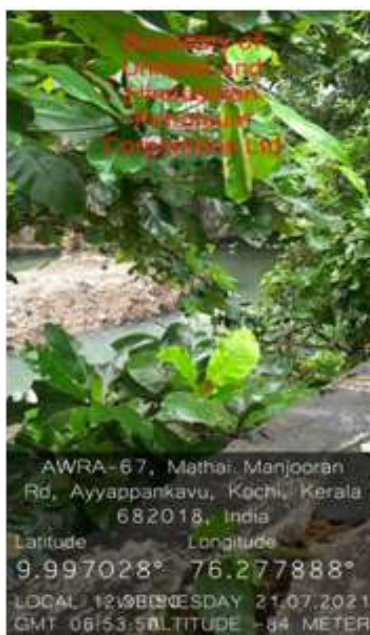
21. At ch.1790m Kannachan thode
meets with Mangalavanam Chathyath
thode
(Narrow point at joining point of
Kannachan thode with Mangalavanam
chathyath thode)

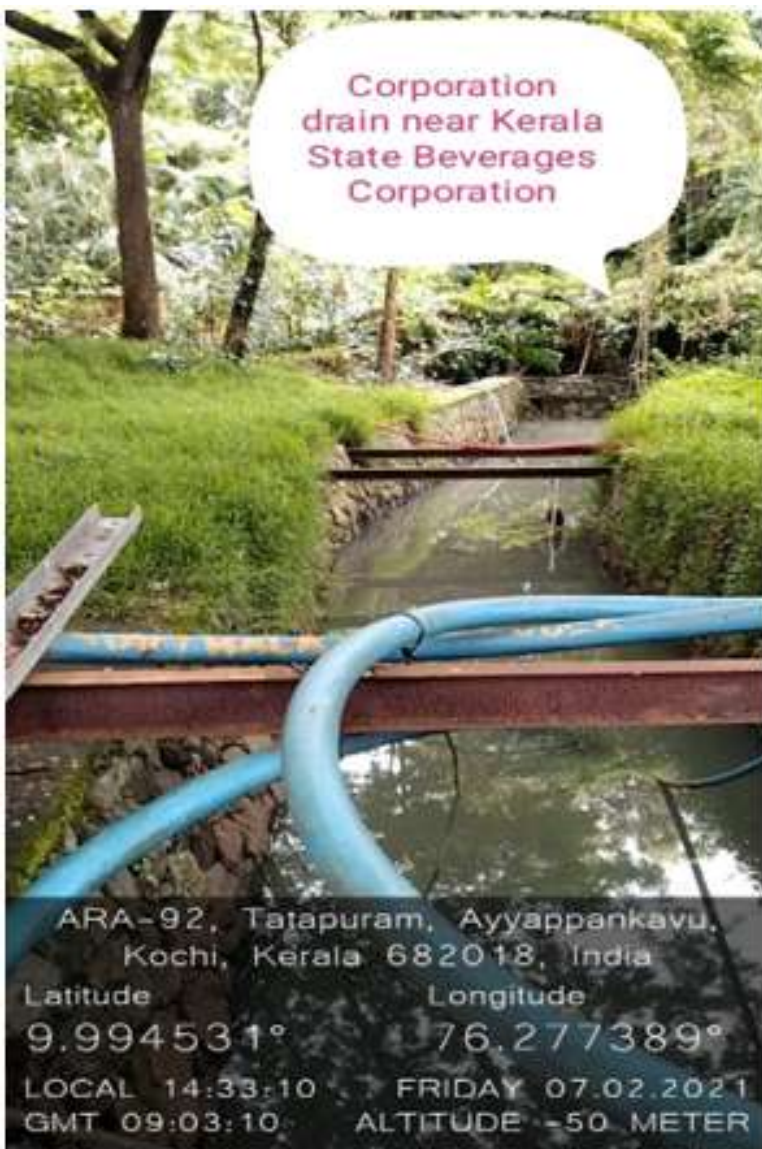
Corporation drain diverted to Mathai Manjooran road Flow blocked due to silt

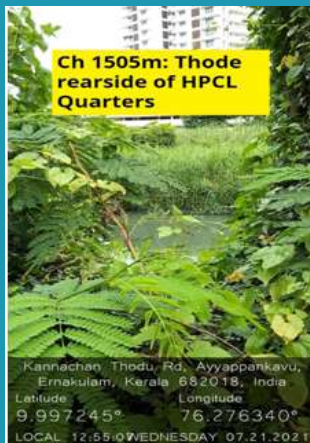
22. At ch.2130m Thick vegetation and silt deposit

Periodicdesiltingandcleaningof all the drainage system is to be arranged without fail

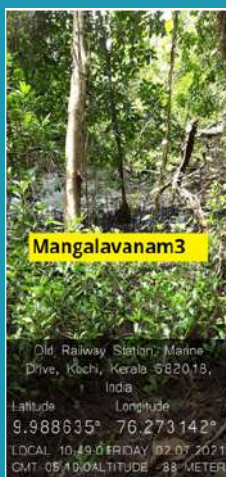
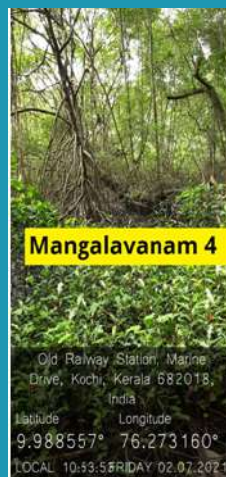
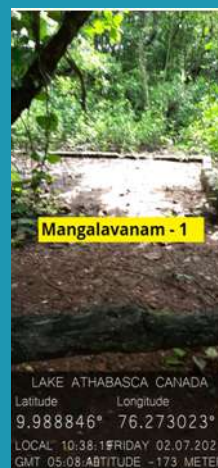
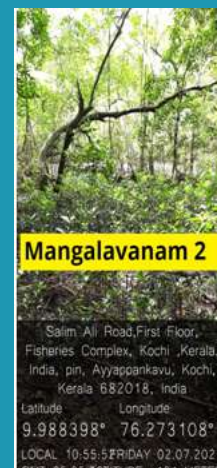
25. At.ch.2892m polluted corporation water to Mangalavanam. (Polluted water reaches to Mangalavanam)

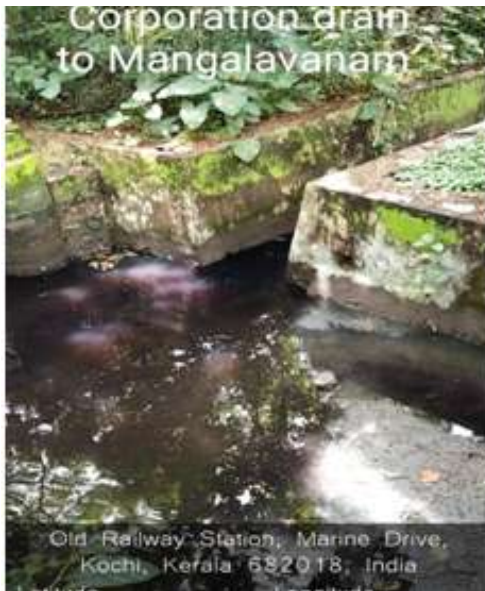
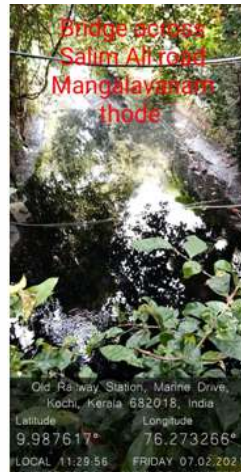
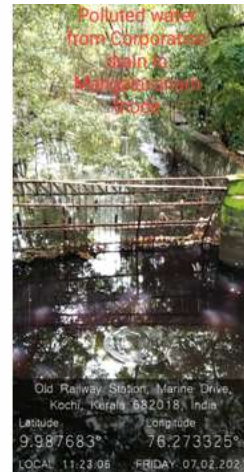
26. At.ch.3045 Brige at Dr. Salim Ali road heavy silt deposit and thick vegetation,no flow

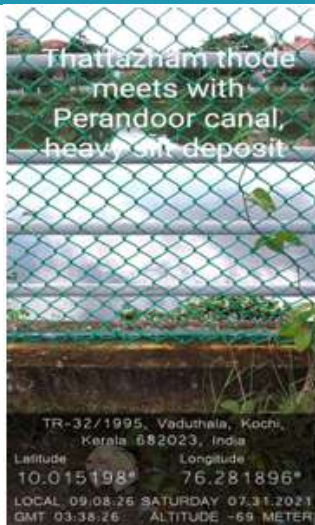
Thattazhamthode reduced to a drain at its origin.

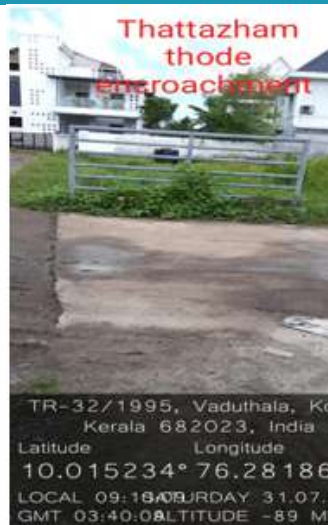
- At chainage 0m to 45m

Thode is converted to drain and road, fully covered

Entire length of thodu was converted to drain, the initial portion of the thode is also fully covered and converted to road. From chainage 741m itself draining out of water is deviated to Perandoorcanal ,(where the thode is originating from Perandoor canal)

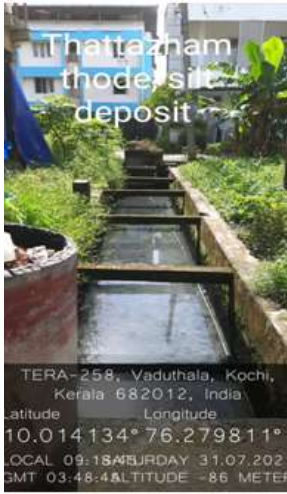
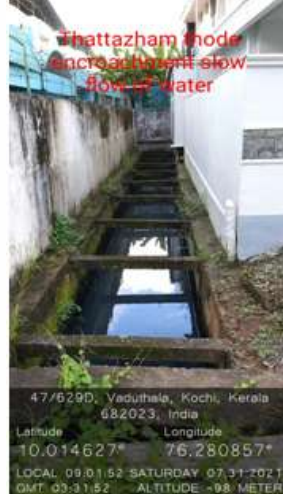
- At chainage 112m and 159m encroachment over slab

Slow flow of water and encroachment

- Demarkate boundary of thode and restore the alignment of the thode and allow the thode free from encroachment.
- Remove the cables and pipe from the vent way of culvert.
- Do protection works to shoreline.
- Provide maximum manholes/ openings to allow water to enter in to the drains
- Periodic desilting and cleaning of all the drainage system is to be arranged without fail.
- Vent way of every culvert point should be easily visible.

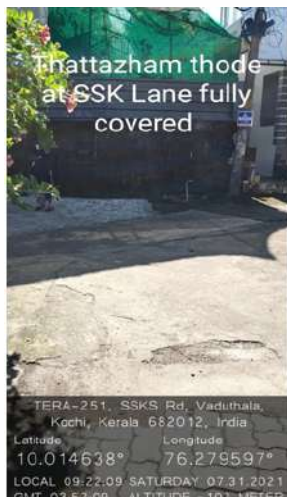
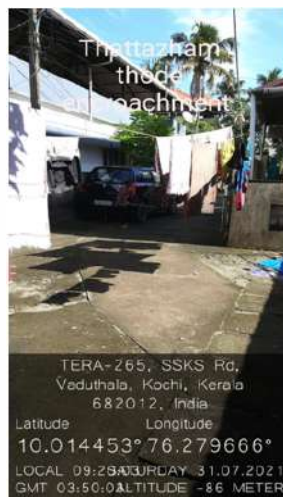
- At chainage 120, thode fully covered and converted to drain & encroachment

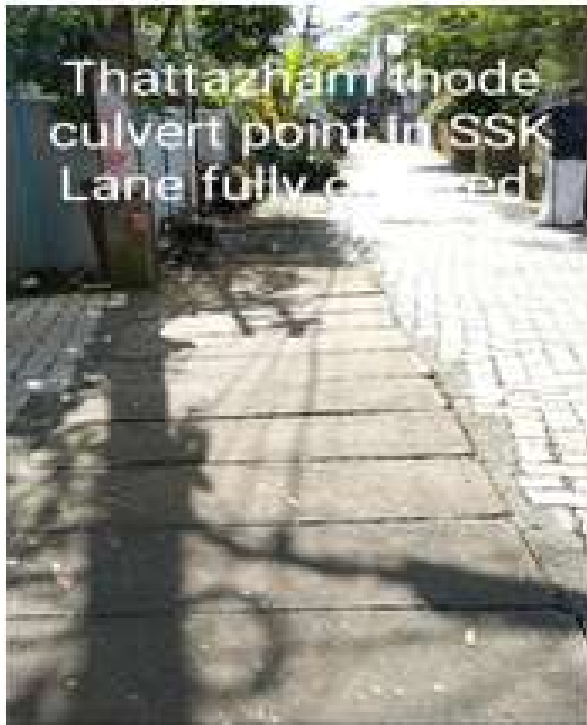
- At chainage 159m culvert point. Thode fully covered and converted to drain

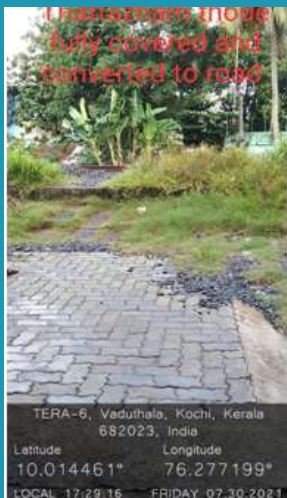
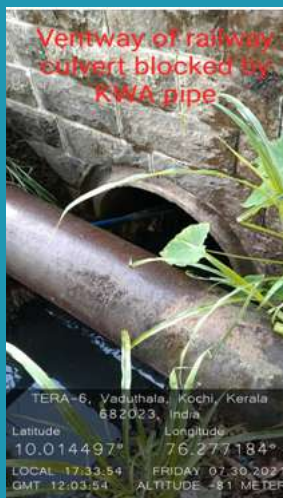
- At chainage 565m Railway cut the thode into two. Ventway of pipe laid below railwayline blocked by KWA pipeline. Thode just before entering the railway culvert point is fully covered, flow of water is blocked here.

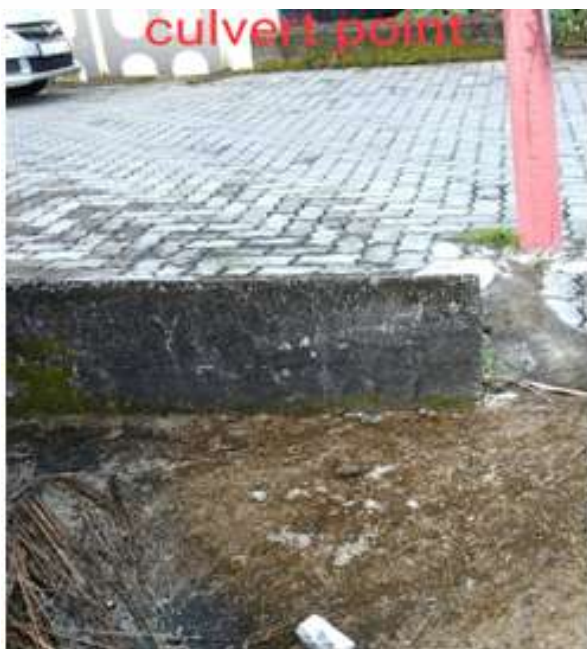
- At chainage 1500m heavy silt deposit upto Vembanattkayal, (70 m length)

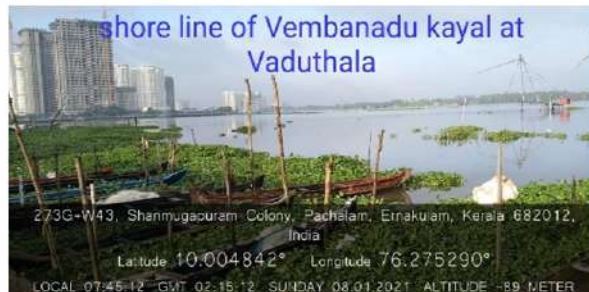
- Shoreline of vembanadkayal at Vaduthala area is of heavy silt deposit, thick growth of weeds.

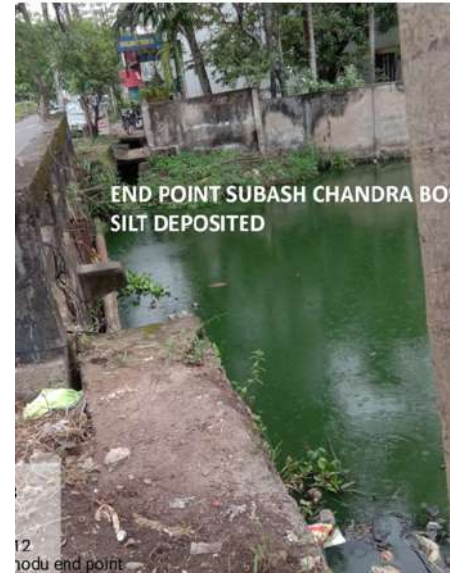
From ch:240m to 920 m many apartments complexes were constructed on both sides of the thodu and boundary walls of these buildings are seems to be encroached to the thodu.

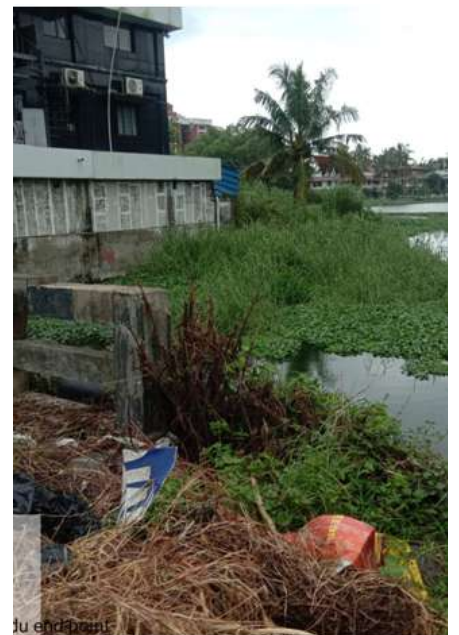
At ch:920 m Subhash Chandrabose road crosses the thodu and a bridge was constructed there with span of 2.5 m .Width of the thodu at this chainage is 16.5 m and the unscientific construction of the bridge almost completely blocked the flow and even in high tide the nearby the areas becomes flooded.
