REPORT ON
**FLOOD
MITIGATION
KOCHI**

IRRIGATION DEPARTMENT
ERNAKULAM
2021

EXECUTIVE SUMMARY

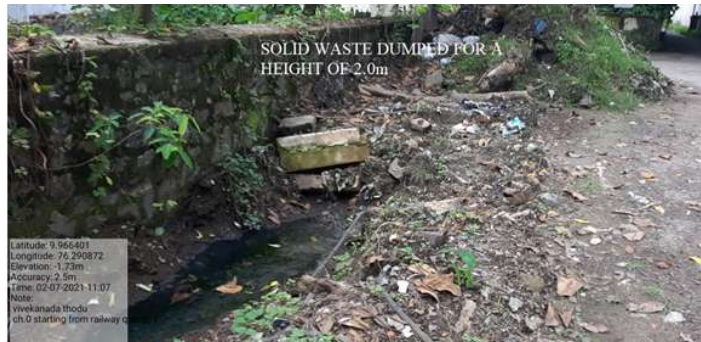
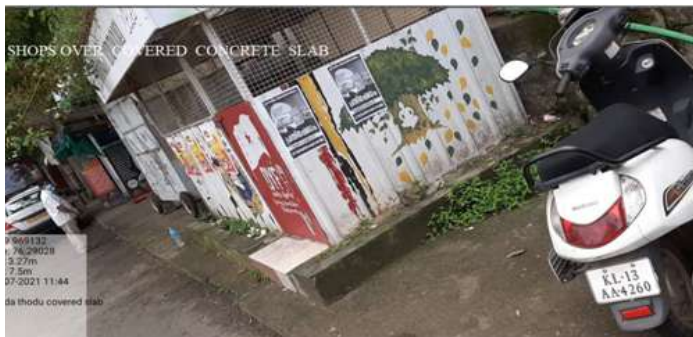
Apart for a length of 300m of the thodu for which the width of the thodu is 2.4m, major portion of the thodu have an average width of 1.70m which has to be reconstructed for an original width of 2.40m.

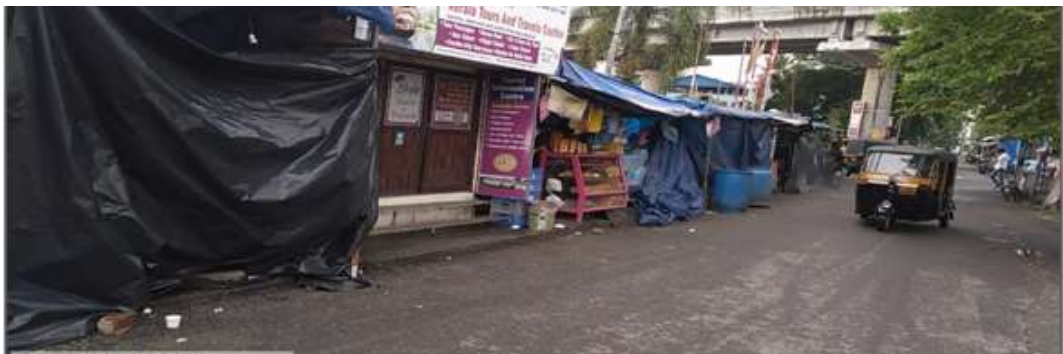
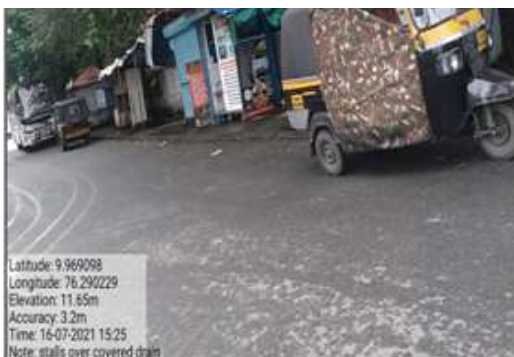
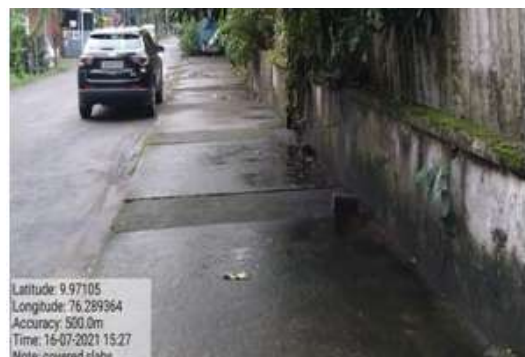
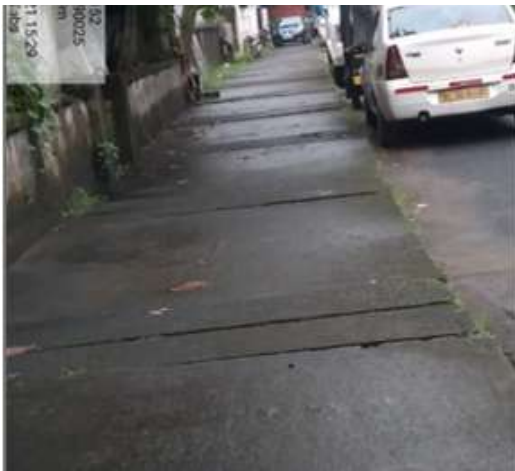
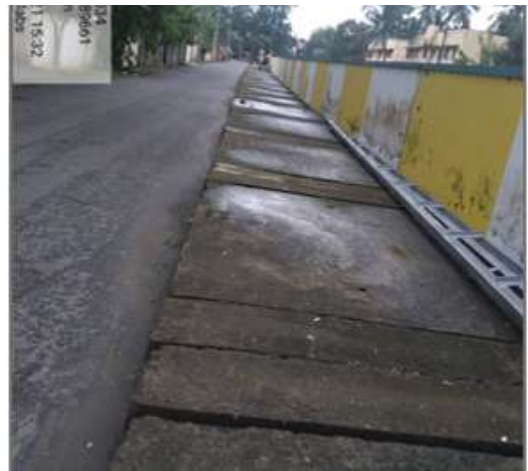
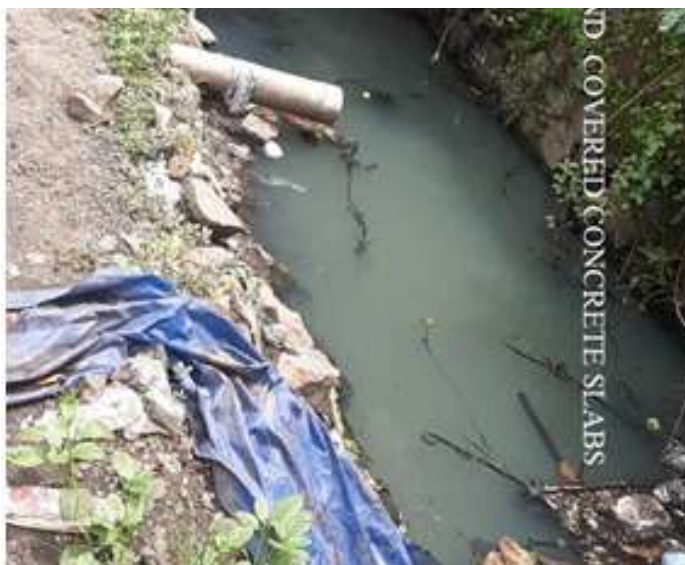
- Along the Vivekananda road starting from the front of south railway station (metro pillar No.740), shops are built over the thodu which was covered by concreteslabs for a length of 200 m . Hence regular desilting of the thodu cannot be done.

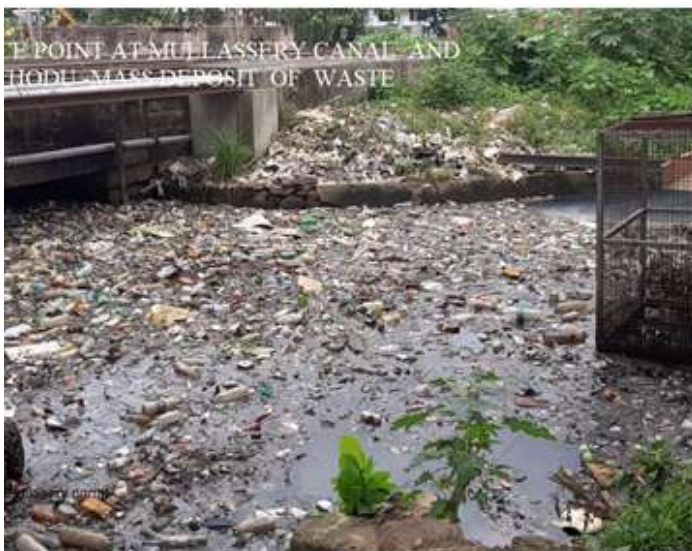
·This natural thodu was converted to the status of a road side drain covered with slabs restricting entry of rainwater into this thodu. Open portion of this thodu were blocked at various intermediate stretches especially along the warehousing corporation road by the accumulation of silt and waste disposal mostly sewage waste resulting in the storm water not reaching its intended outlets.

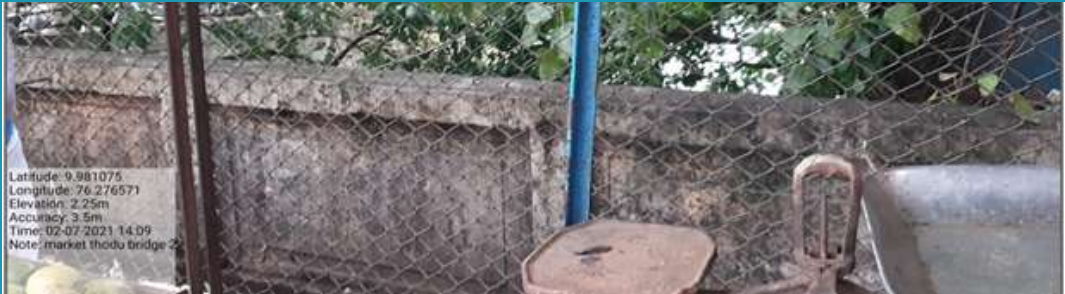
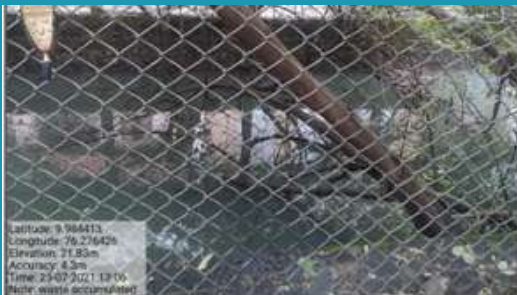
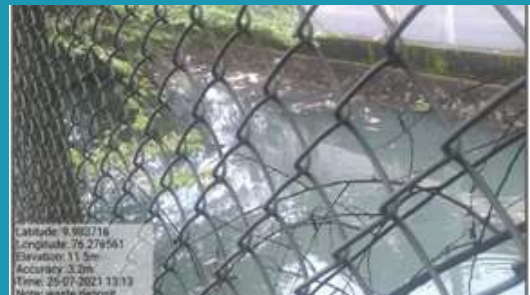
Thick jungle covering the stretch of the canal upto the Marine Drive bridge for a length of 500m.

- Flow of water is obstructed due to waste disposal at the starting point upto a length of 10m.
- Silt deposit along the bridges of the canal inside the market thereby obstructing the flow.
- Protective wire mesh tampered and side protection works destroyed for mass waste dumping from shops along the Basin road for a length of 25 m.

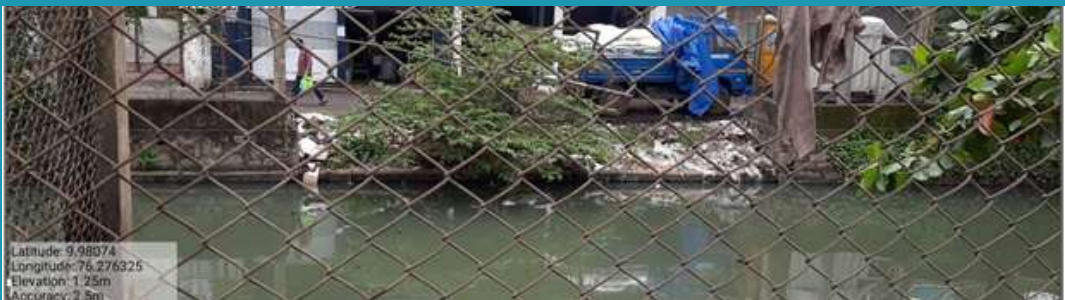
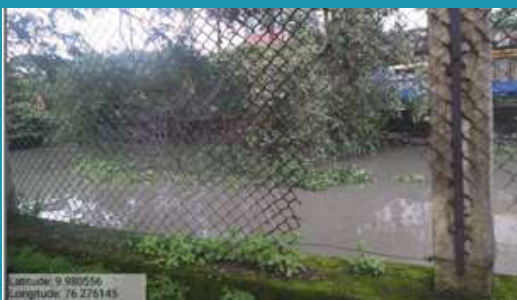
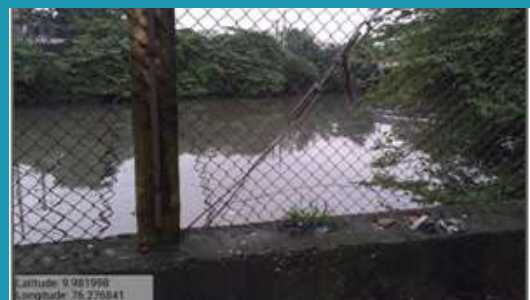
Flow of water is obstructed along the Ch from 0.00 m to Ch 10.00 m due to waste disposal.

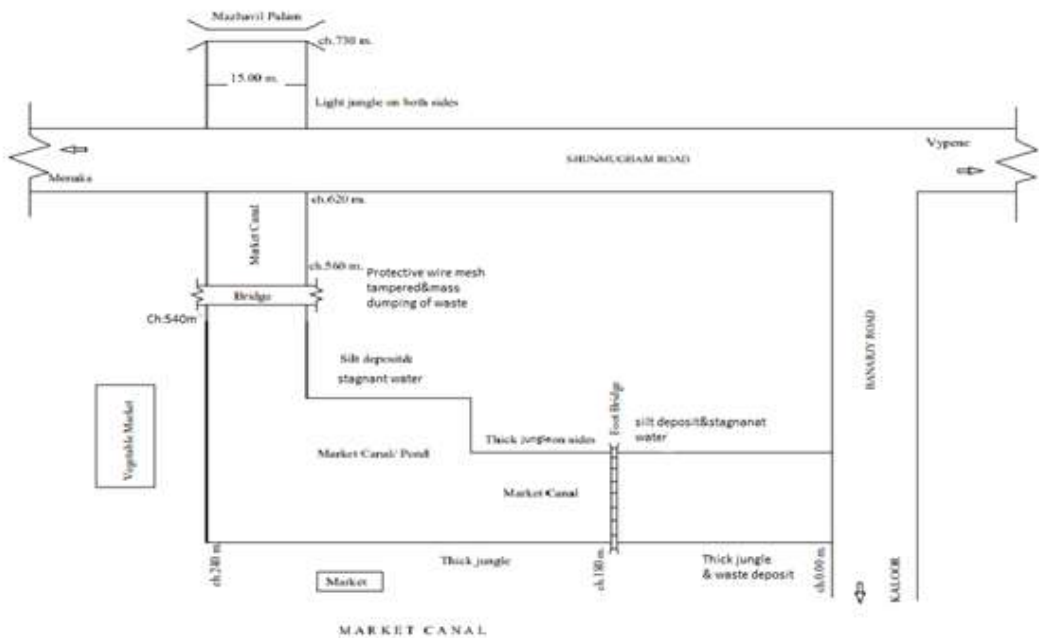
LINE SKETCH

Thick jungle and
waste deposit
